Dunkellin River and Aggard Stream Flood Relief Scheme,  
Description of the Proposed Works

# Galway County Council

### Description of the Proposed Works

TOBIN CONSULTING ENGINEERS

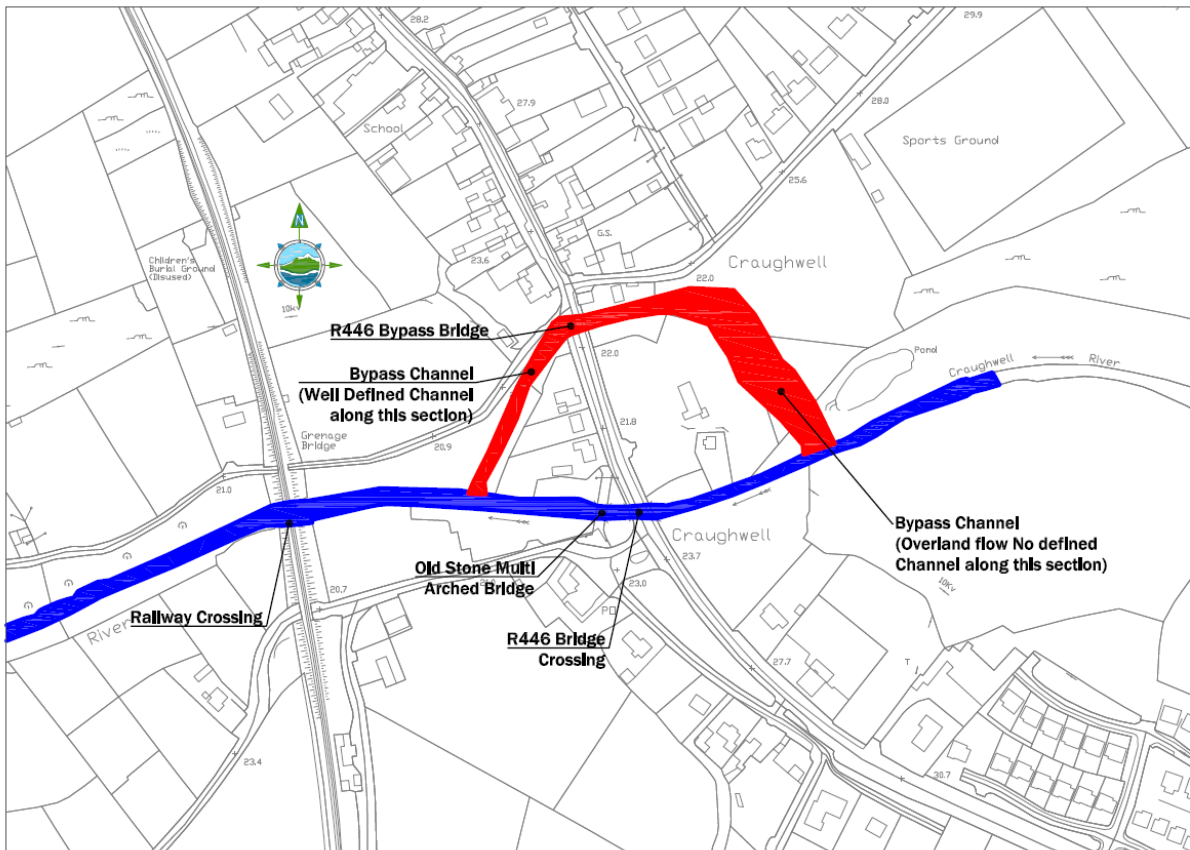
During normal flow conditions, surface water flows are restricted to the main Craughwell River, coloured blue in Figure 1-4, and pass under two bridge crossings namely; the main R446 Bridge (formerly N6) and the old multi-arched stone bridge.

However, when flow conditions dictate excess surface water flow is directed around the main bridge crossing via an overflow channel and a further bridge crossing of the R446, highlighted in red on Figure 1-4. The effectiveness of this overflow channel (bypass channel) is limited, as it is not fully connected to the Craughwell River at its upstream location. High flows must follow a short section of overland flow before entering the overflow channel.

**Figure 1-4 – Zone 1 Craughwell River at Craughwell Village**

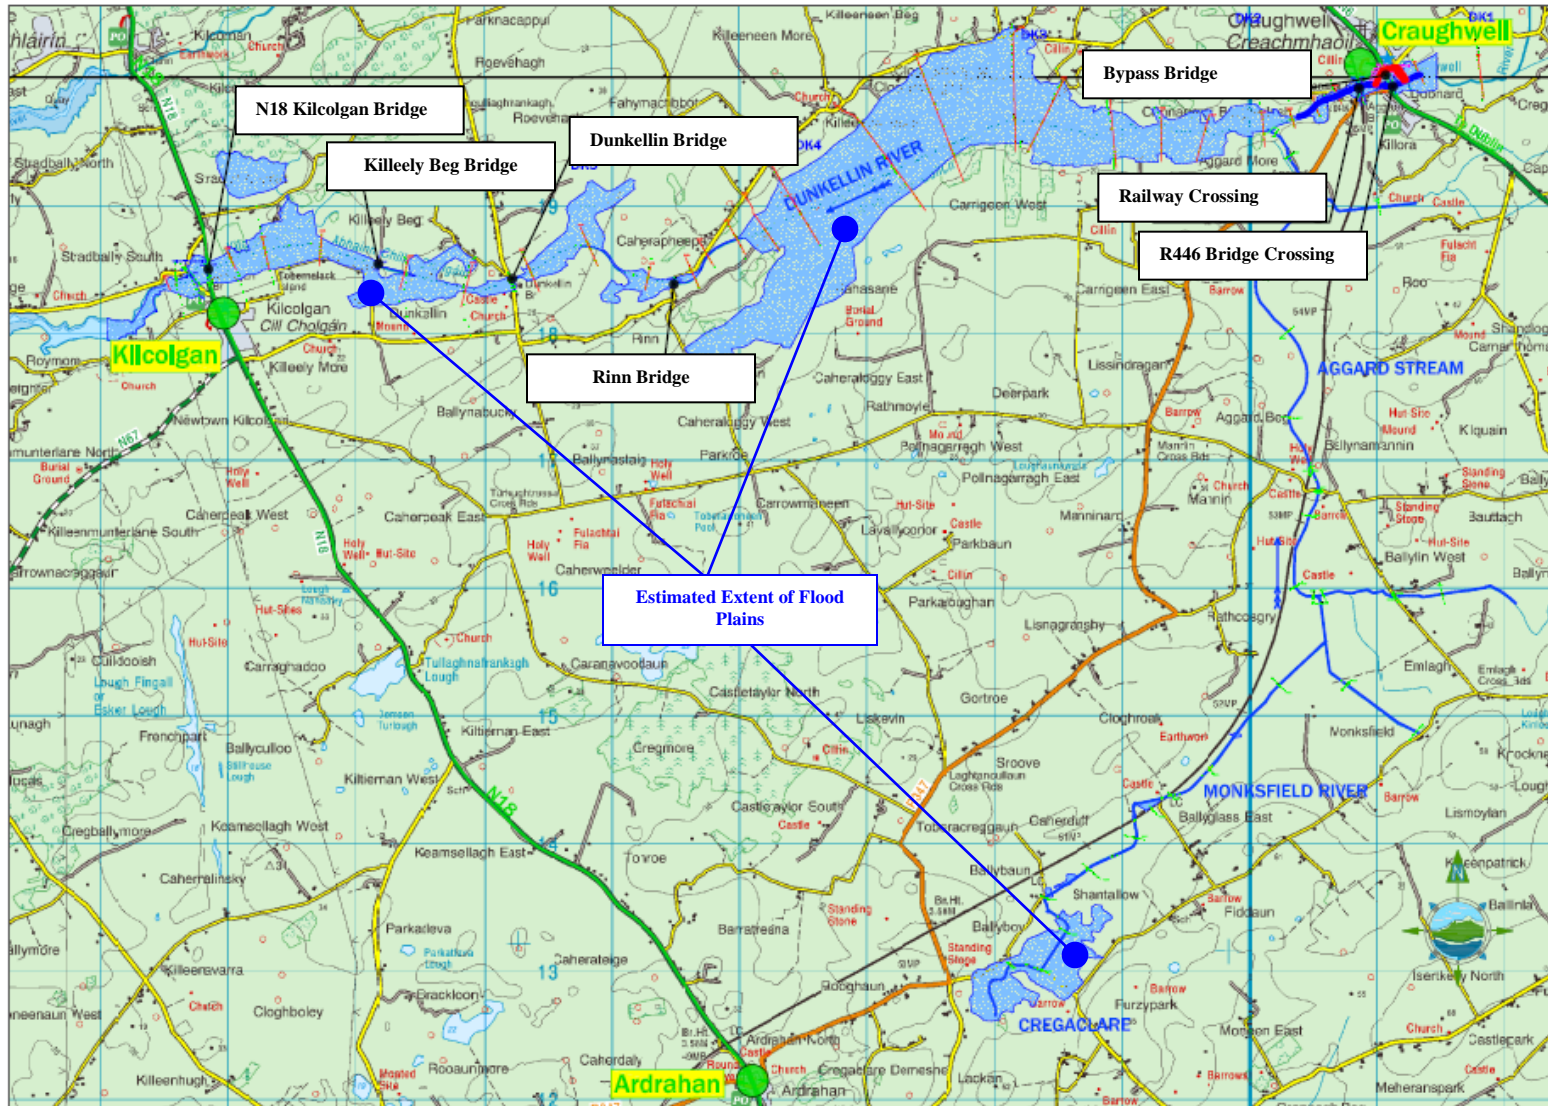
Following a review of aerial photography of the November 2009 event and by establishing an account of local anecdotal evidence, the estimated flood plain during the November 2009 event can be established. This flood plain is shown in Figure 2-3.

Figure 2-3 – Estimated Flood Plains along the Dunkellin and Aggard Stream based on Photography of the Nov 09 Event and local anecdotal evidence

From the recorded hydrographs of the event, aerial photography, measured wrack levels, direct observation from local residents and the estimated flood plain contained in Figure 2-3 it can be observed that:

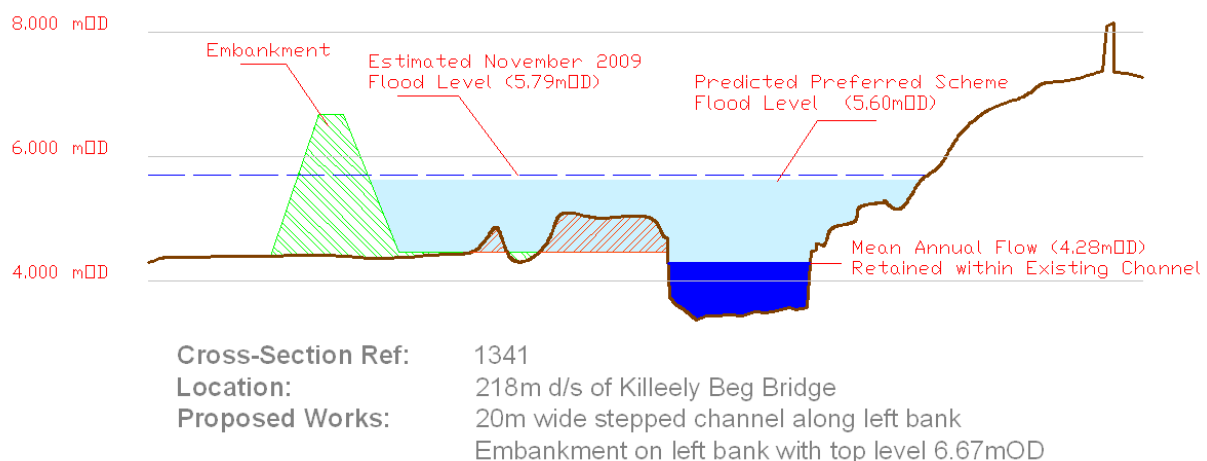
Figure 3-1 provides an illustration of a typical cross section of the works to be undertaken along this section of the Dunkellin River.

**Figure 3-1 – Typical Cross Sectional Detail downstream of Killeely Beg Bridge**

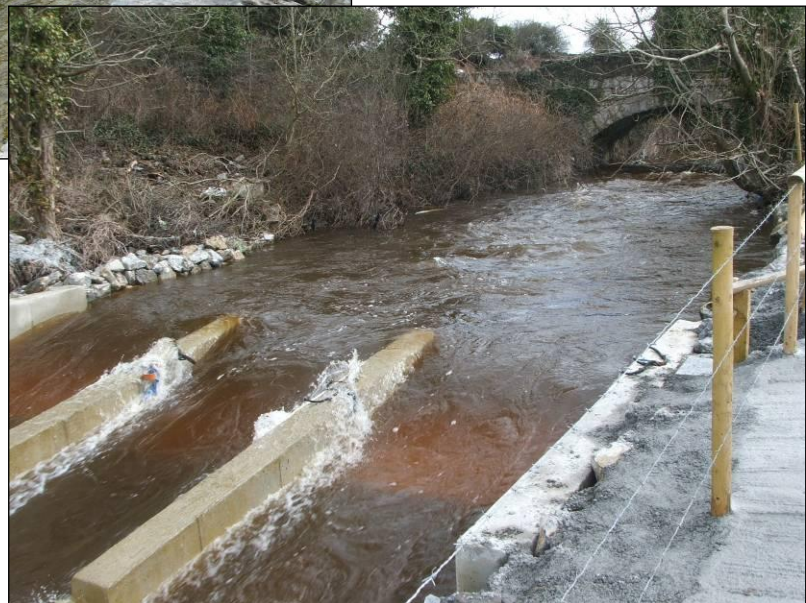
*It is proposed to replicate the existing structure at a location upstream of the Killeely Beg Bridge.  
Note : change in depth of flow at this structure*

The proposed salmon counter will be constructed in cast-in-situ concrete and this will be undertaken in two halves, utilising cofferdam type construction whereby flow can be restricted to one half of the channel width allowing the civil engineering works to be undertaken in the dry conditions of the other half. This method of construction reduces the risk of wet concrete and other construction debris entering the river.

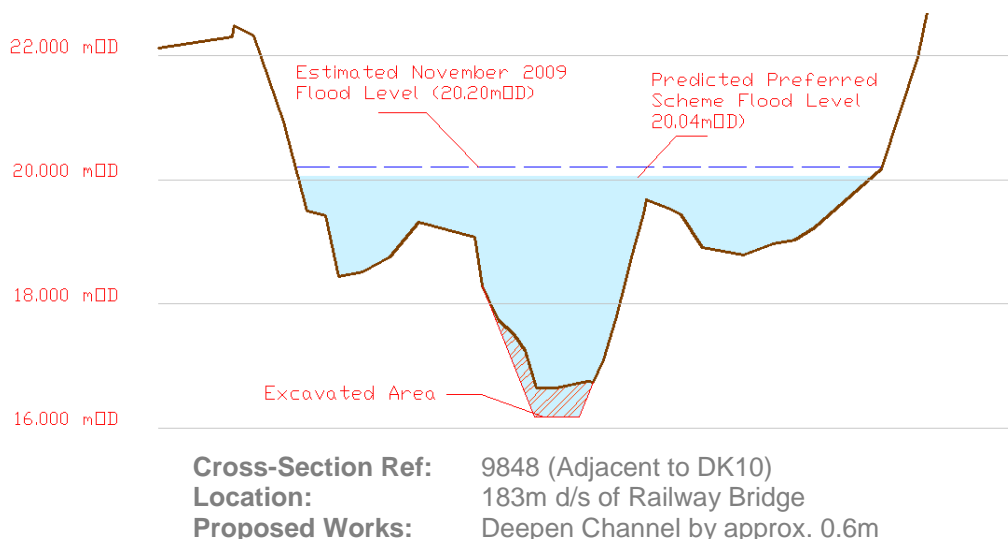
Figure 3-8 provides an illustration of a typical cross section of the works to be undertaken along this section of the river in the vicinity of Craughwell Village.

**Figure 3-8 – Proposed Works Channel Works in the vicinity of Craughwell Village and sketch of cofferdam location**

It is envisaged that excavation of the channel in this location will be dependent on the phasing of works along the bypass channel, low flow conditions in the river and the extent to which flow in the river can be diverted or restricted to one half of the existing channel. In addition it is also proposed to retain existing bankside trees (if healthy and suitable for retention) provided that their retention does not pose a concern with regard to the safe construction of the works, safe recreational use of the channel and safe maintenance of the channel. It is expected that a qualified arborist will be retained at the detailed design stage to examine and determine the most appropriate trees that can be retained or if necessary make recommendations with regard to the replacement of trees that require removal.

Works associated with channel deepening in the vicinity of the old stone bridge and the bridge crossings of the R446 can be undertaken in dry conditions whereby the bypass channel can be utilised a diversion route once the proposed channel works and underpinning on the bypass channel are complete.

It is envisaged that temporary cofferdam type construction or temporary sheet pile walls (with a length of 50 to 100m depending on the depth of water and ground conditions) will be used in the location described in Figure 3-8. This process allows river water to be directed to one half of the channel width allowing the civil engineering works to be undertaken, in relatively dry conditions, on the other side of the channel. Once this half of the proposed channel works is excavated, within the confines of the cofferdam, it is expected that river water will be directed to the new section allowing the adjacent excavations to be completed. This sequence of construction is expected to commence at the lower downstream point of the works and continue upstream in this “*leap-frog*” type construction method. This method of construction reduces the risk of construction debris and silt entering the river.

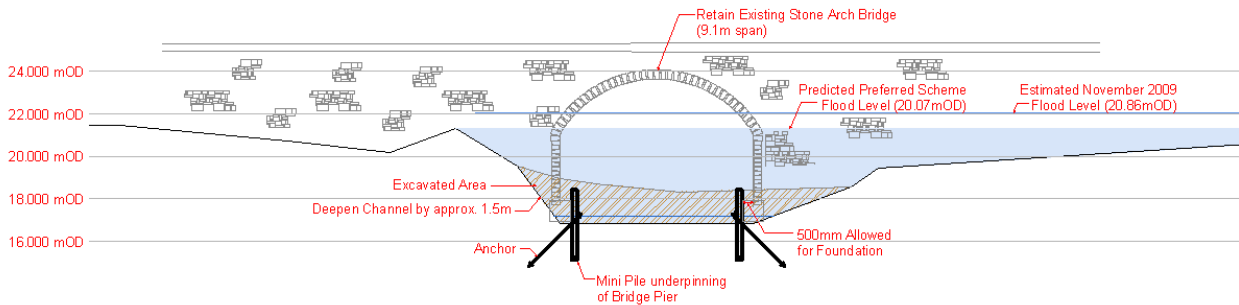
It is envisaged that the foundations of the existing railway bridge will require scour protection through the use of a secant or contiguous piled wall along each side of the bridge piers or abutments i.e., item (b) above. However, this work will require the use of either a floating barge or construction of a temporary cofferdam to facilitate access to the bridge piers. The use of temporary cofferdams allows the works to be undertaken in two phases, whereby flow can be restricted to one half of the channel width allowing the civil engineering works to be undertaken in the dry conditions which exist within the other half of the channel.

**Figure 3-9 – Proposed Works at the Railway Bridge in Craughwell**

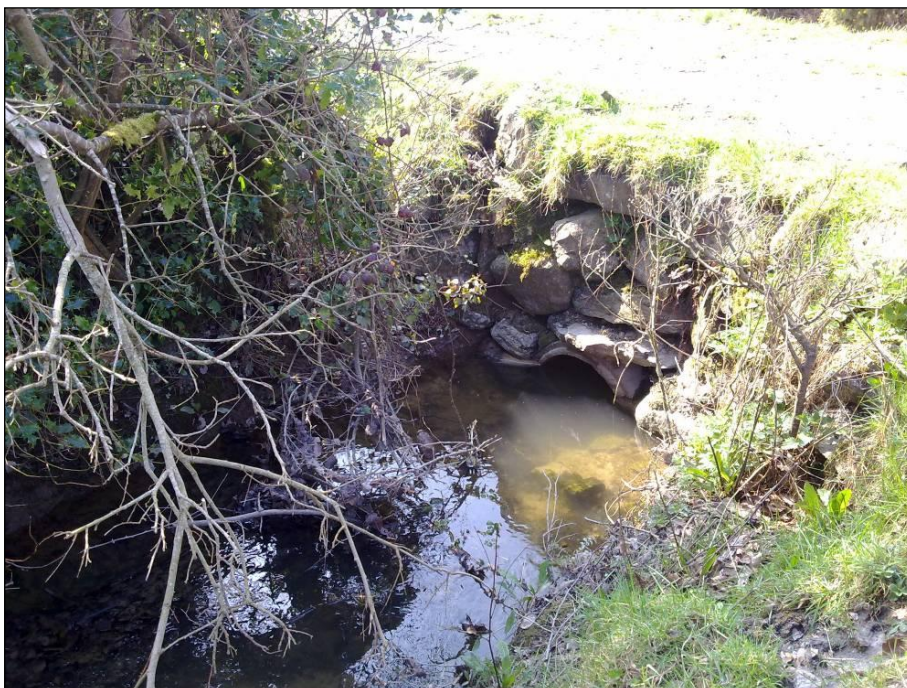
The proposed works along the Aggard Stream will consist of culvert replacement works whereby existing blocked and undersized piped crossings will be replaced with larger diameter piped culverts. The proposed works will involve minor localised excavations within the existing stream. The overall proposal for works along the Aggard Stream is to replace blocked culverts (circa 14 No. culverts) with 1500mm diameter precast concrete open jointed pipes.

Photographs No. 24 & 25 provide an illustration of typical culverts which require replacement along the Aggard Stream.

**Photograph 25 – Typical Culvert along the Aggard Stream which requires replacement**

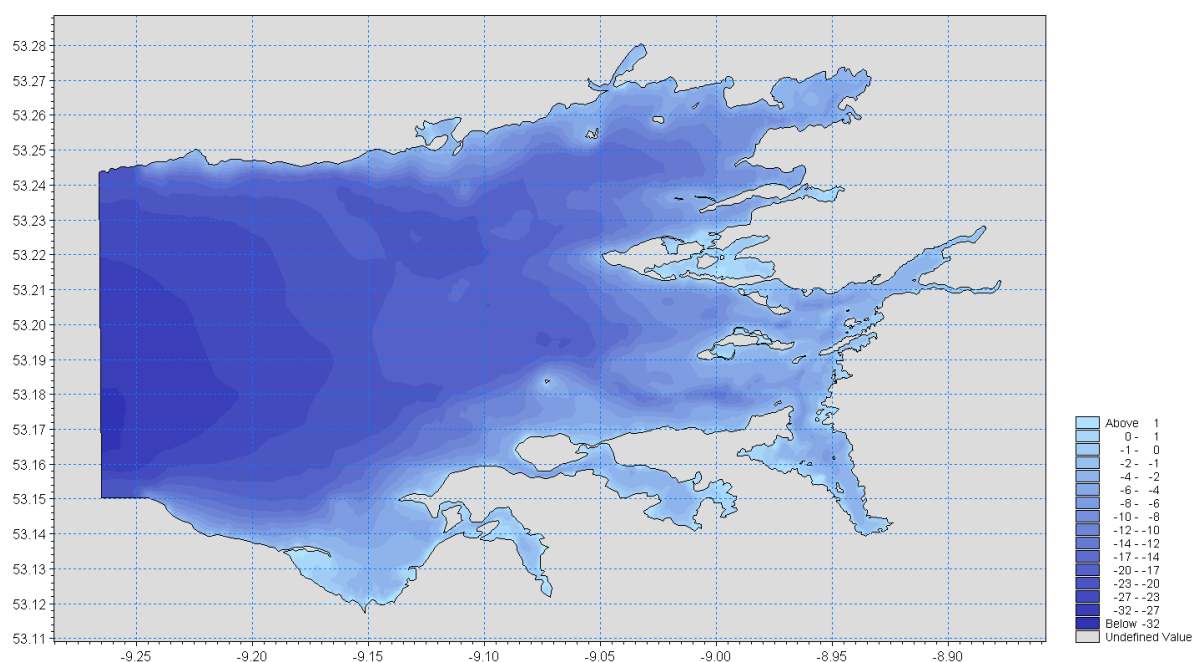
**Figure 2.1: Galway Bay model Extent and bathymetry**

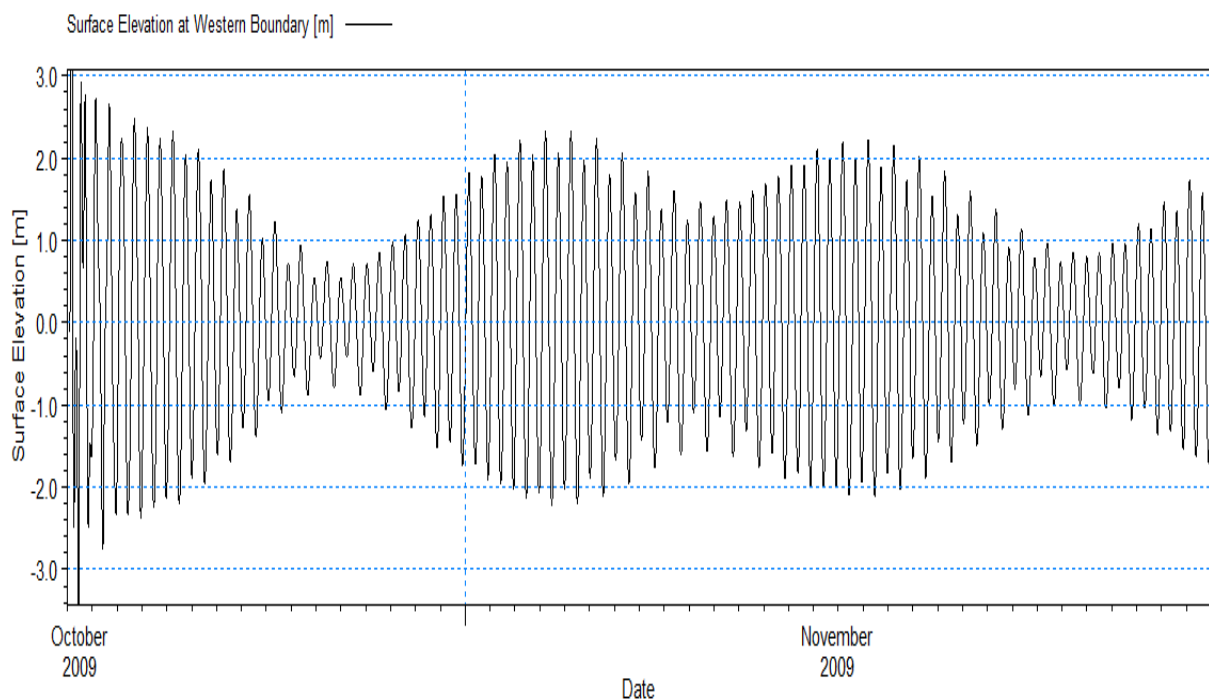
**Figure 2.2: Tidal elevation inside Galway Bay.**

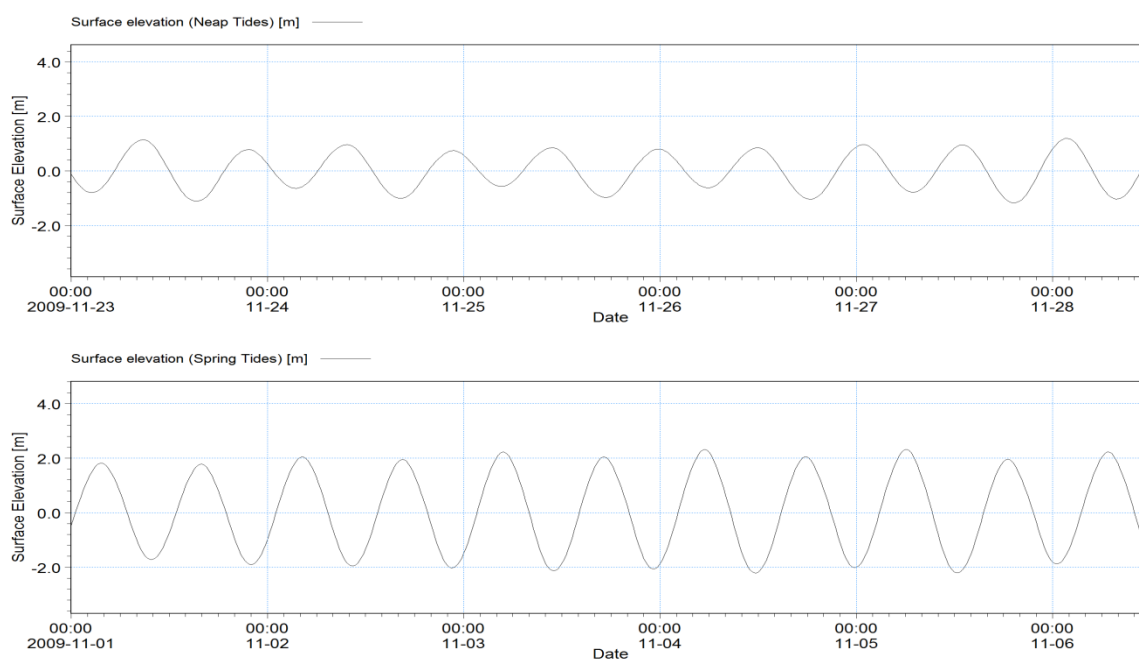
**Figure 2.3: Surface elevations during Neap (upper) and Spring (lower) tides**

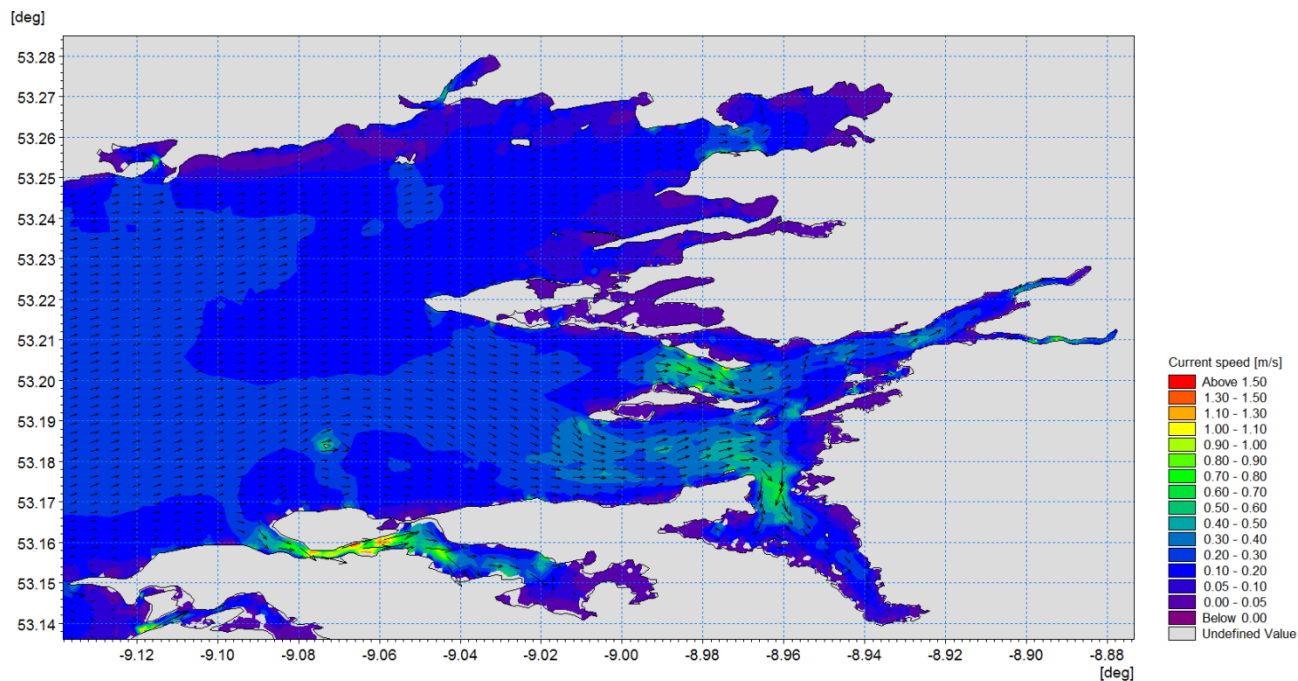
Figure 2.4: Current velocities during a typical spring flood tidal regime

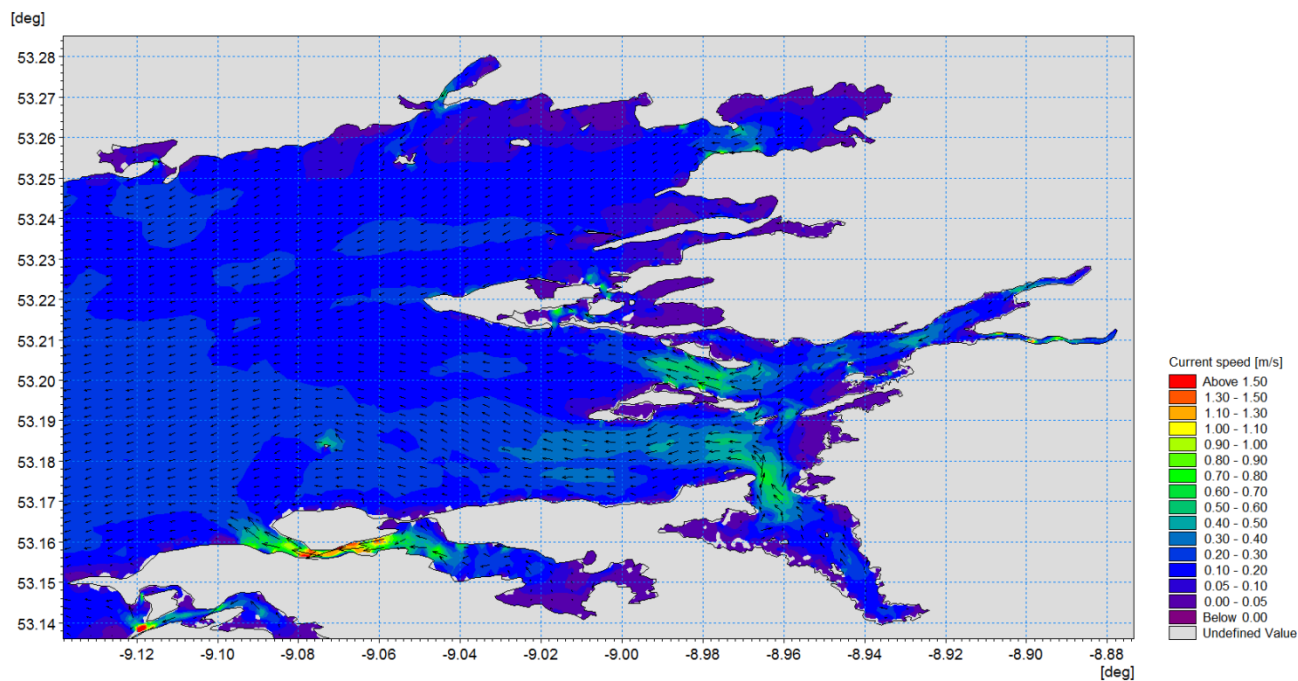
Figure 2.5: Current velocities during a typical neap flood tidal regime.

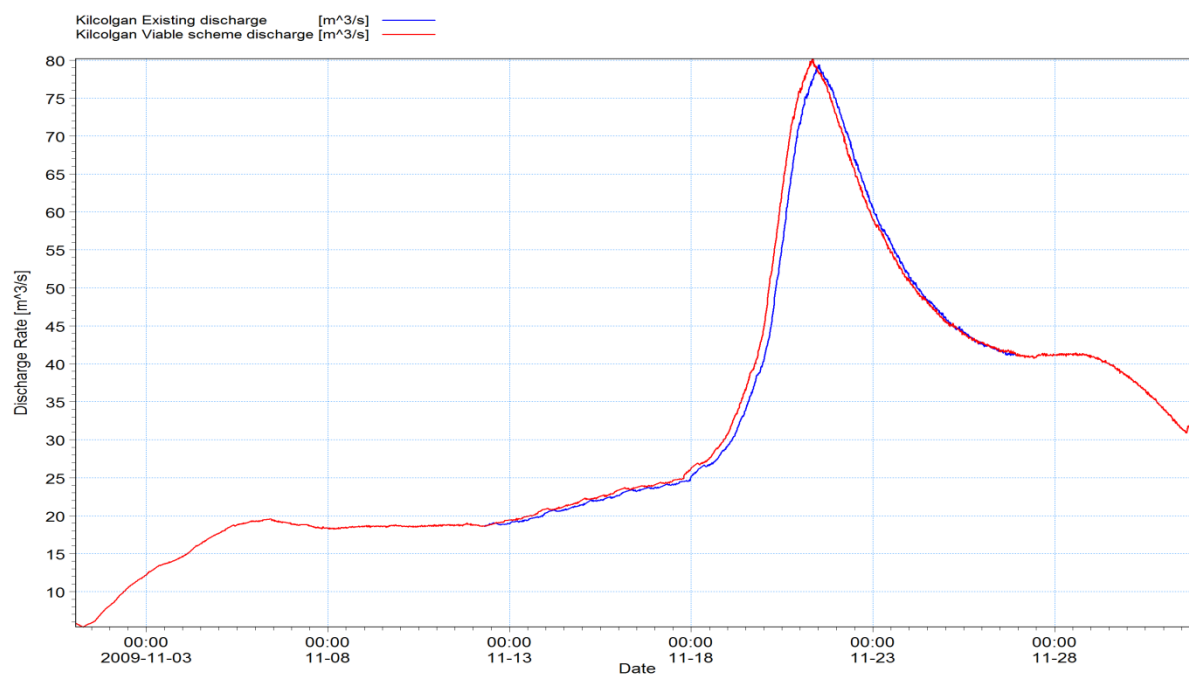
**Figure 2.8: Kilcolgan hydrographs: existing (blue) and proposed Dunkellin Scheme (red)**

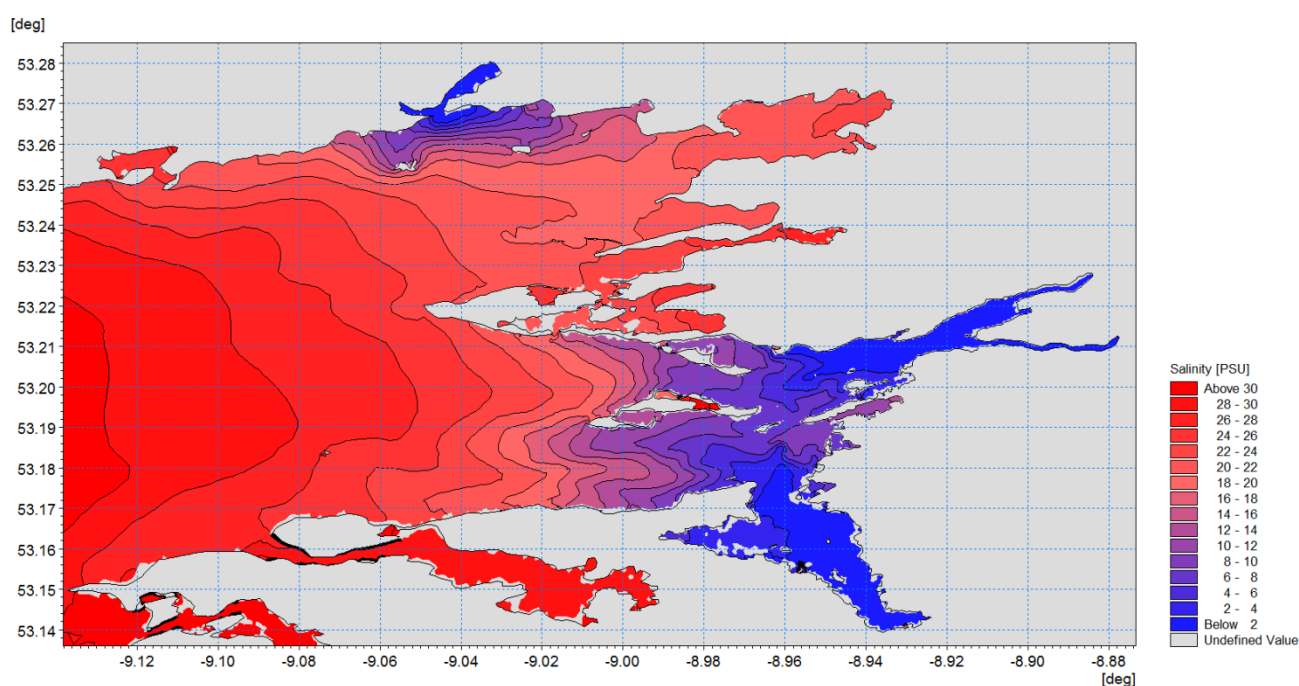
**Figure 3.1: Salinity bed layer - low water with peak river flows – 14.15pm 21<sup>st</sup> Nov 2009**

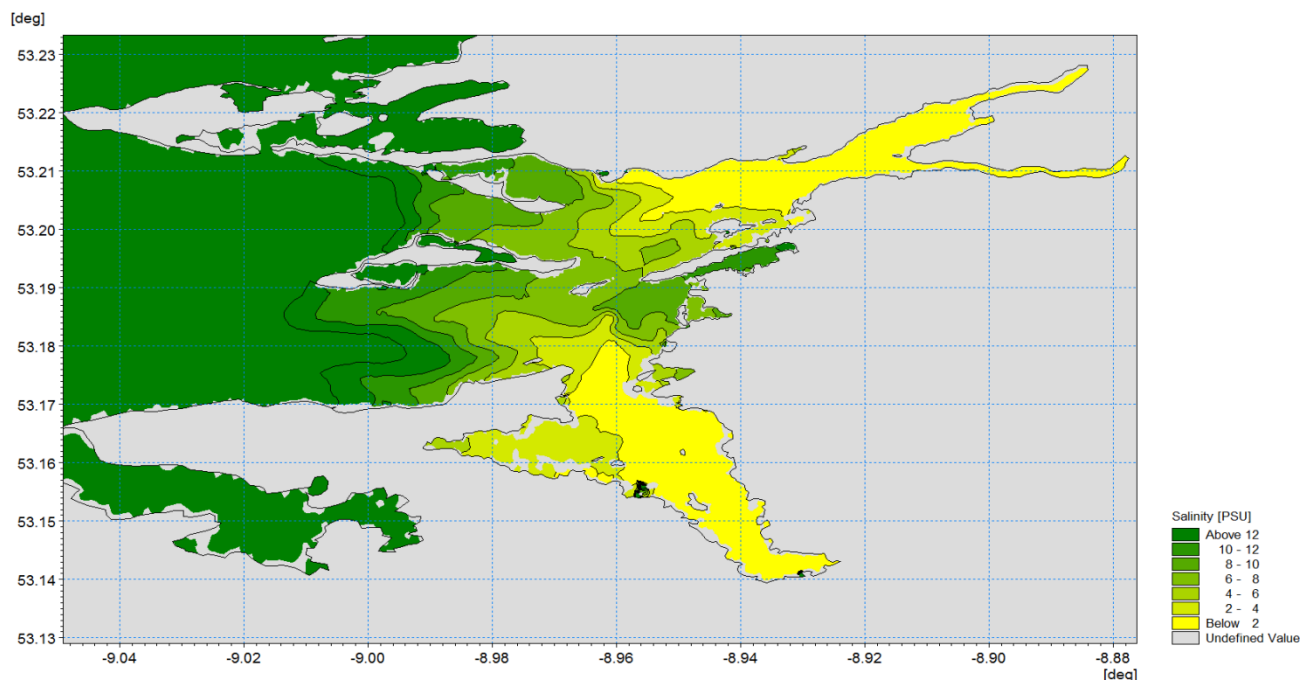
**Figure 3.3: Salinity, bed layer with the Dunkellin Scheme – 14.15pm 21<sup>st</sup> November 2009**

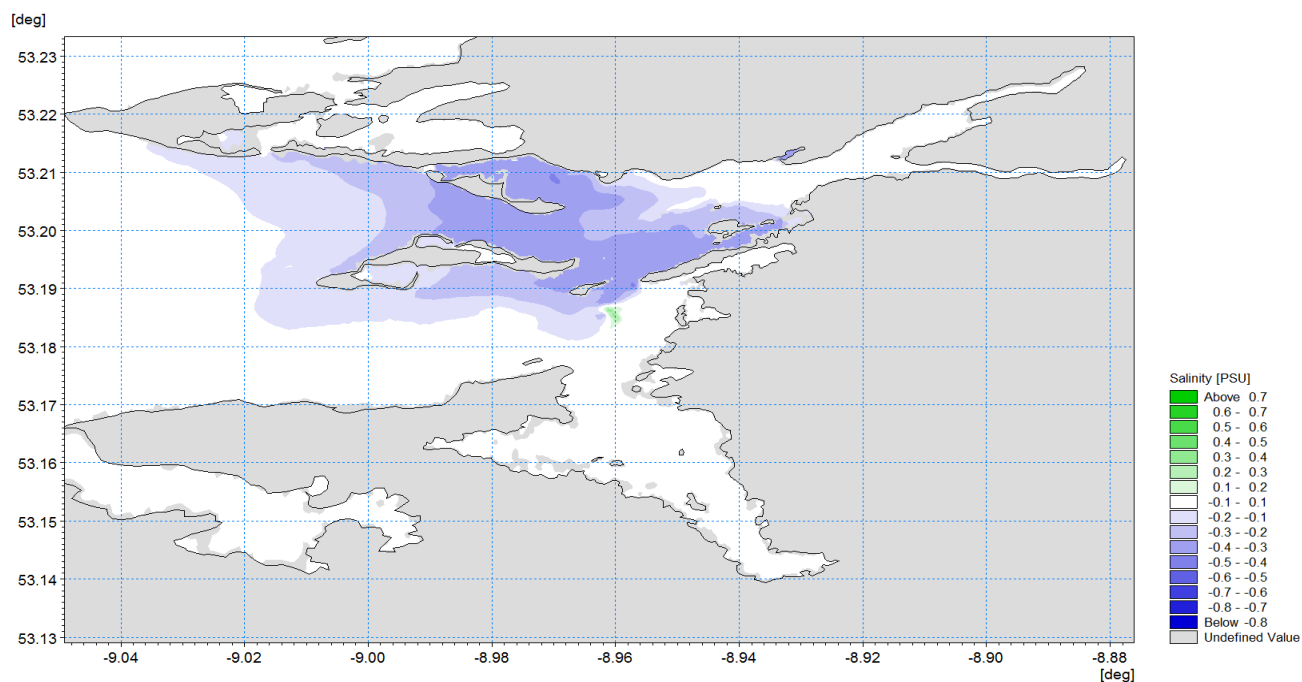
**Figure 3.4: Salinity difference (proposed minus existing) –14.15pm 21<sup>st</sup> November 2009**

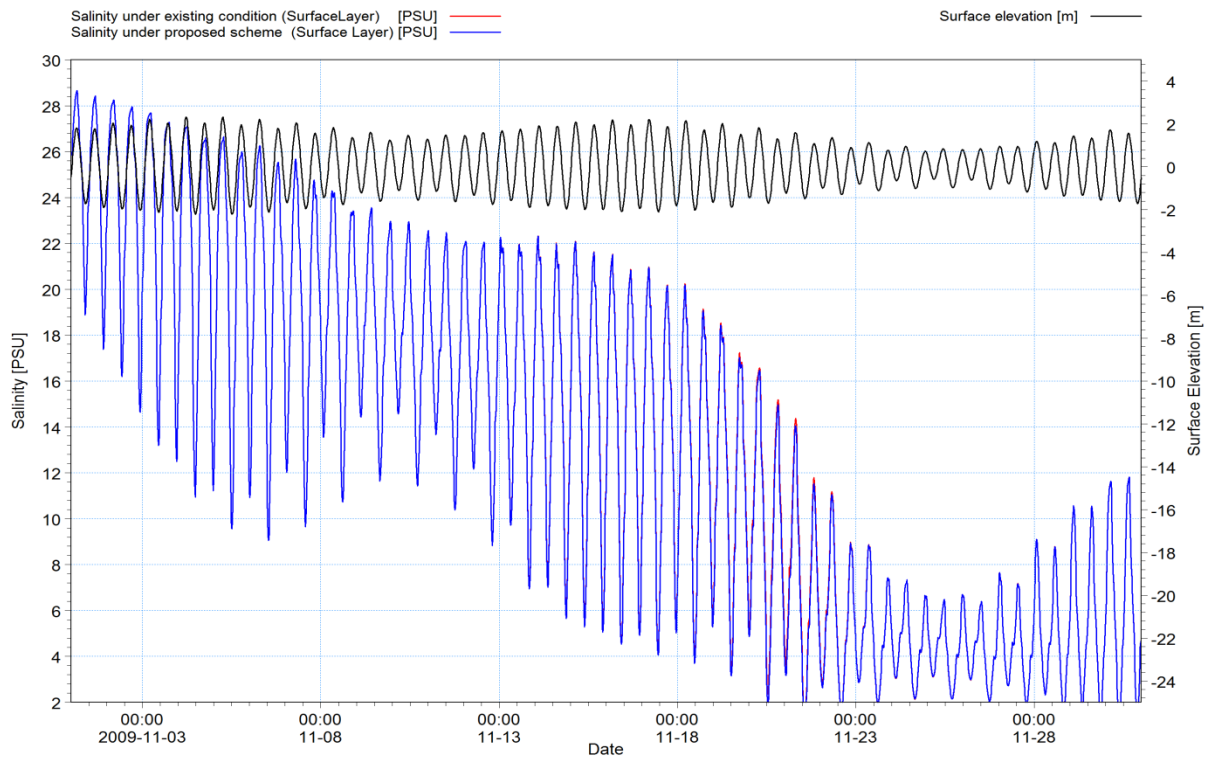
Figure 3.6: Salinity variation at Lynch's Quay during November 2009 under existing conditions and under proposed flood alleviation scheme

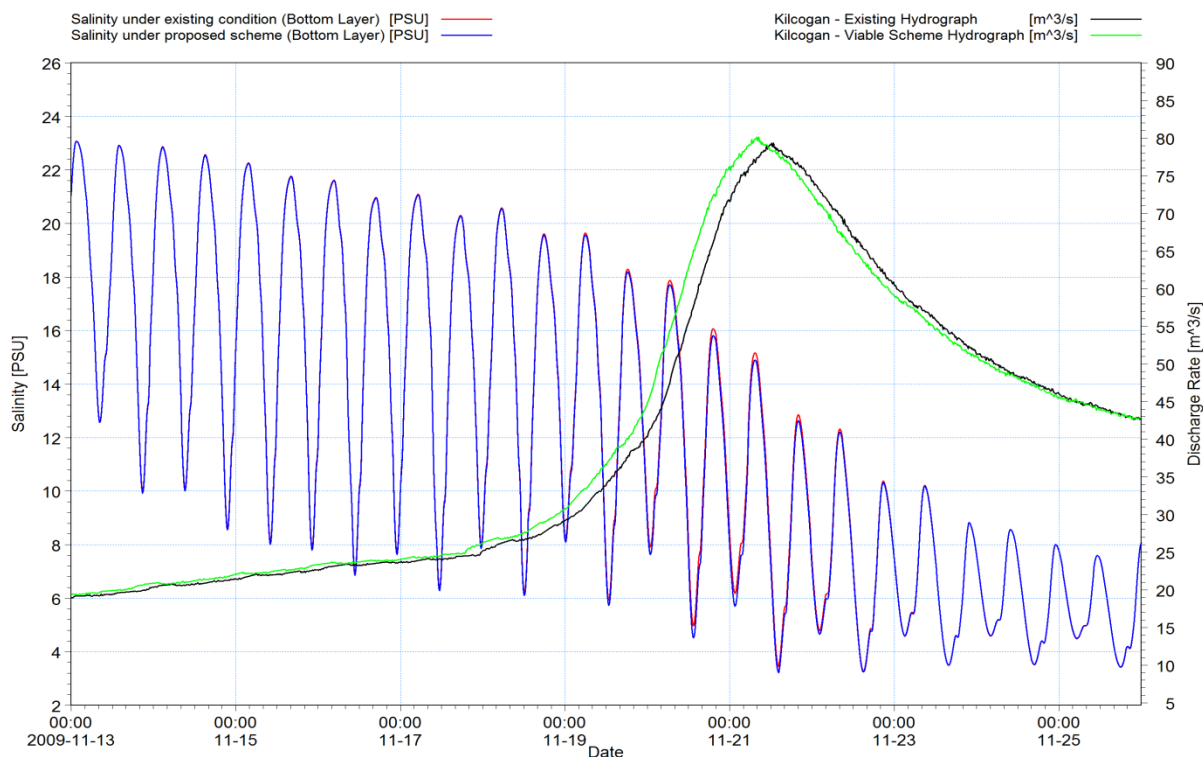
**Figure 3.7: Detail of peak flow period under existing conditions and under proposed flood alleviation scheme at Lynch's Quay**
