Appendix A12: Noise and Vibration

Verified Photomontages of
N63 Liss to Abbey Realignment Scheme

EAG 405

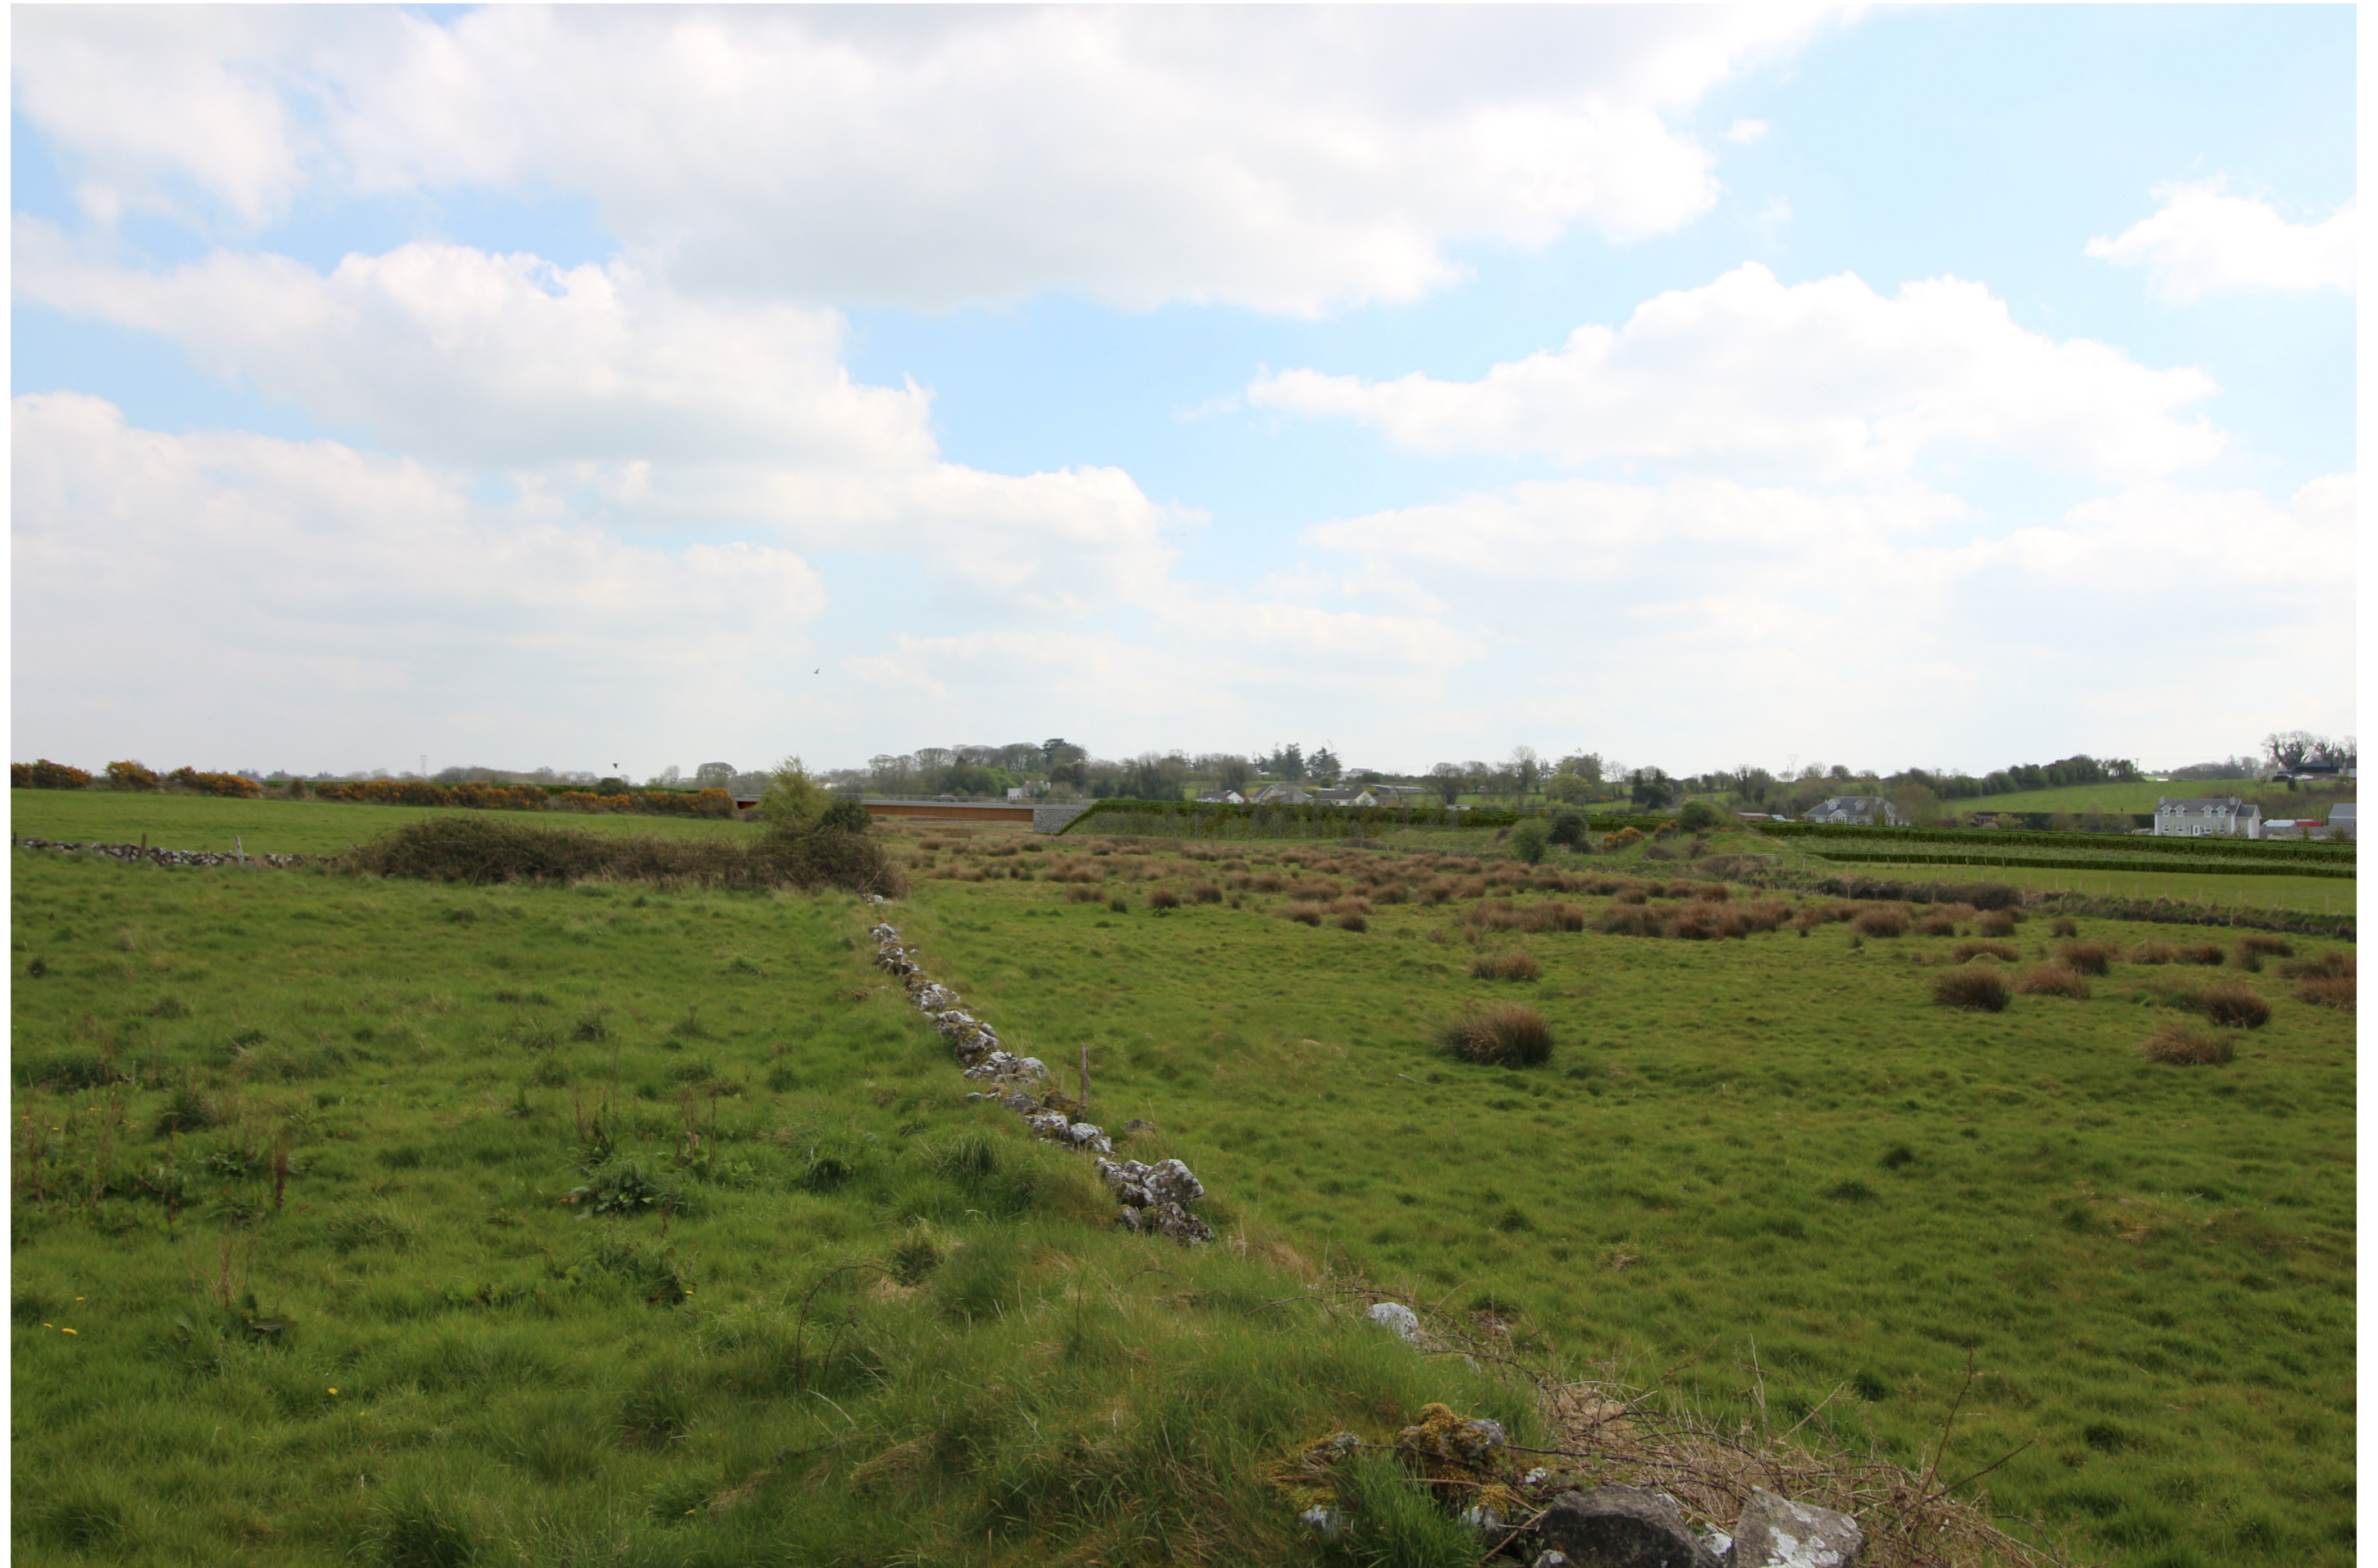
www.gnet.ie
VIEW 1A	PROPOSED	17-11-2021	22-04-2021	Proposed N63 Liss to Abbey Realignment Scheme

This process means incorporating a 3D rendered model of the proposed road development into the photograph to achieve the final result.

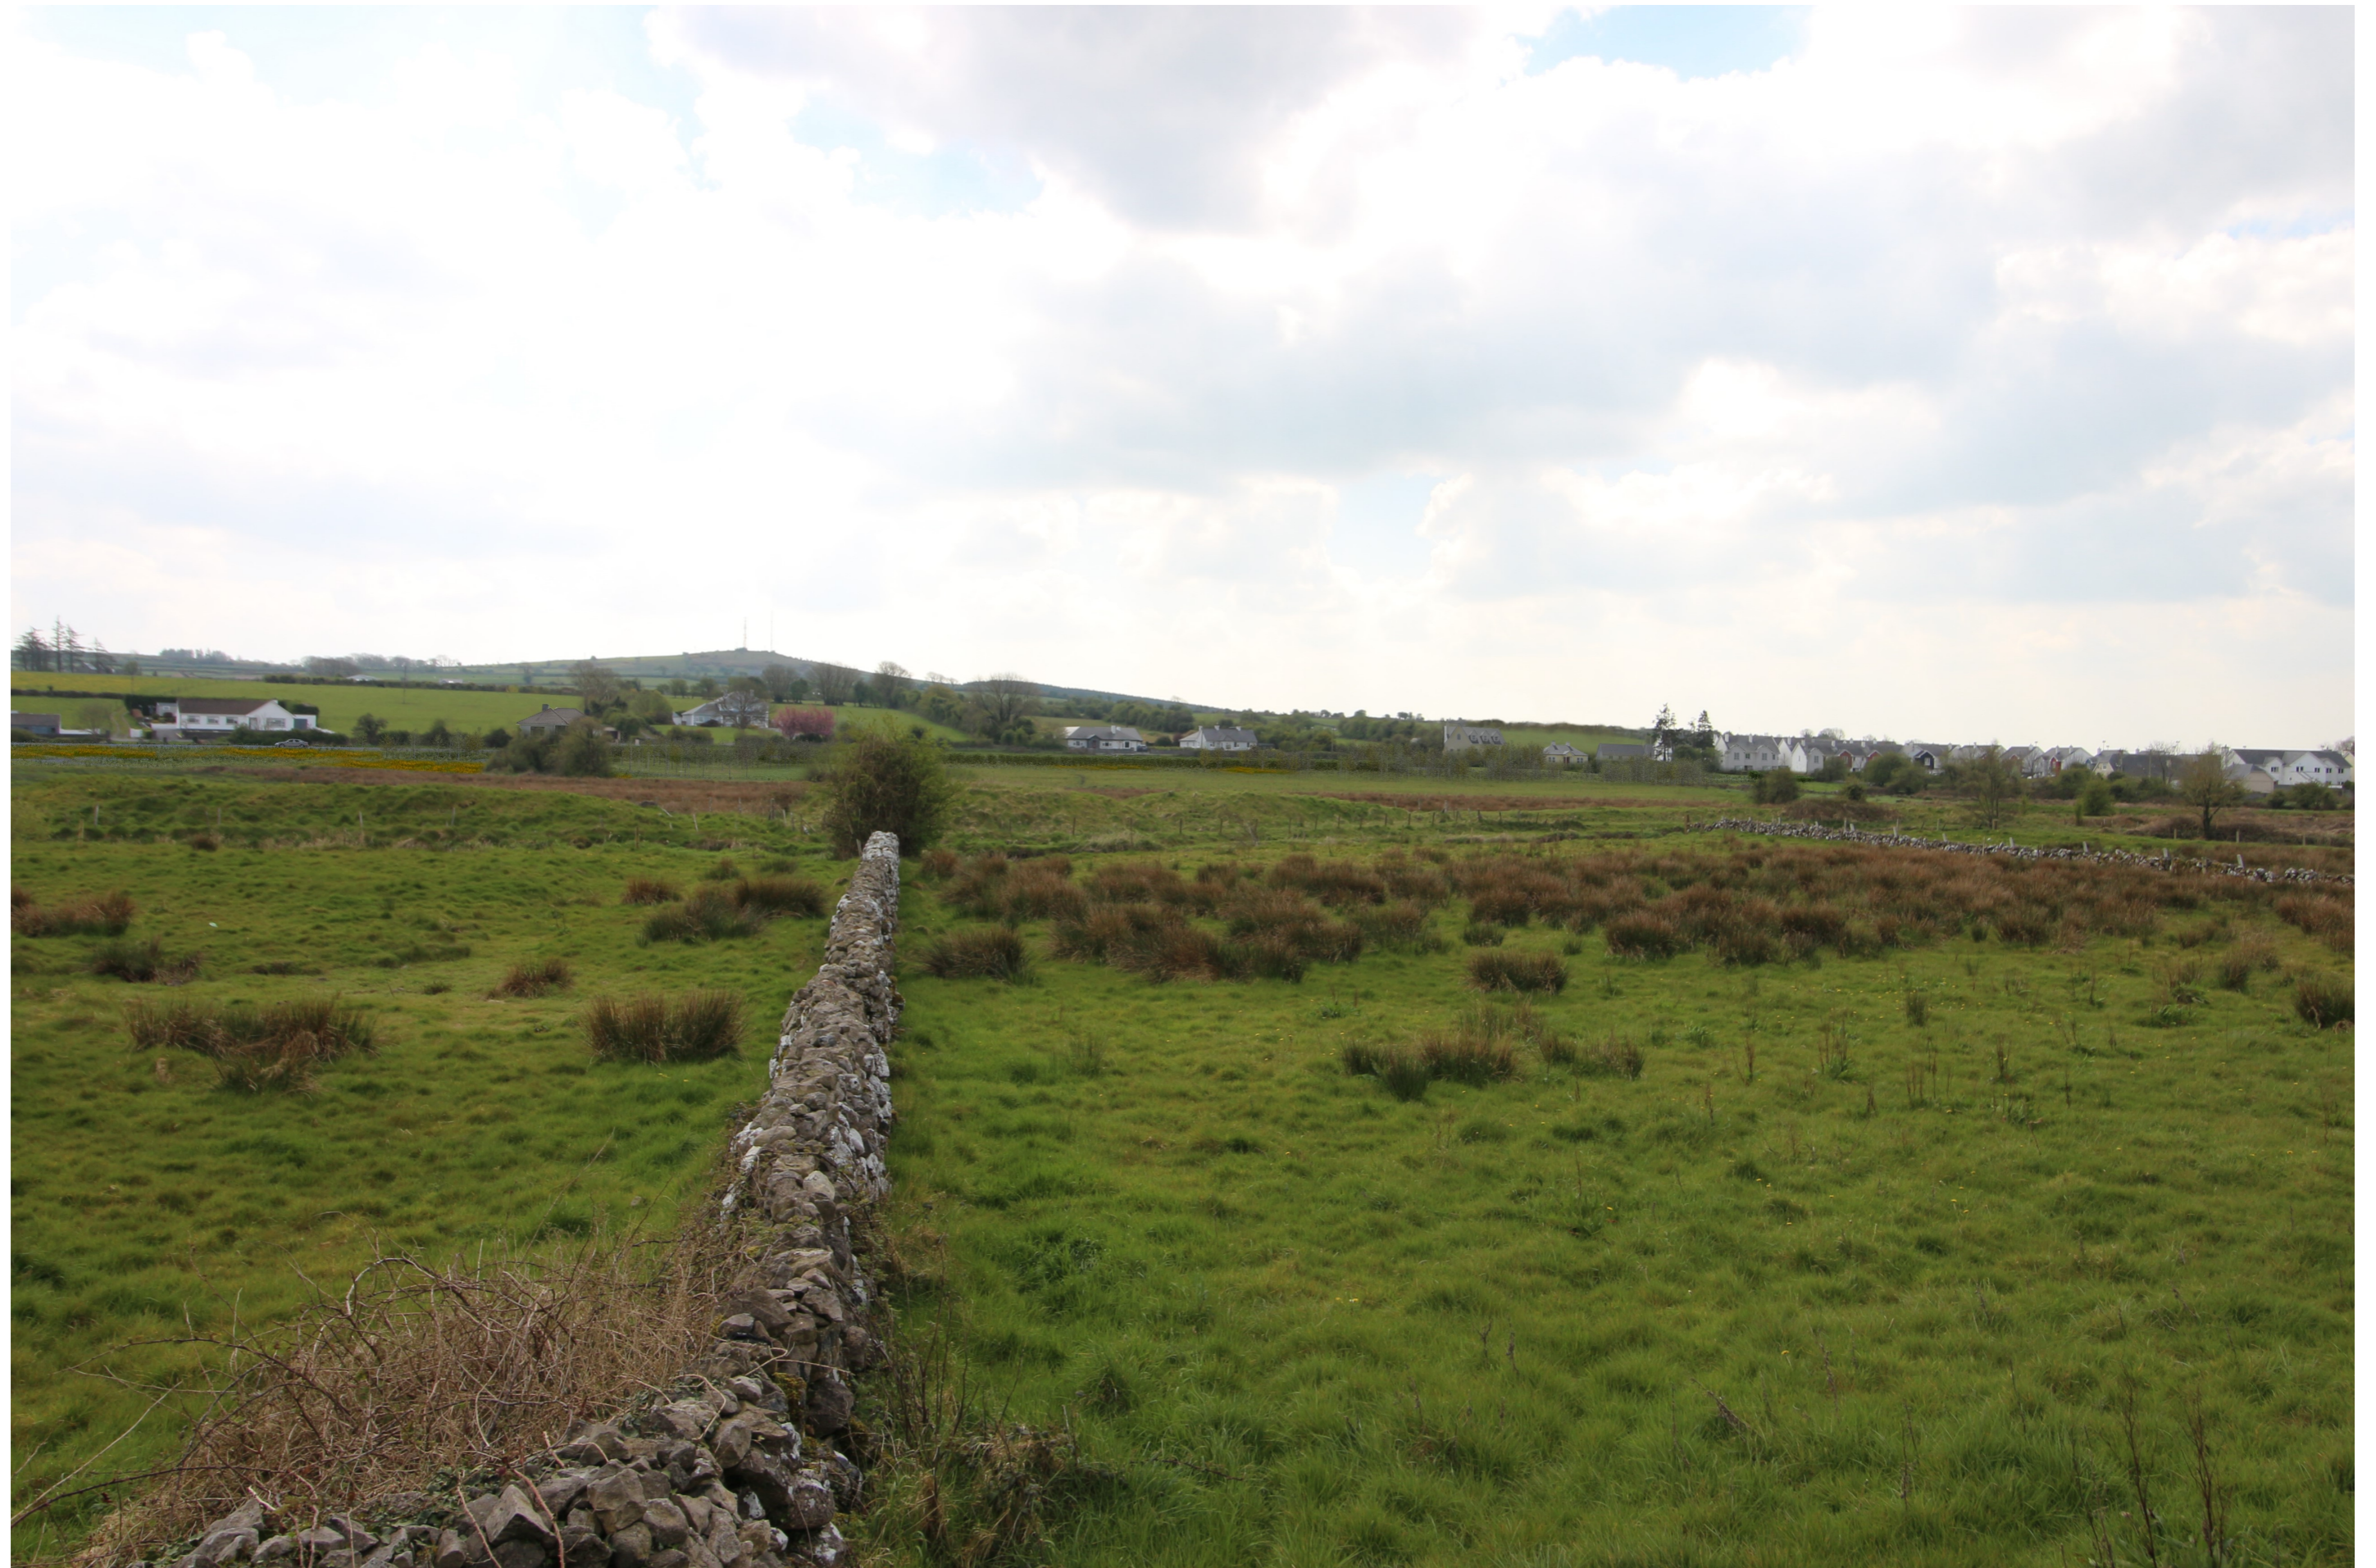
www.gnet.ie
VIEW 1B	PROPOSED	17-11-2021	22-04-2021	Proposed N63 Liss to Abbey Realignment Scheme

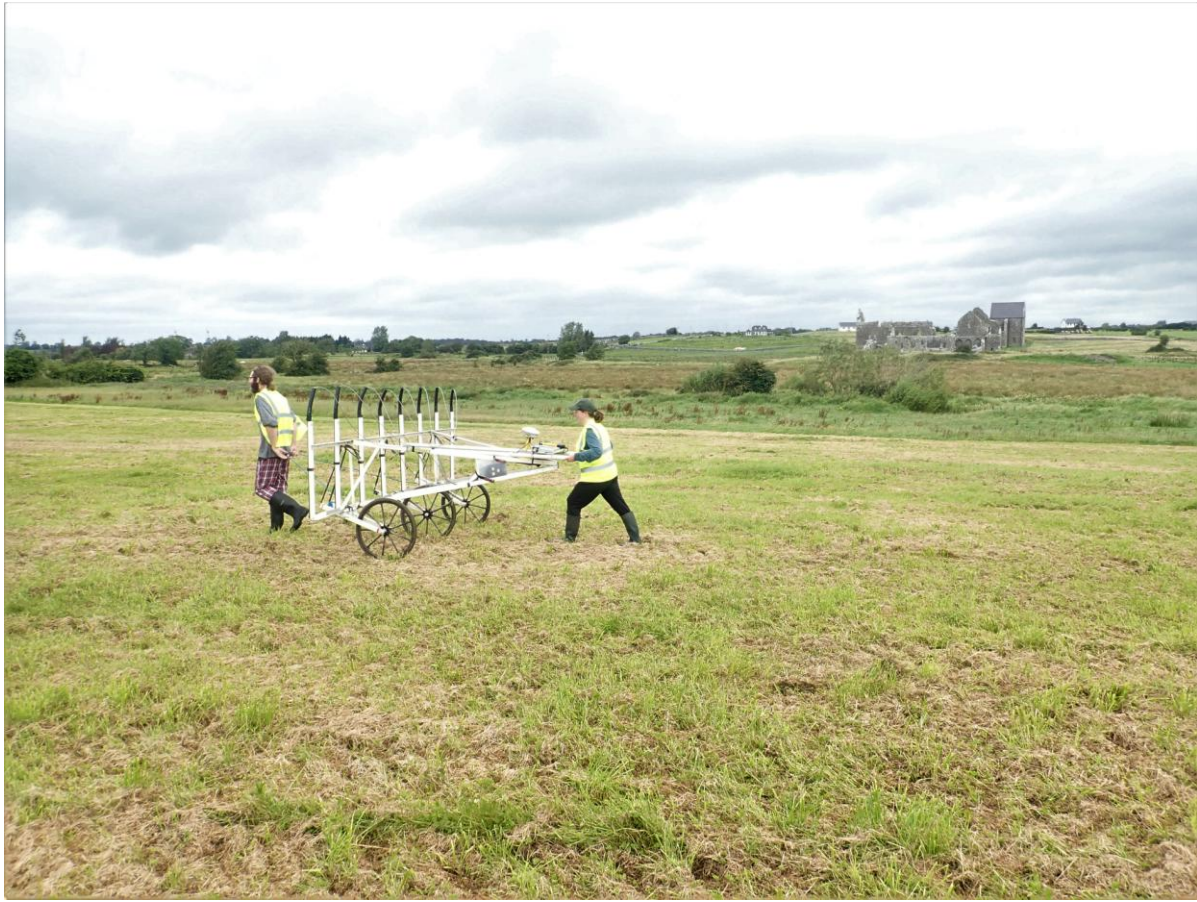
Magnetometer survey in operation on the N63, on land overlooking Abbeyknockmoy Cisterican Abbey.

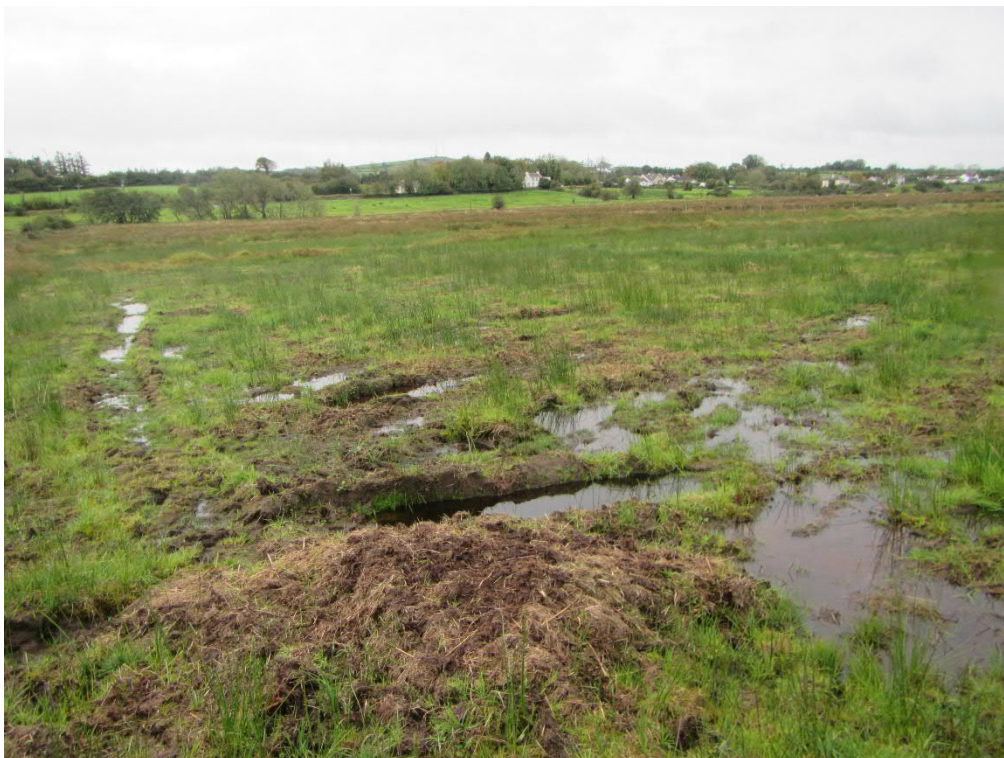
Photograph 14.8 Extremely wet ground within the Proposed Road Development to the north of the Abbart River.

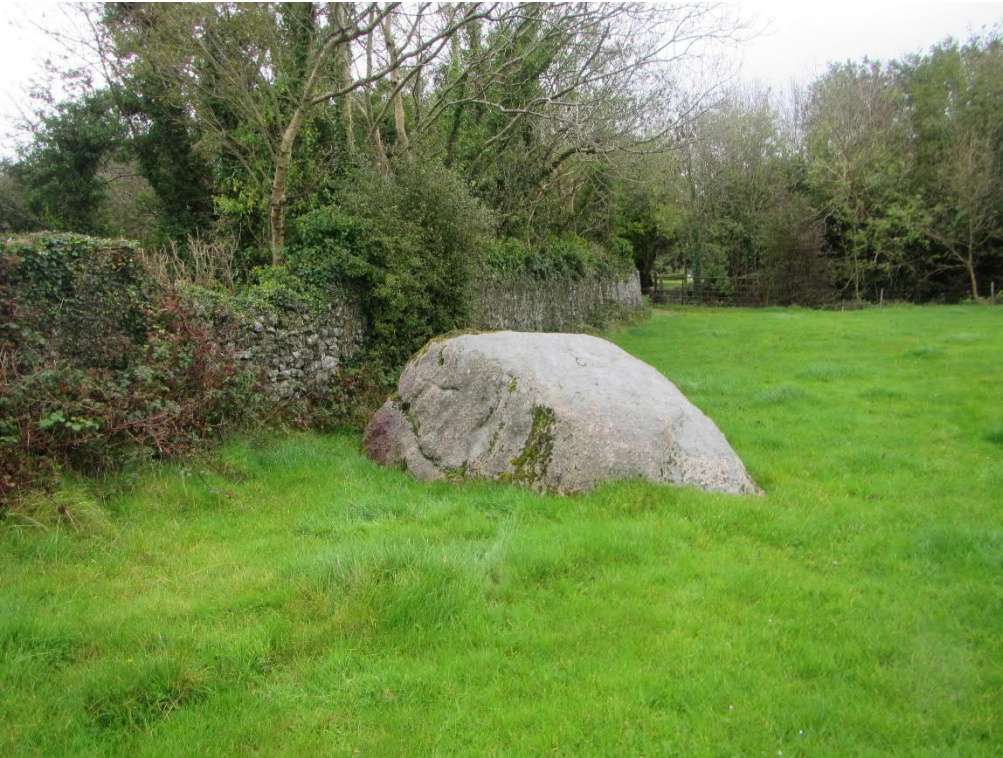
Photograph 14.15 Exposed bedrock in east of the Proposed Road Development.
