Galway County Council

Five years annual monitoring of Rahasane Turlough

2022 report (Year 2) on monitoring programme post works on Flood Relief Scheme

February 2023

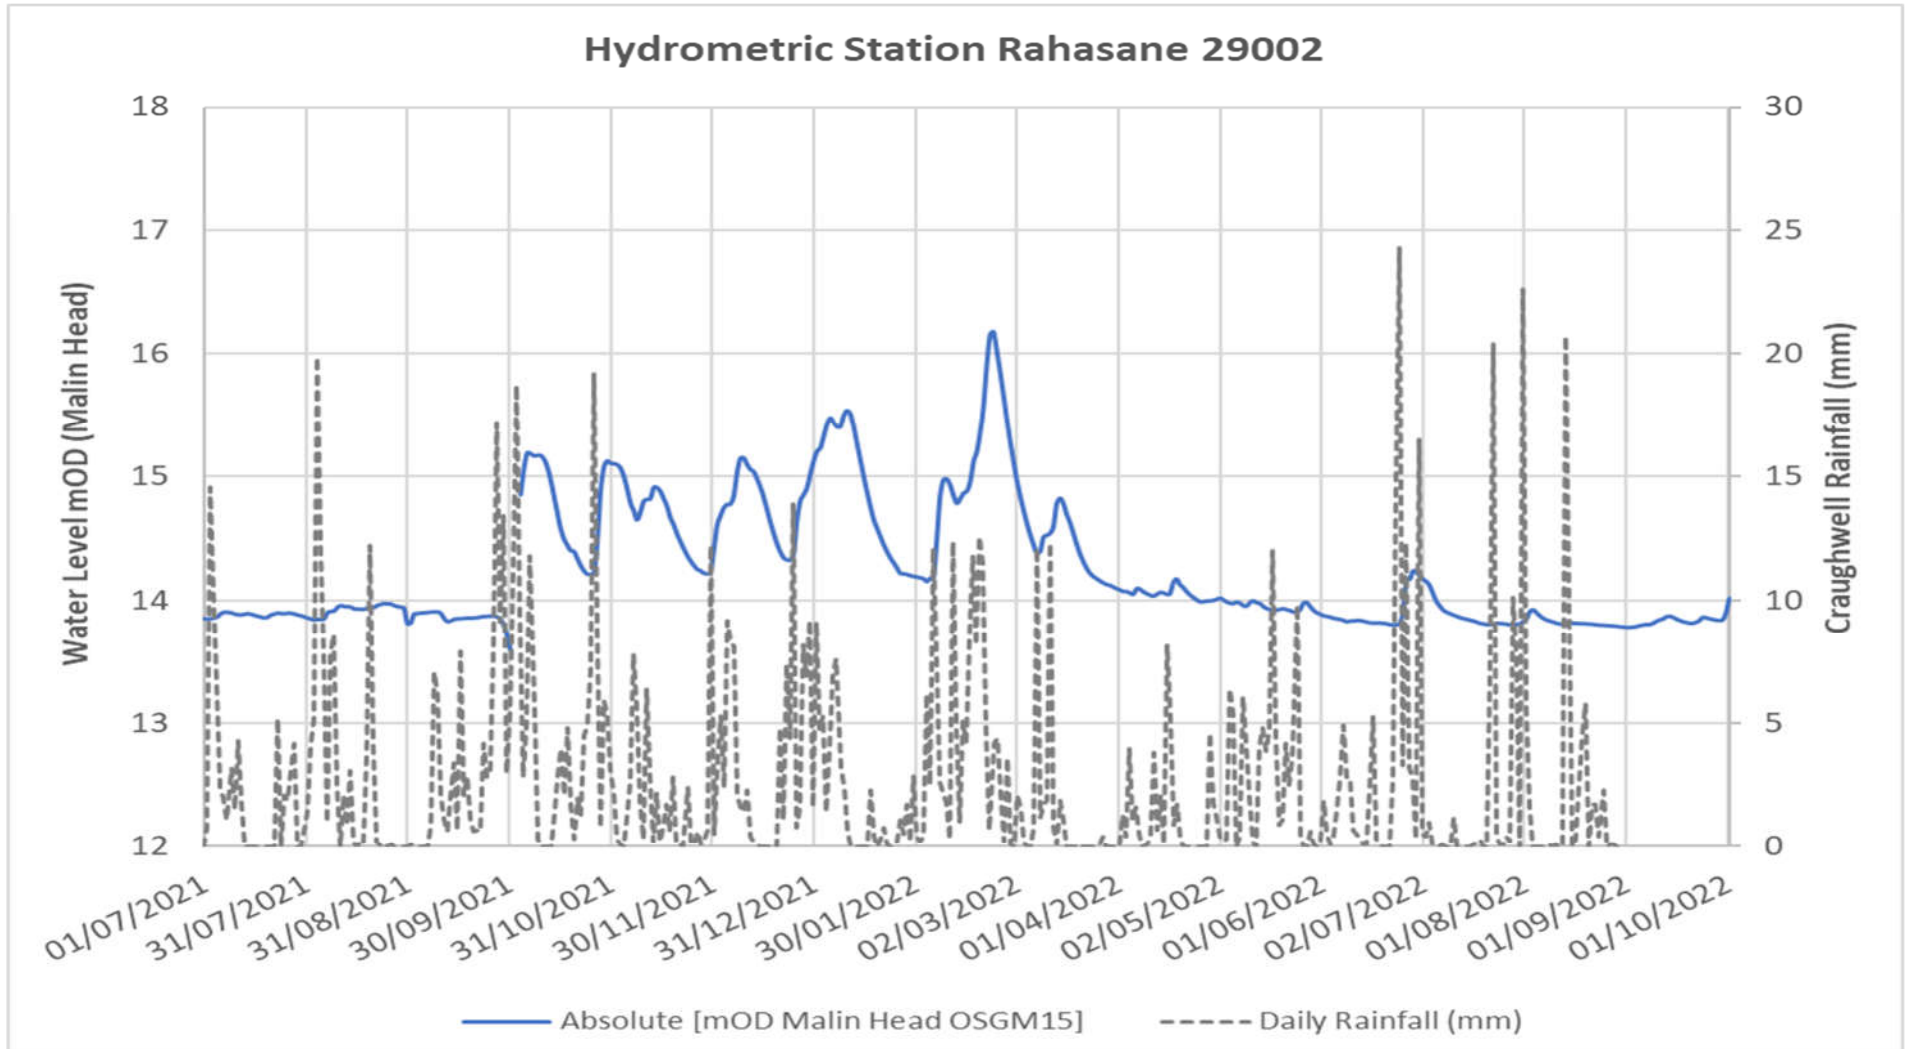
Figure 3: Rahasane Turlough 29002, Q3 2021 through Q3 2022 Water Level and Rainfall (Craughwell) Data

Water level data for Q3 2021 through Q3 2022 from Rahasane Turlough 29002 are presented in Figure 3. Water levels over this period ranged from 13.6 mOD to 16.4 mOD (mean = 14.3 mOD). As with the other streams, a large rainfall event towards the end of June resulted in a sharp water level rise to 14.2 mOD. Water level fell through July to <13.8 m by the start of August. As with Craughwell 29007, the high rainfall events in July and August 2022 (up to 22.5 mm) were not mirrored by increased stream water levels.

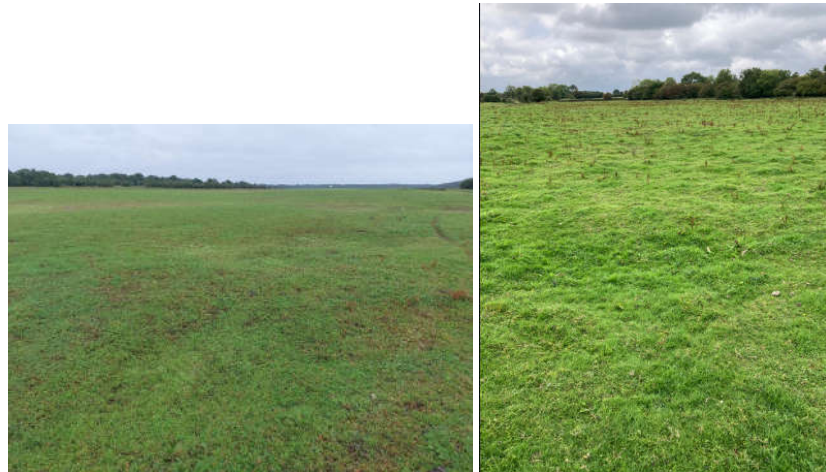
Plate 5 Shallow depressions (left: 2021, right: 2022)

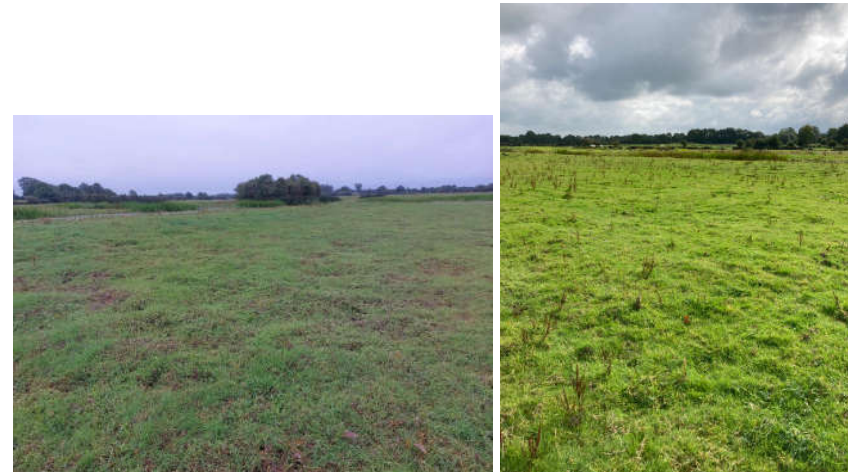
Plate 6 Shallow depressions (left: 2021, right: 2022)

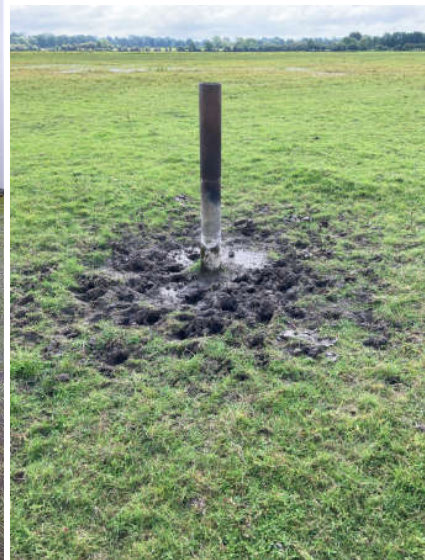
Specific other features of interest noted on the site walkover survey are summarised in Table 1 and include monitoring wells. The team checked with GSI and other researchers of turlough hydrology, but the purpose or circumstances around the presence of monitoring wells are not known.

Plate 7 Monitoring well (condition unknown) (left: 2021, right: 2022)

A10	547683	718724	Existing well	Condition unknown. Consider condition survey for possible monitoring.	
A11	547408	718725	Enclosed depression	Possible location for groundwater recharge/discharge (estavelle). Monitor for changes.	No change
A12	547411	718730	Enclosed depression	Possible location for groundwater recharge/discharge (estavelle). Monitor for changes.	No change
B1	546551	718960	Small scale depression	Monitor for changes.	NA (newly identified)
B2	546629	719112	Estavelle (?) Low water levels (<200mm)	Possible location for groundwater recharge/discharge. Monitor for changes.	NA (newly identified)
B3	546839	719313	Estavelle/spring	Feeds stream that flows SW to main channel. Monitor for changes.	NA (newly identified)
B4	547006	719548	Turlough water	-	NA (newly identified)
B5	547308	719874	Estavelle	Location of groundwater recharge/discharge. Monitor for changes.	NA (newly identified)
B6	547310	719876	Estavelle	Location of groundwater recharge/discharge. Monitor for changes.	NA (newly identified)

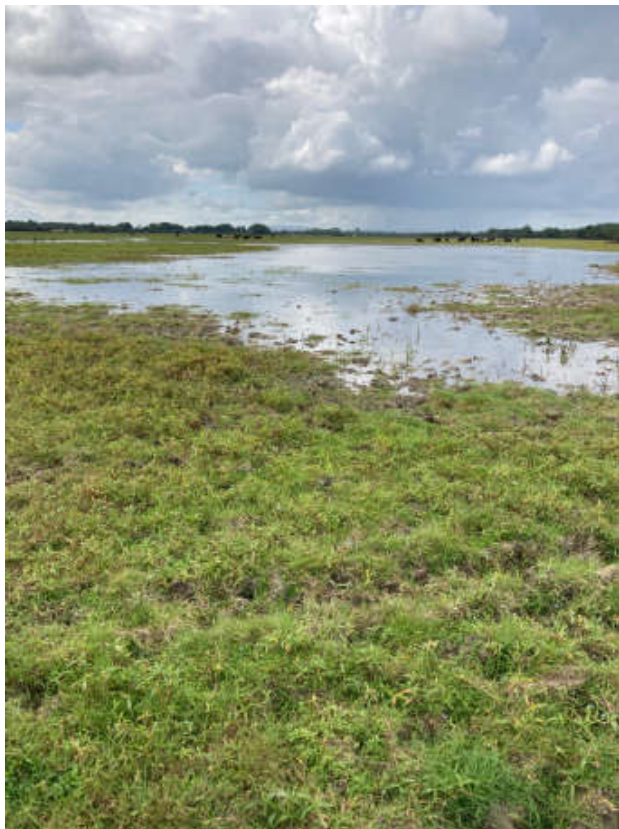
Plate 9 Pond appears to drain to main channel

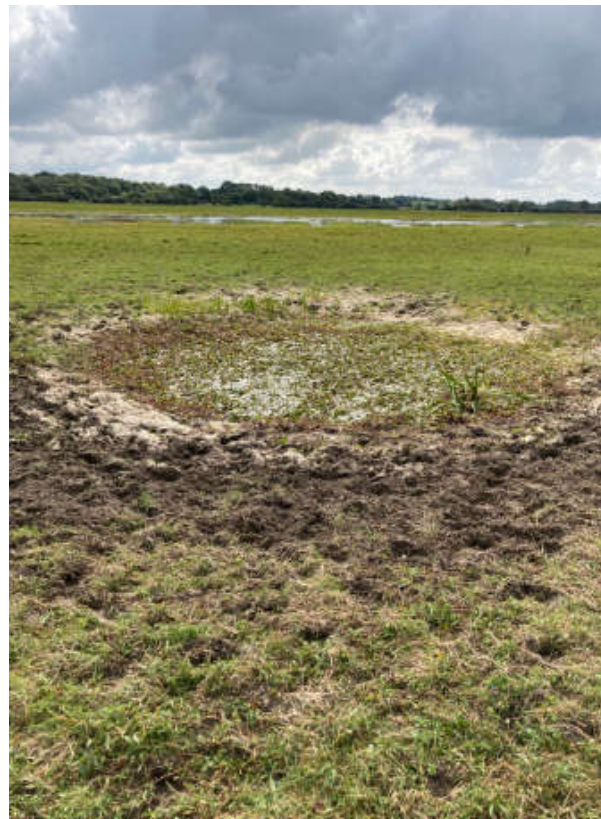
Plate 10 Estavelle

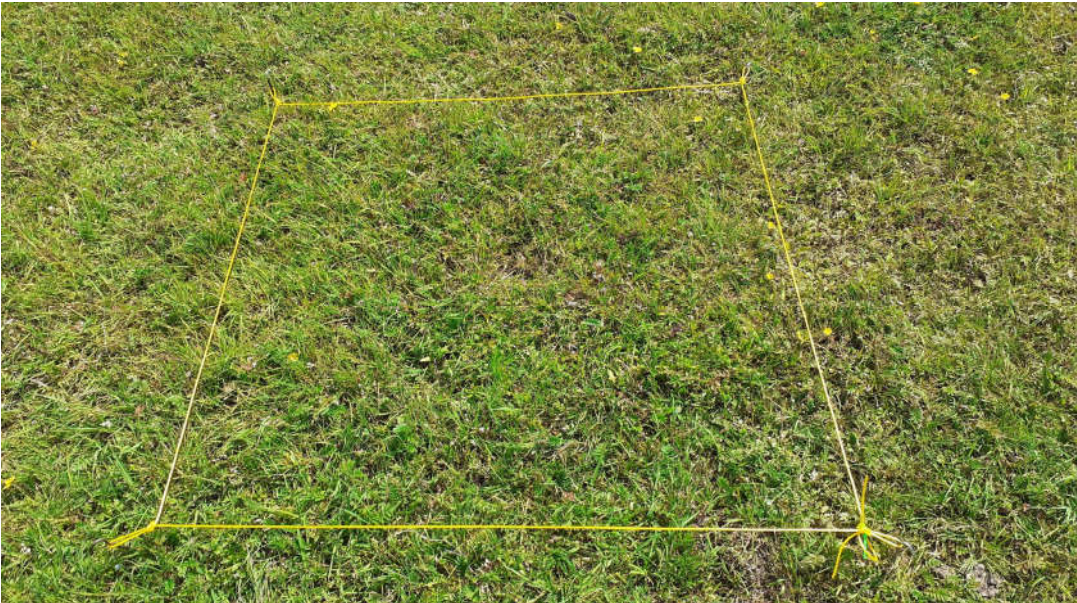
Table 20: Photo and additional notes from Relevé 22 (Transect 4), Rahasane Turlough, Co. Galway

Relevé	T4R22
Date	13-07-2022
Comments, notes or threats:	
The vegetation at this location was grazed quite tightly by sheep at the time of the survey. The relevé and surrounding area was almost fully vegetated, and poaching was not recorded at his location. The ground was dry and firm underfoot.

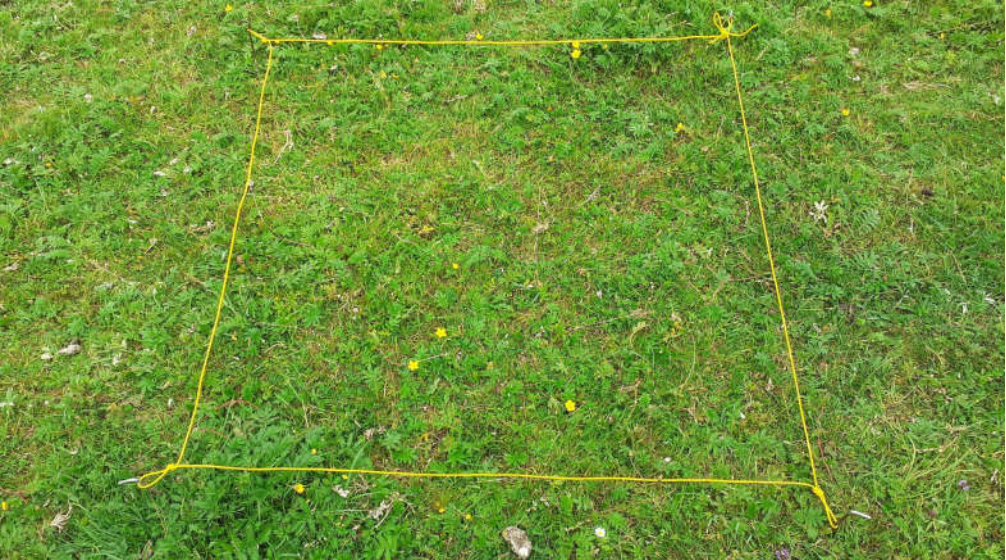
Table 25: Photo and additional notes from Relevé 18 (Transect 6), Rahasane Turlough, Co. Galway

Relevé	T6R18
Date	13-07-2022
Comments, notes or threats:	
<p>This relevé is located in a flat area, which was firm underfoot and dry at the time of the survey. The area was grazed by sheep and cattle, with lots of animal droppings present in the area. While the vegetation had been grazed very short, no poaching was recorded.</p>
