Galway County Council

Five years annual monitoring of Rahasane Turlough

2022 report (Year 2) on monitoring programme post works on Flood Relief Scheme

February 2023

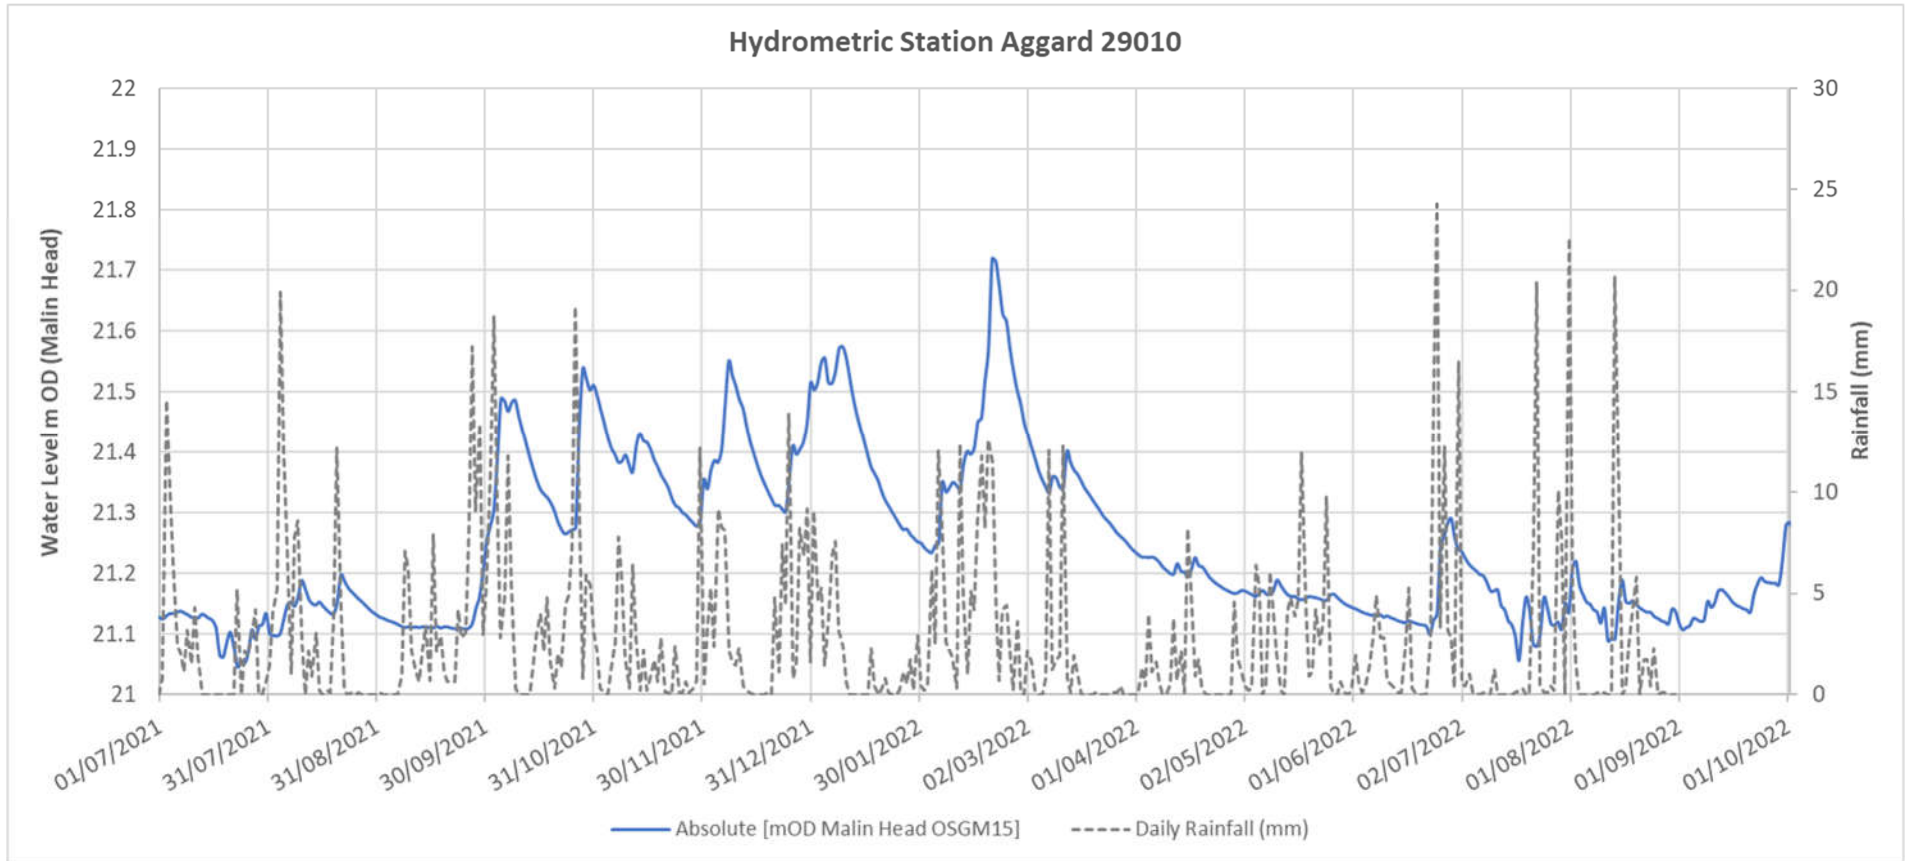
Figure 2: Aggard 29010, Q3 2021 through Q3 2022 Water Level and Rainfall (Craughwell) Data

Water level data for Q3 2021 through Q3 2022 from Aggard Bridge 29010 are presented in Figure 2. Water levels over this period ranged from 21.5 mOD to 21.9 mOD (mean = 21.3 mOD). The data incorporate some 'noise' but the water levels response is generally very similar to that described for Station 29007.

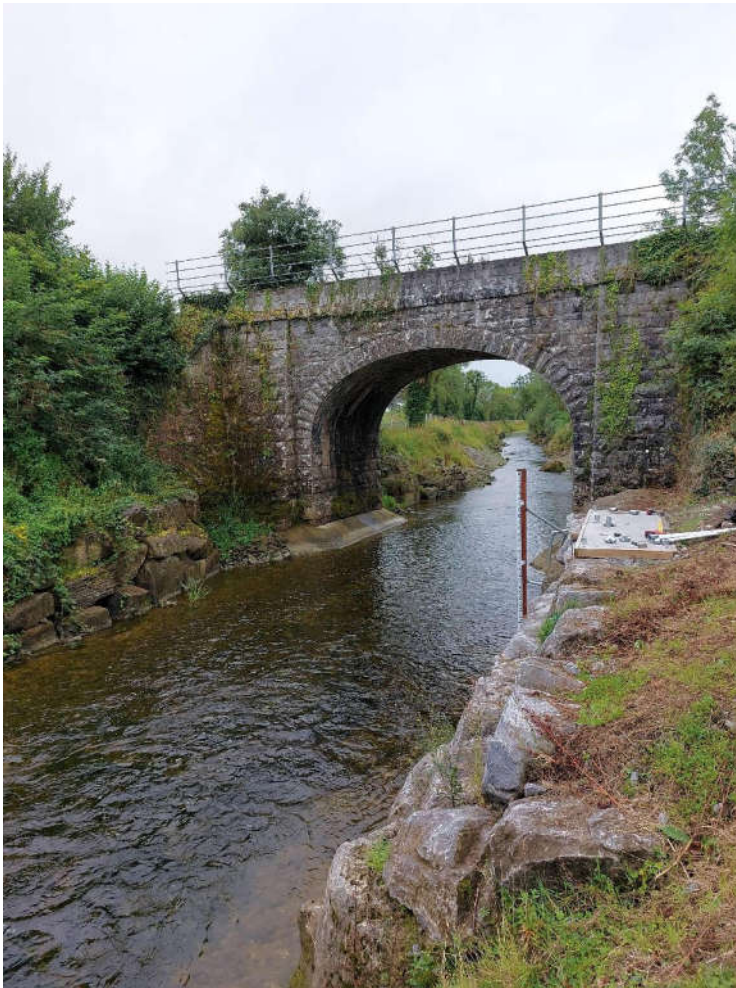
Plate 1 OPW Hydrometric Station Craughwell 29007 (facing west)

Craughwell 29007 (Plate 1) is a relatively new hydrometric station on the Dunkellin River. It is approximately 230 m downstream of former monitoring station 29007. The latter was replaced with the new station following the construction of the FRS through Craughwell village. The new station 29007 is located upstream of a bridge and is positioned to measure the river levels where the natural river course and the FRS are combined. It records the water level and temperature at 15-minute intervals using an OTT PLS sensor. The data are stored in a data logger and automatically loaded to a server via solar-powered telemetry.

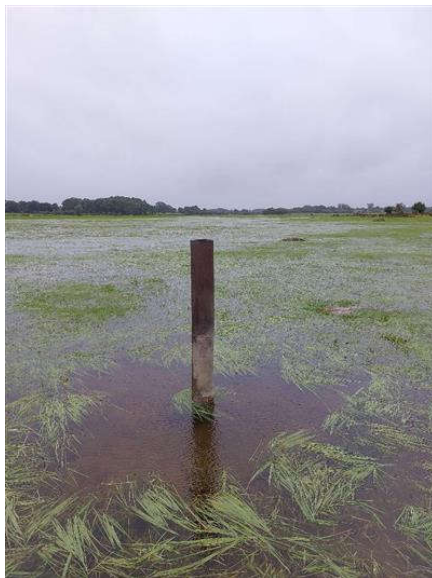
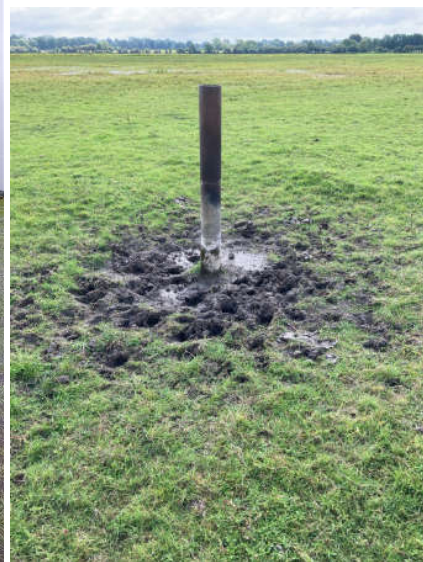
Plate 7 Monitoring well (condition unknown) (left: 2021, right: 2022)

A10	547683	718724	Existing well	Condition unknown. Consider condition survey for possible monitoring.	
A11	547408	718725	Enclosed depression	Possible location for groundwater recharge/discharge (estavelle). Monitor for changes.	No change
A12	547411	718730	Enclosed depression	Possible location for groundwater recharge/discharge (estavelle). Monitor for changes.	No change
B1	546551	718960	Small scale depression	Monitor for changes.	NA (newly identified)
B2	546629	719112	Estavelle (?) Low water levels (<200mm)	Possible location for groundwater recharge/discharge. Monitor for changes.	NA (newly identified)
B3	546839	719313	Estavelle/spring	Feeds stream that flows SW to main channel. Monitor for changes.	NA (newly identified)
B4	547006	719548	Turlough water	-	NA (newly identified)
B5	547308	719874	Estavelle	Location of groundwater recharge/discharge. Monitor for changes.	NA (newly identified)
B6	547310	719876	Estavelle	Location of groundwater recharge/discharge. Monitor for changes.	NA (newly identified)

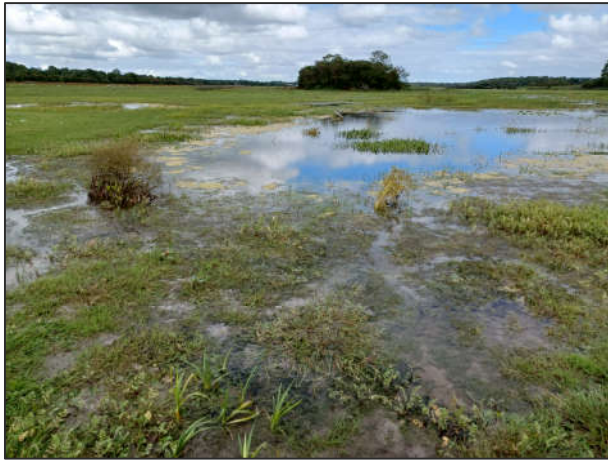
Plate 11 Photo of Site 1 (macroinvertebrate and PSYM survey; 23.08.22)

is high densities of algae, which were responding to the warm water and presumably to high concentrations of nutrients. Slimy floating algae was visually observed at all sites, as were cattle, sheep and horses and evidence of grazing and poaching, providing further evidence of nutrient impact. Photosynthesis raises pH, and the high values recorded are therefore probably at least partially due to this. The concentrations contrast with 2021, when oxygen was low (29-51%) and pH much more acidic (6.3-6.7). Conductivity readings were general similar in 2022 to 2021, except at site 2, where it had approximately doubled, suggesting a possible localised runoff input.

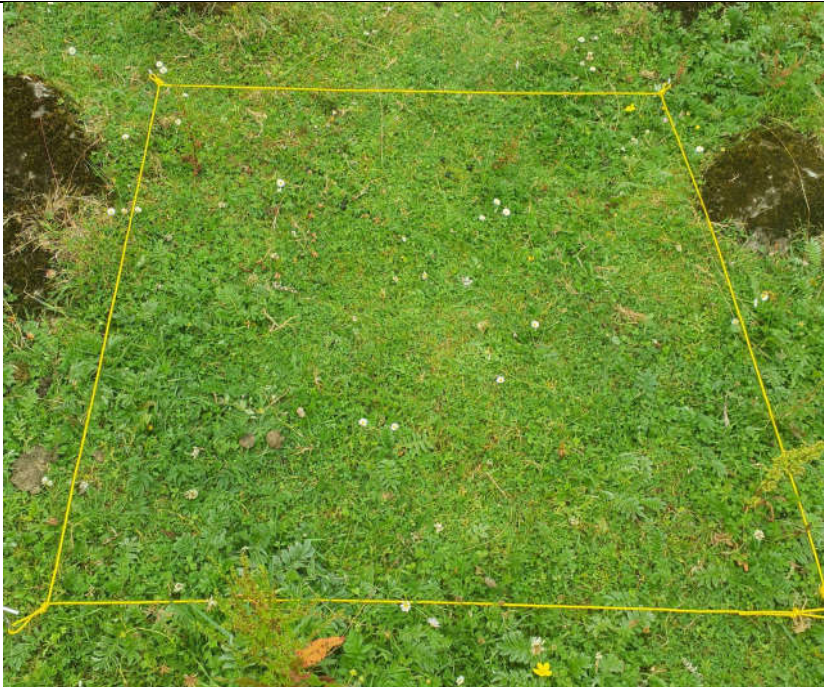
Table 11: Photo and additional notes from Relevé 2 (Transect 2), Rahasane Turlough, Co. Galway.

Relevé	T2R2
Date	12-07-2022
Comments, notes or threats:	
<p>This area was grazed closely by sheep, and sheep droppings were present at the time of the survey. No bare ground or signs of poaching were noted. The general area around the relevé had several rocks on the surface. The ground was dry and firm underfoot, locally undulating slightly but overall quite level.</p>

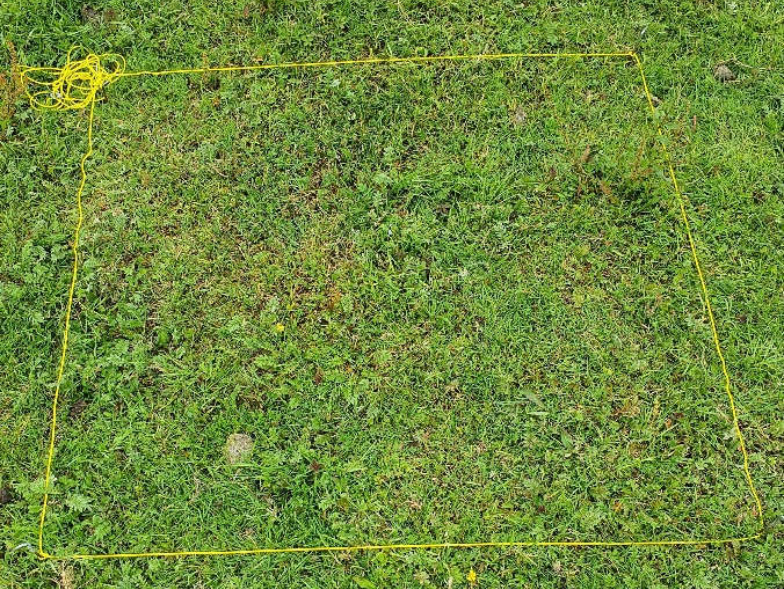
Table 12: Photo and additional notes from Relevé 4 (Transect 2), Rahasane Turlough, Co. Galway.

Relevé	T2R4
Date	12-07-2022
Comments, notes or threats:	
The area in which this relevé is located was grazed by sheep and horses. The vegetation had been grazed quite tightly by the time of the survey. The relevé was almost fully vegetated, with no poaching recorded.

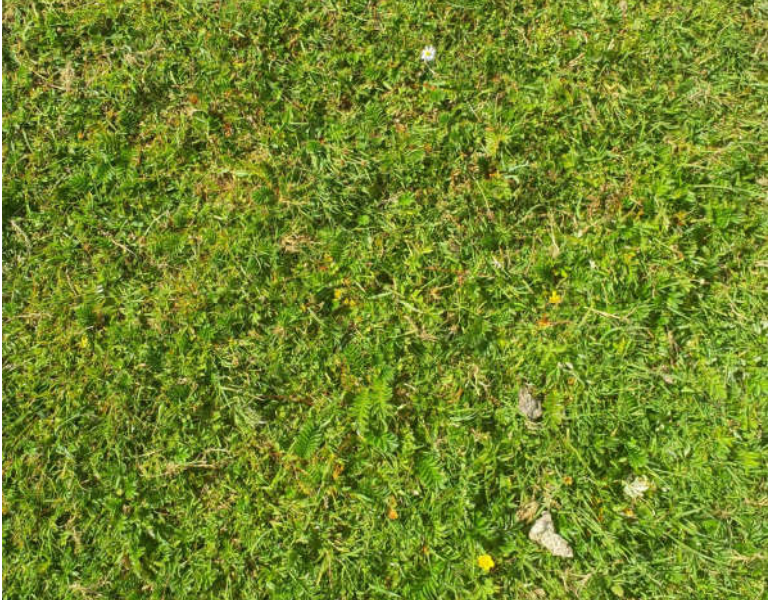
Table 13: Photo and additional notes from Relevé 6 (Transect 2), Rahasane Turlough, Co. Galway.

Relevé	T2R6
Date	12-07-2022
Comments, notes or threats:	
This relevé is located on a raised bank along the central channel. The ground was dry and firm underfoot at the time the survey was conducted. The vegetation was grazed very short by sheep. A lot of sheep droppings were present in this area. The ground did not show signs of poaching.

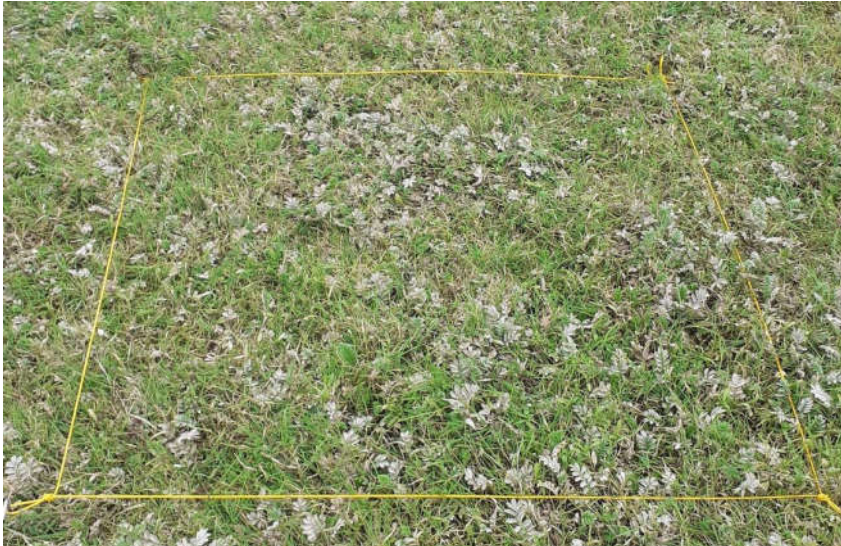
Table 14: Photo and additional notes from Relevé 12 (Transect 2), Rahasane Turlough, Co. Galway.

Relevé	T2R12
Date	12-07-2022
Comments, notes or threats:	
The vegetation in the area of this relevé was grazed short by sheep and horses. The area was almost fully vegetated and no poaching of the ground was recorded.

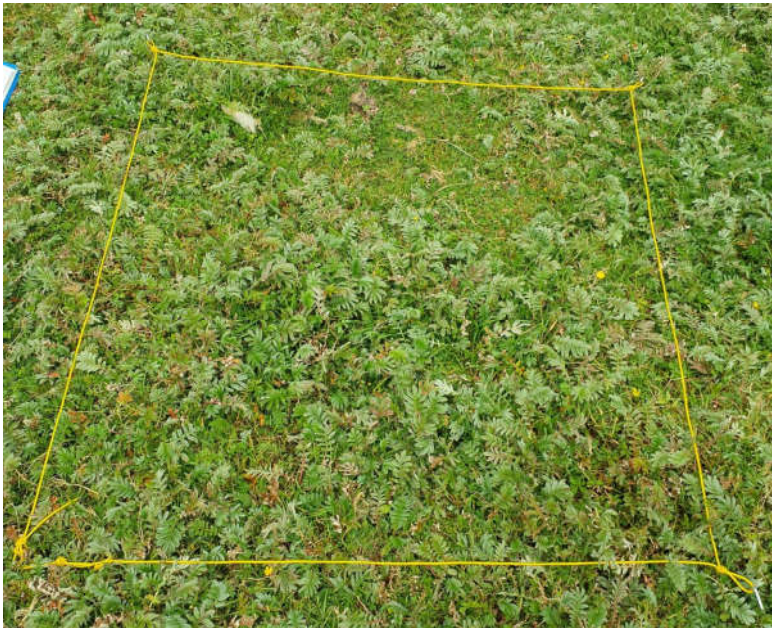
Table 15: Photo and additional notes from Relevé 16 (Transect 2), Rahasane Turlough, Co. Galway.

Relevé	T2R16
Date	12-07-2022
Comments, notes or threats:	
The area in which this relevé was located was grazed by sheep, horses and donkeys, which were present in the surrounding area during the survey. Sheep's wool and droppings were noted within the relevé. The vegetation was dominated by <i>Potentilla anserina</i> (silverweed), which was growing quite luxuriantly. The ground in this area was generally level, with minor localised undulations, and was dry and firm underfoot during the survey. Some outcrops of rock were present in the surrounding area.

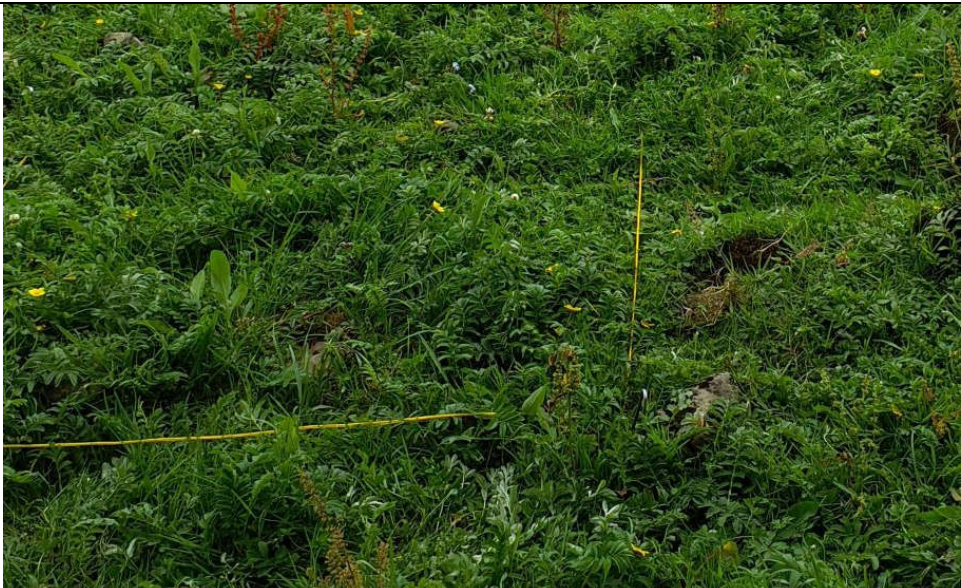
Table 16: Photo and additional notes from Relevé 5 (Transect 4), Rahasane Turlough, Co. Galway.

Relevé	T4R5
Date	13-07-2022
Comments, notes or threats:	
<p>This relevé was located near a hedgerow. The ground was very firm and dry underfoot at the time of the survey. Several rocks were present on the ground in the general area surrounding the relevé. The area did not appear to have been recently grazed. The relevé was fully vegetated, except for some small stones.</p>

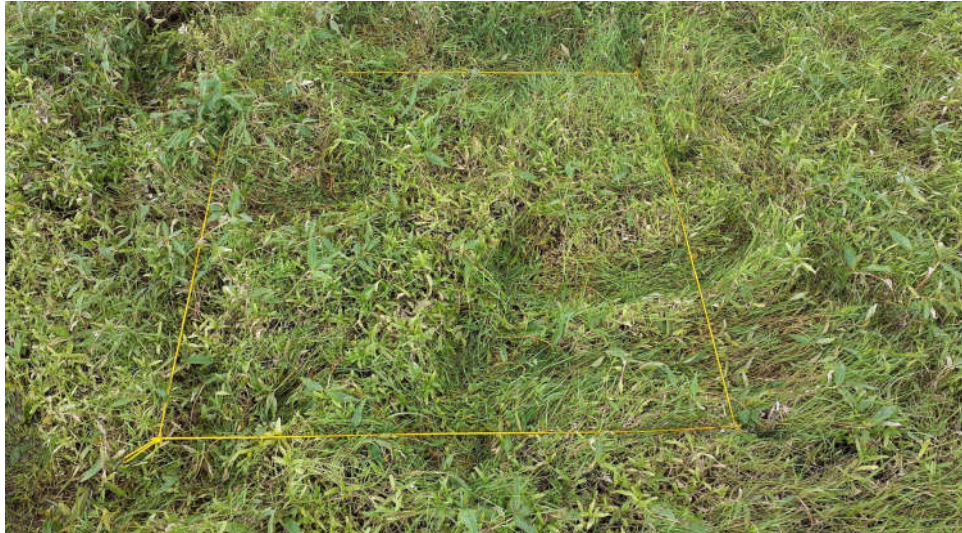
Table 17: Photo and additional notes from Relevé 10 (Transect 4), Rahasane Turlough, Co. Galway.

Relevé	T4R10
Date	13-07-2022
Comments, notes or threats:	
<p>This was a wet area with a little surface water, but the ground was quite firm underfoot. The vegetation did not appear to have recently been grazed at the time of the survey.</p>

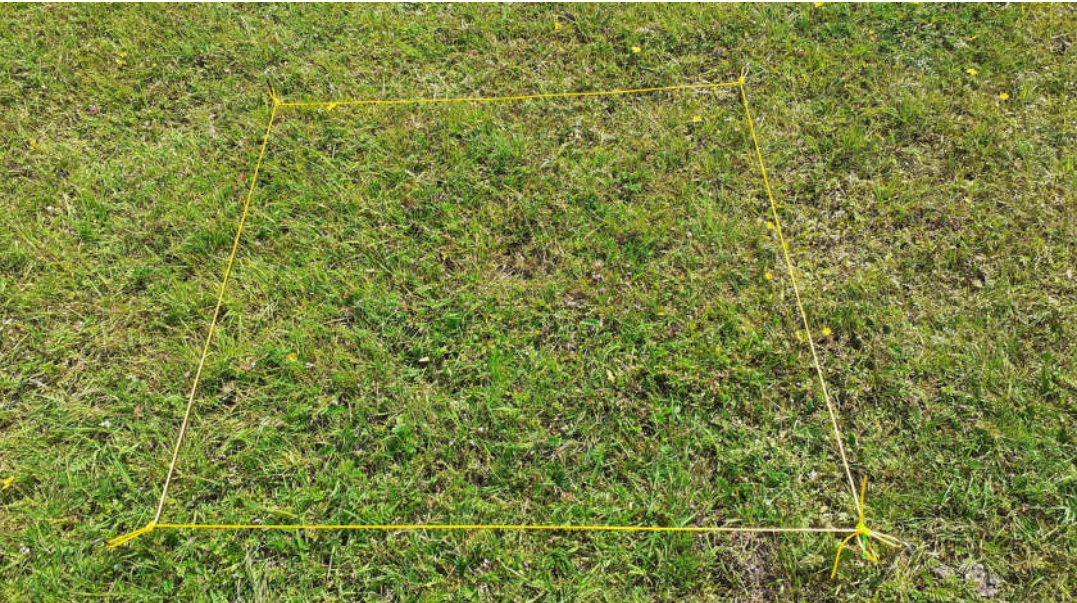
Table 20: Photo and additional notes from Relevé 22 (Transect 4), Rahasane Turlough, Co. Galway

Relevé	T4R22
Date	13-07-2022
Comments, notes or threats:	
The vegetation at this location was grazed quite tightly by sheep at the time of the survey. The relevé and surrounding area was almost fully vegetated, and poaching was not recorded at his location. The ground was dry and firm underfoot.

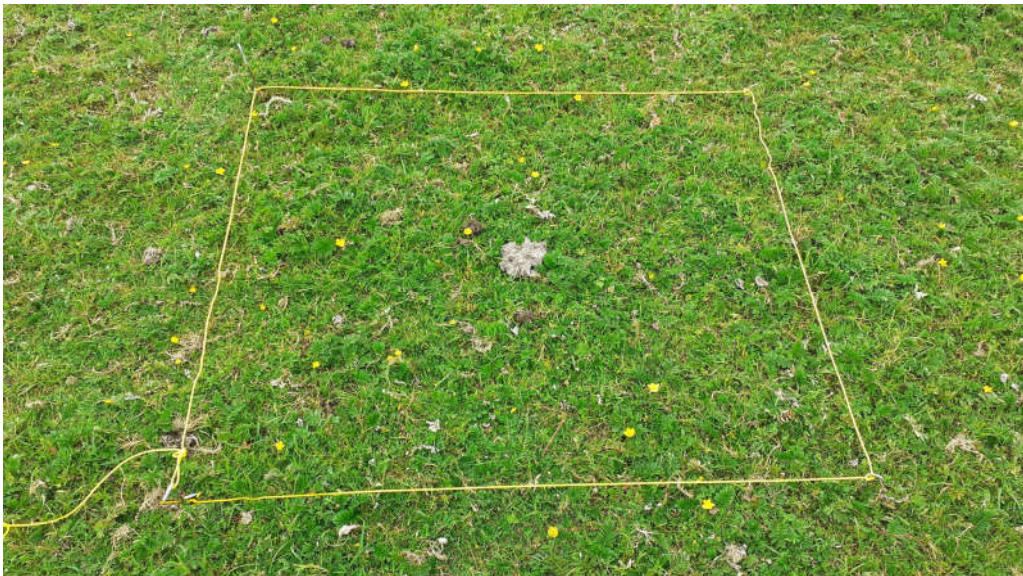
Table 23: Photo and additional notes from Relevé 12 (Transect 6), Rahasane Turlough, Co. Galway.

Relevé	T6R12
Date	13-07-2022
Comments, notes or threats:	
The ground at this location was dry and firm underfoot at the time of the survey visit. The area is level, and the vegetation had been grazed tightly by sheep.

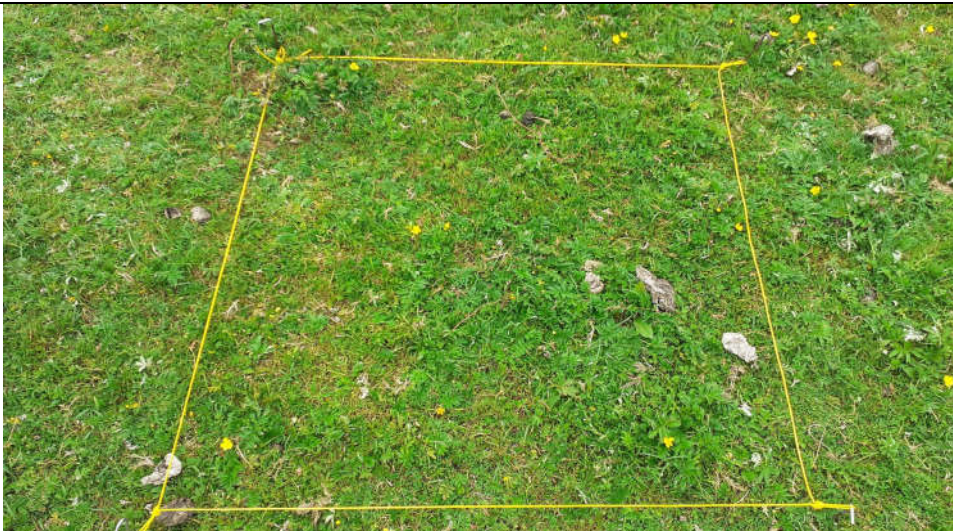
Table 24: Photo and additional notes from Relevé 16 (Transect 6), Rahasane Turlough, Co. Galway

Relevé	T6R16
Date	13-07-2022
Comments, notes or threats:	
This relevé was located on an area of level ground, very firm underfoot at the time of the survey. The relevé was fully vegetated but had been grazed very short by sheep, which were present at the time of the survey. No poaching was noted.

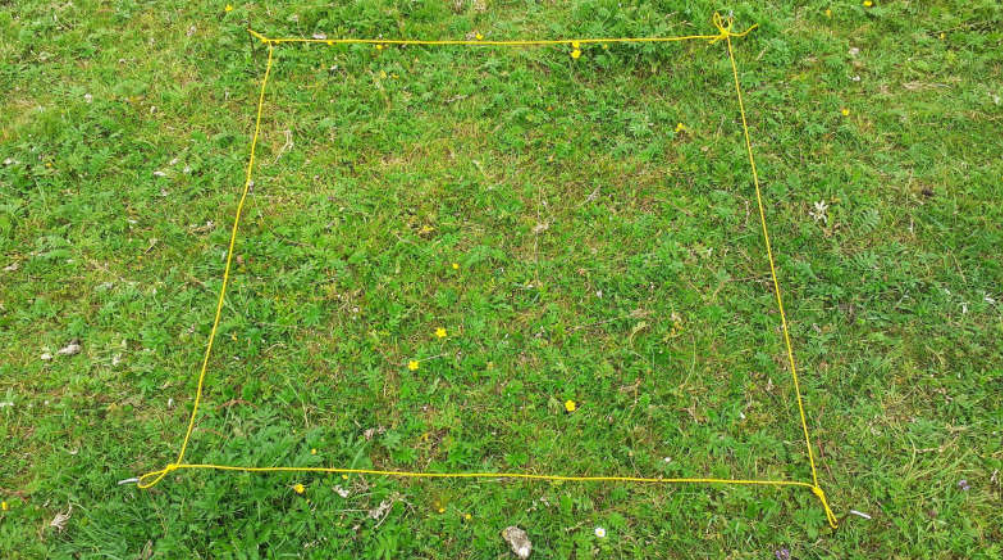
Table 25: Photo and additional notes from Relevé 18 (Transect 6), Rahasane Turlough, Co. Galway

Relevé	T6R18
Date	13-07-2022
Comments, notes or threats:	
<p>This relevé is located in a flat area, which was firm underfoot and dry at the time of the survey. The area was grazed by sheep and cattle, with lots of animal droppings present in the area. While the vegetation had been grazed very short, no poaching was recorded.</p>
