Dunkellin River and Aggard Stream Flood Relief Scheme

Natura Impact Statement (NIS)

October 2014

Client	Galway County Council					
Project Title	Dunkellin River and Aggard Stream Flood Relief Scheme					
Document Title	Natura Impact Statement					
Document No.	MGE0260RP0007					
This Document Comprises	DCS	TOC	Text	List of Tables	List of Figures	No. of Appendices
	1	1	116	1	1	7

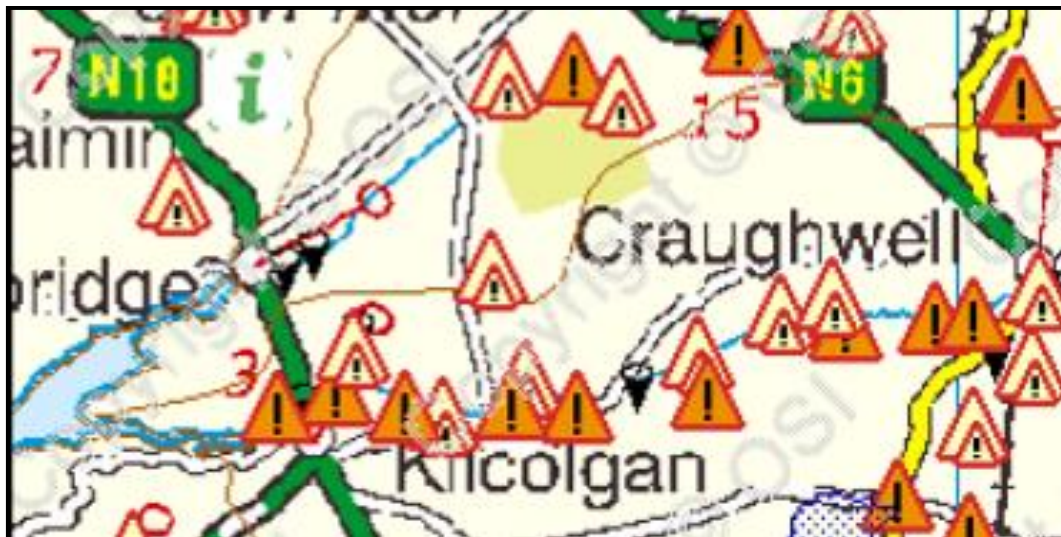
Figure 5.3 Extract from OPW Flood Hazard Map within the Dunkellin River catchment (www.opw.ie)

There is a history of flooding in the Dunkellin River catchment including the most notable flood events of recent times in November 2009 and January 2005. **Figure 5.3** shows the numerous flooding events that have been recorded by the OPW in the study area. **Images 5.1-5.4** show aerial views of flood events.

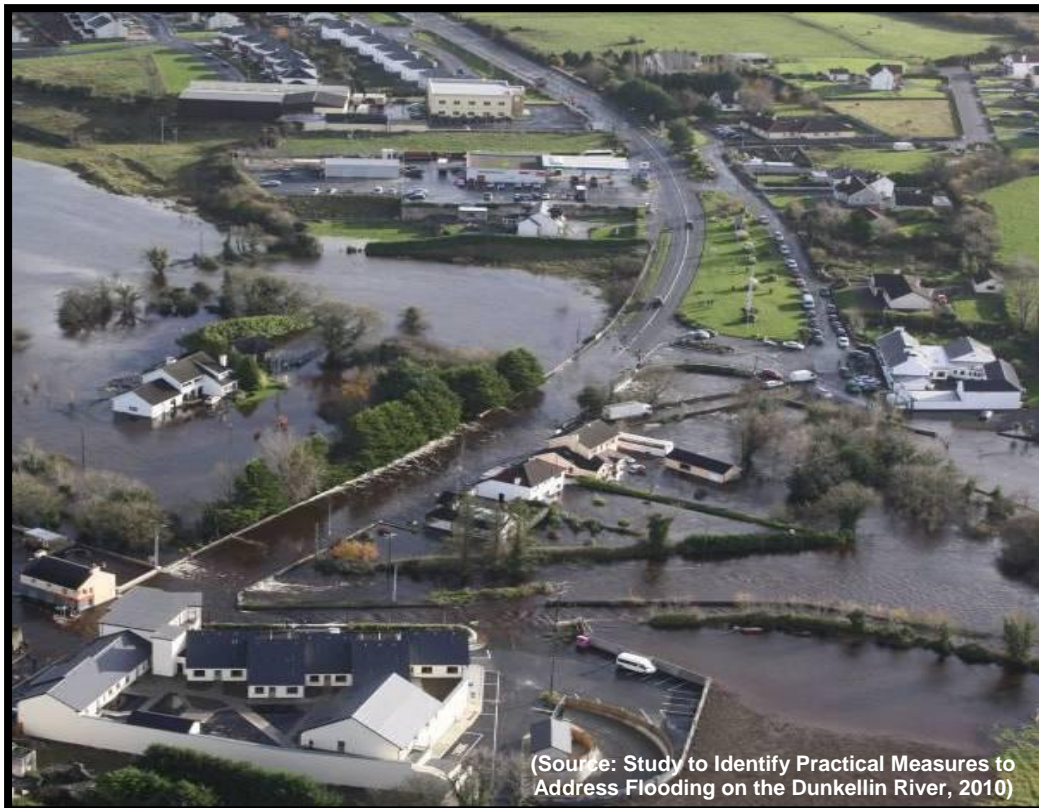
Image 5.1 Flooding in Craughwell at the Main R446 crossing on 20th Nov 2009 (Source Tobin, 2014)

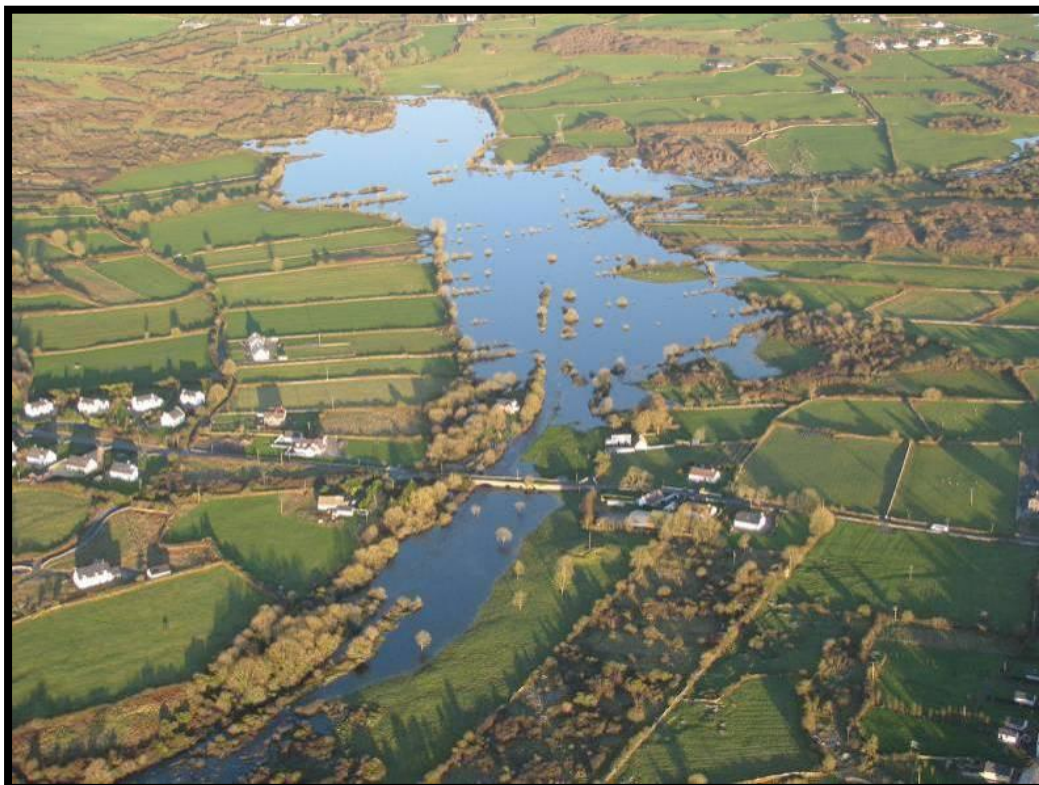
Image 5.2 Flooding at Dunkellin Bridge on 23rd Nov 2009 (Source Tobin, 2014)

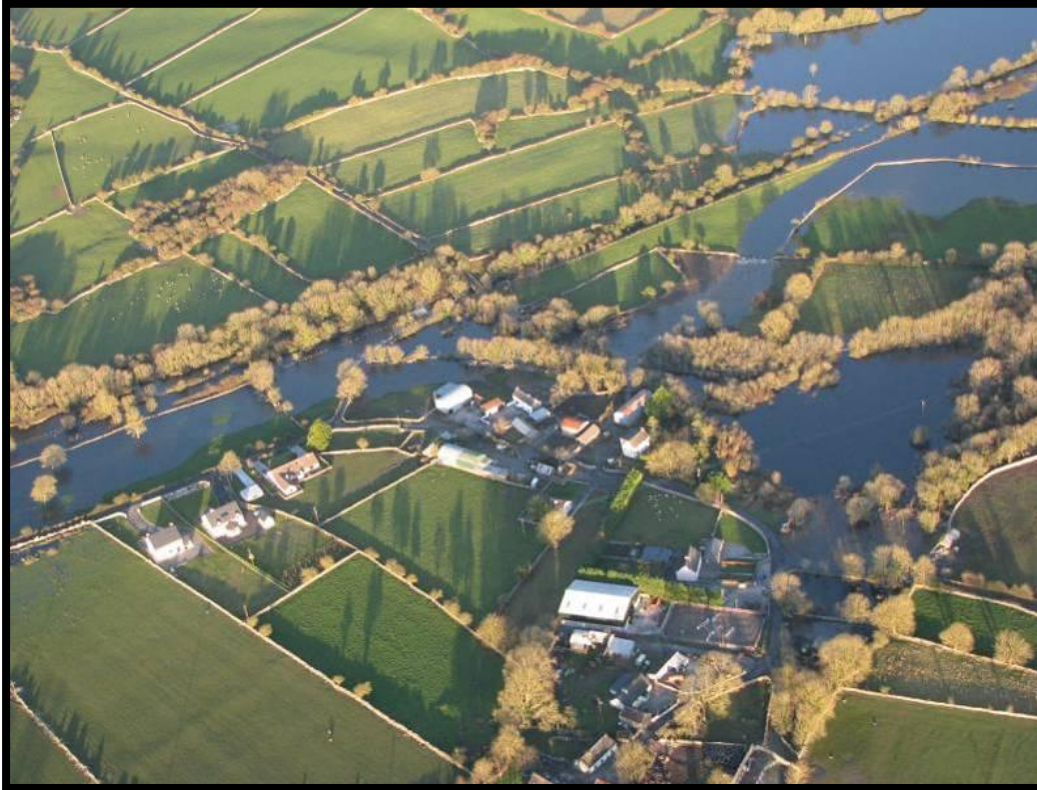
Image 5.3 Flooding in townland of Killeely Beg on 23rd Nov 2009 (Source Tobin, 2014)

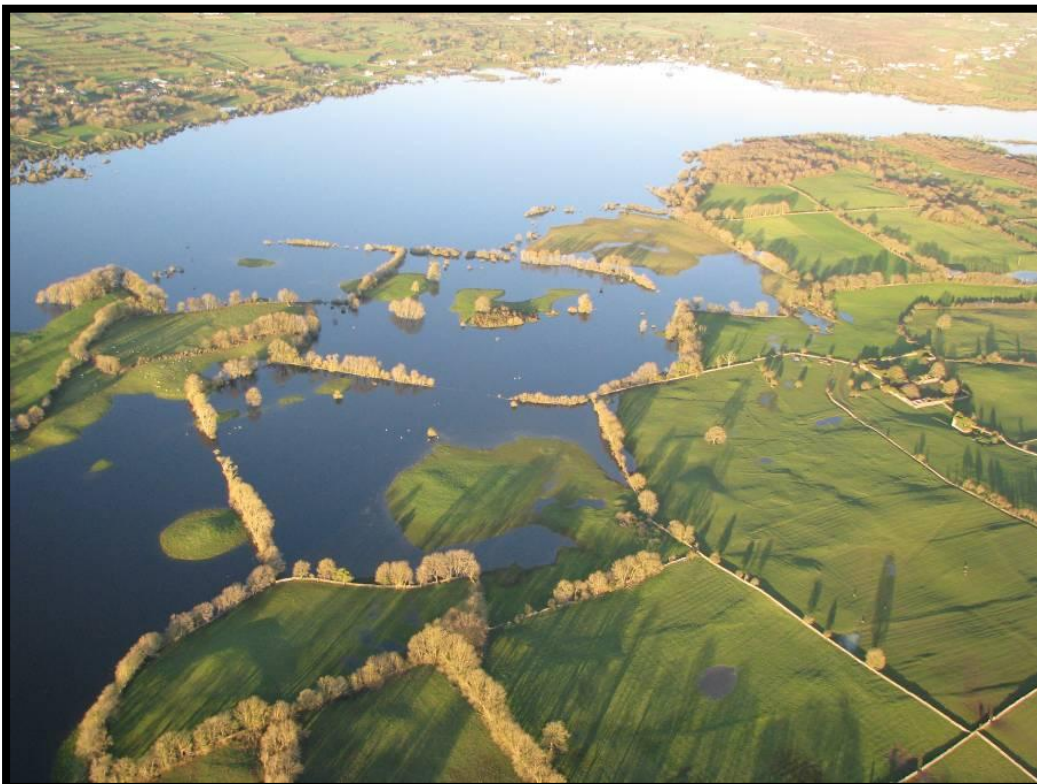
Image 5.4 Rahasane Turlough downstream of Craughwell on 23rd Nov 2009 (Source Tobin, 2014)

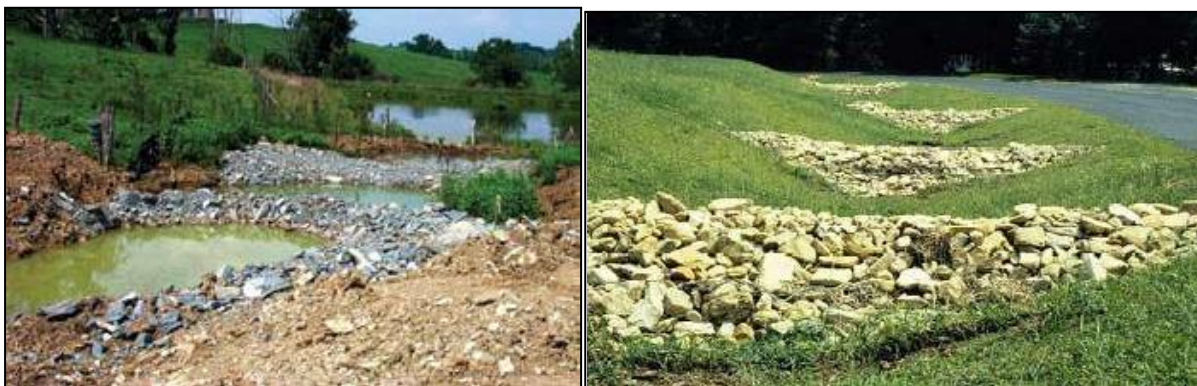
Storm runoff from the working area and landspreading sites will be conveyed via a swale located on the down slope of the working area. Swales are wide, shallow, gently sloping depressions used to convey water. They increase stormwater infiltration and are a low maintenance option to remove sediments, nutrients and pollutants whilst adding a visually aesthetic component to a site. Swales are most effective on gentle slopes with the incorporation of attenuation features such as silt traps, see **Image 9.1** and **Image 9.2**, which attenuate flow and encourage the sedimentation of any potential silt. The flow will discharge to a proposed soakpit and a double silt curtain will be provided at the outfall prior to being discharged to the watercourse. The silt traps must be cleaned out regularly, to ensure the effectiveness of the system. These facilities will be inspected/ maintained at least on a daily basis and the maintenance record will be available for inspection by the Client and other statutory organisations as part of the method statement.

Image 9.1 and 9.2 Example of Silt Traps and Swale with Check Dams to control sediment

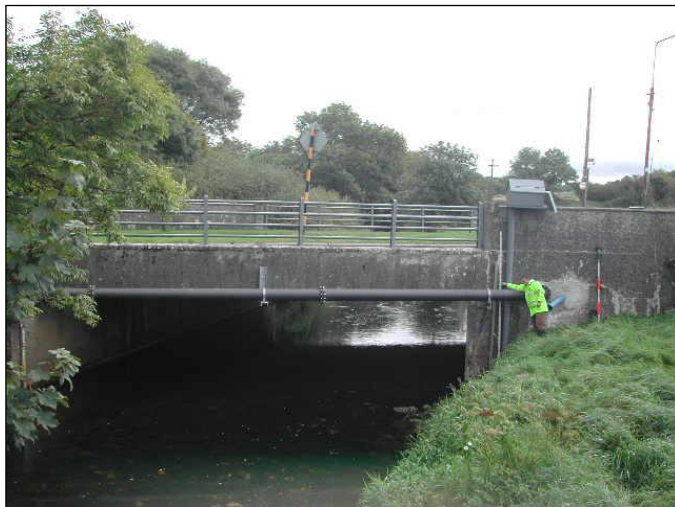
Photograph No. 2

**Main R446 Bridge Crossing
along the main channel looking
upstream from the multi-arched
stone bridge crossing shown in
Photograph No. 3**

Note : Full span of bridge available for flow and the water main located on the downstream face does not impede flows.

- a. The overflow or bypass channel within Craughwell Village (Photograph No. 1),
- b. The two road bridges (Photograph No's. 2 and 3),
- c. The old multi-arched stone bridge (Photograph No. 4) and
- d. The railway bridge (Photograph No. 5).

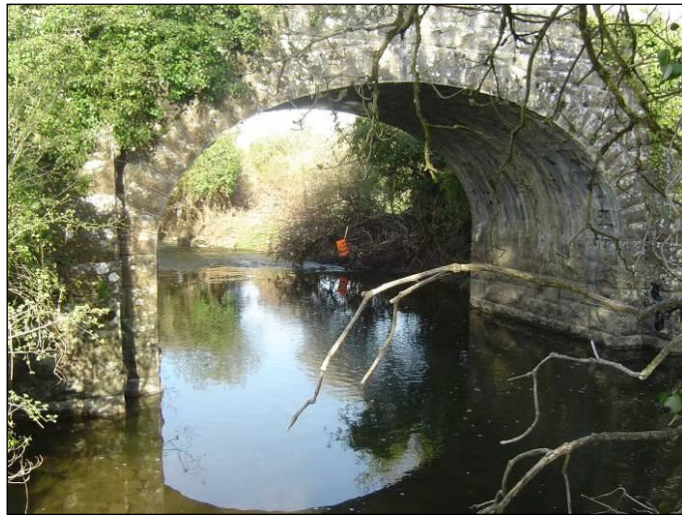
Photo No. 5

Railway Bridge looking downstream through the stone arch.

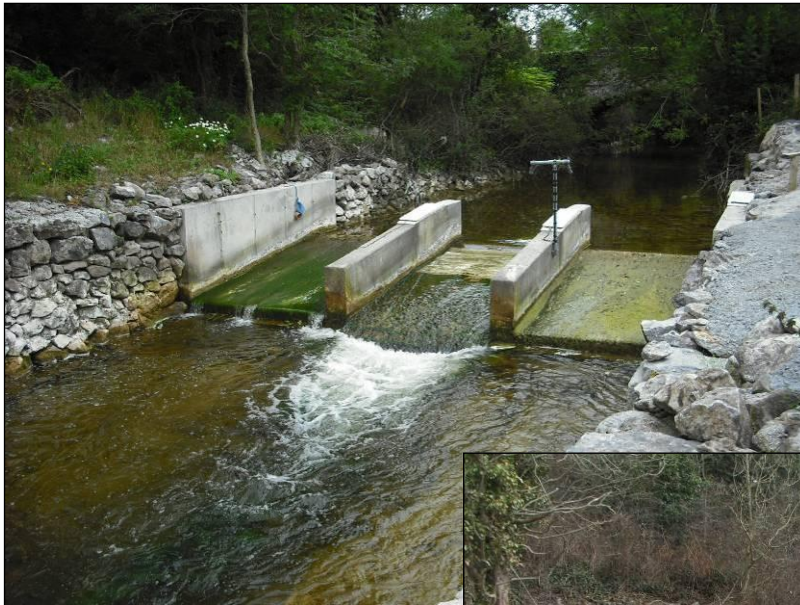
**Photographs No. 22 and 23
Existing Salmon Counter**

The existing salmon counter, shown in Photographs No. 22 and 23, is impacting on the high level water surface profile in the vicinity of Killeely Beg Bridge and is resulting in high water levels upstream of the bridge. Following consultation with the Inland Fisheries Ireland and

*It is proposed to replicate the existing structure at a location upstream of the Killeely Beg Bridge.
Note : change in depth of flow at this structure*

other local parties, it is proposed to relocate this structure to a location upstream of the Killeely Beg Bridge. The proposed structure will be similar in all aspects to the existing concrete structure.

The proposed salmon counter will be constructed in cast-in-situ concrete and this will be undertaken in two halves, utilising cofferdam type construction whereby flow can be restricted to one half of the channel width allowing the civil engineering works to be undertaken in the dry conditions of the other half. This method of construction reduces the risk of wet concrete and other construction debris entering the river.

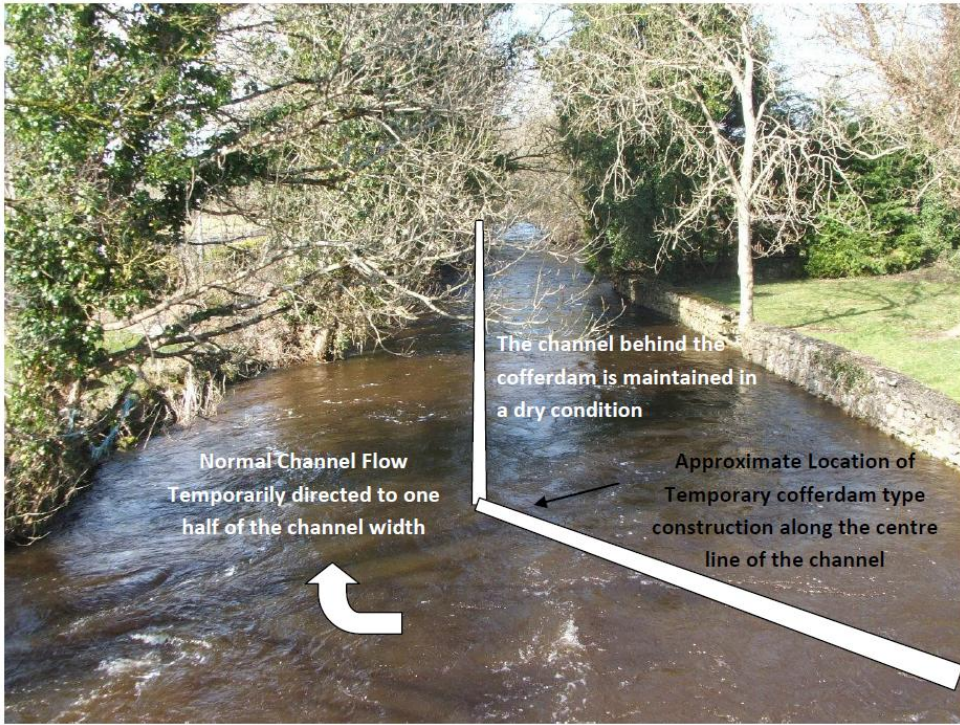
Figure 3-8 – Proposed Works Channel Works in the vicinity of Craughwell Village and sketch of cofferdam location

Figure 3-8 provides an illustration of a typical cross section of the works to be undertaken along this section of the river in the vicinity of Craughwell Village.

It is envisaged that temporary cofferdam type construction or temporary sheet pile walls (with a length of 50 to 100m depending on the depth of water and ground conditions) will be used in the location described in Figure 3-8. This process allows river water to be directed to one half of the channel width allowing the civil engineering works to be undertaken, in relatively dry conditions, on the other side of the channel. Once this half of the proposed channel works is excavated, within the confines of the cofferdam, it is expected that river water will be directed to the new section allowing the adjacent excavations to be completed. This sequence of construction is expected to commence at the lower downstream point of the works and continue upstream in this “*leap-frog*” type construction method. This method of construction reduces the risk of construction debris and silt entering the river.

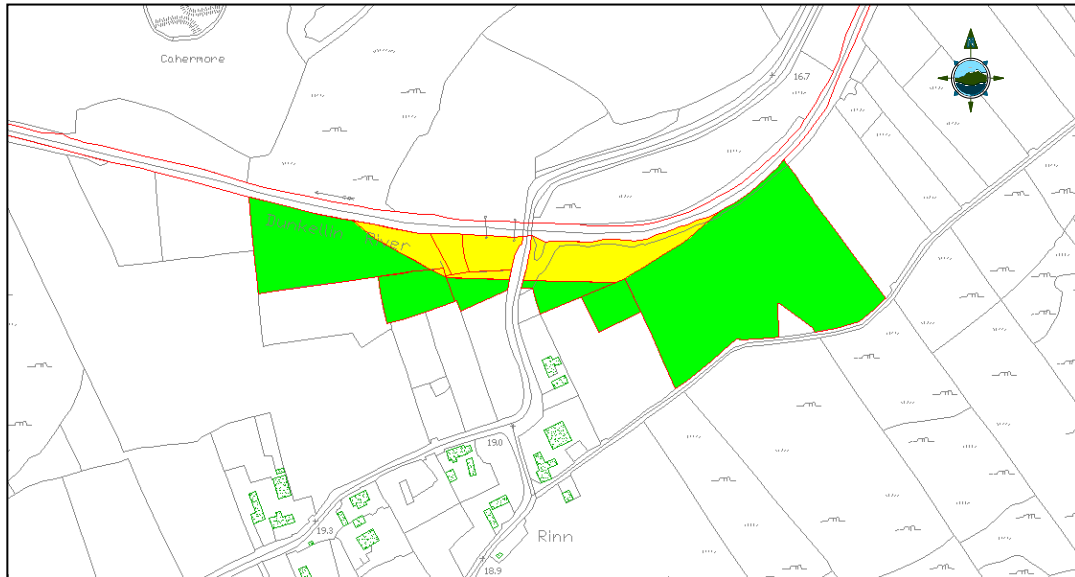
Figure 6-4 – Approximate Location of Lands required for deposition of excavated material (green) upstream of Rinn Bridge (Yellow Areas indicate extent of channel excavations)

- c. Downstream of the Rahasane Turlough cSAC but upstream of Rinn Bridge, it is expected that channel widening along the Dunkellin, will require the excavation of approximately 5,000m³ of gravels and an amount of rock. It is expected that at least 3,500m³ of rock will be excavated and that over 50% of this material can be reused in creating side slope protection along the lower reaches of the Dunkellin River, downstream of the Dunkellin Bridge. This will require significant traffic movement in the area to cater for this reuse of material. It is expected that the remaining material (circa 1,500m³) which will consist of overburden or sandy gravels can be reused along the left bank. This technique will again involve topsoil stripping (and storage) on the left bank in advance of channel works, spreading of the excavated material across the

stripped works area and reinstatement of the left bank with the stored topsoil. Alternatively, an embankment, constructed from excavated material may be created along the left bank to minimise the need for transport of the excavated material away from the works area.

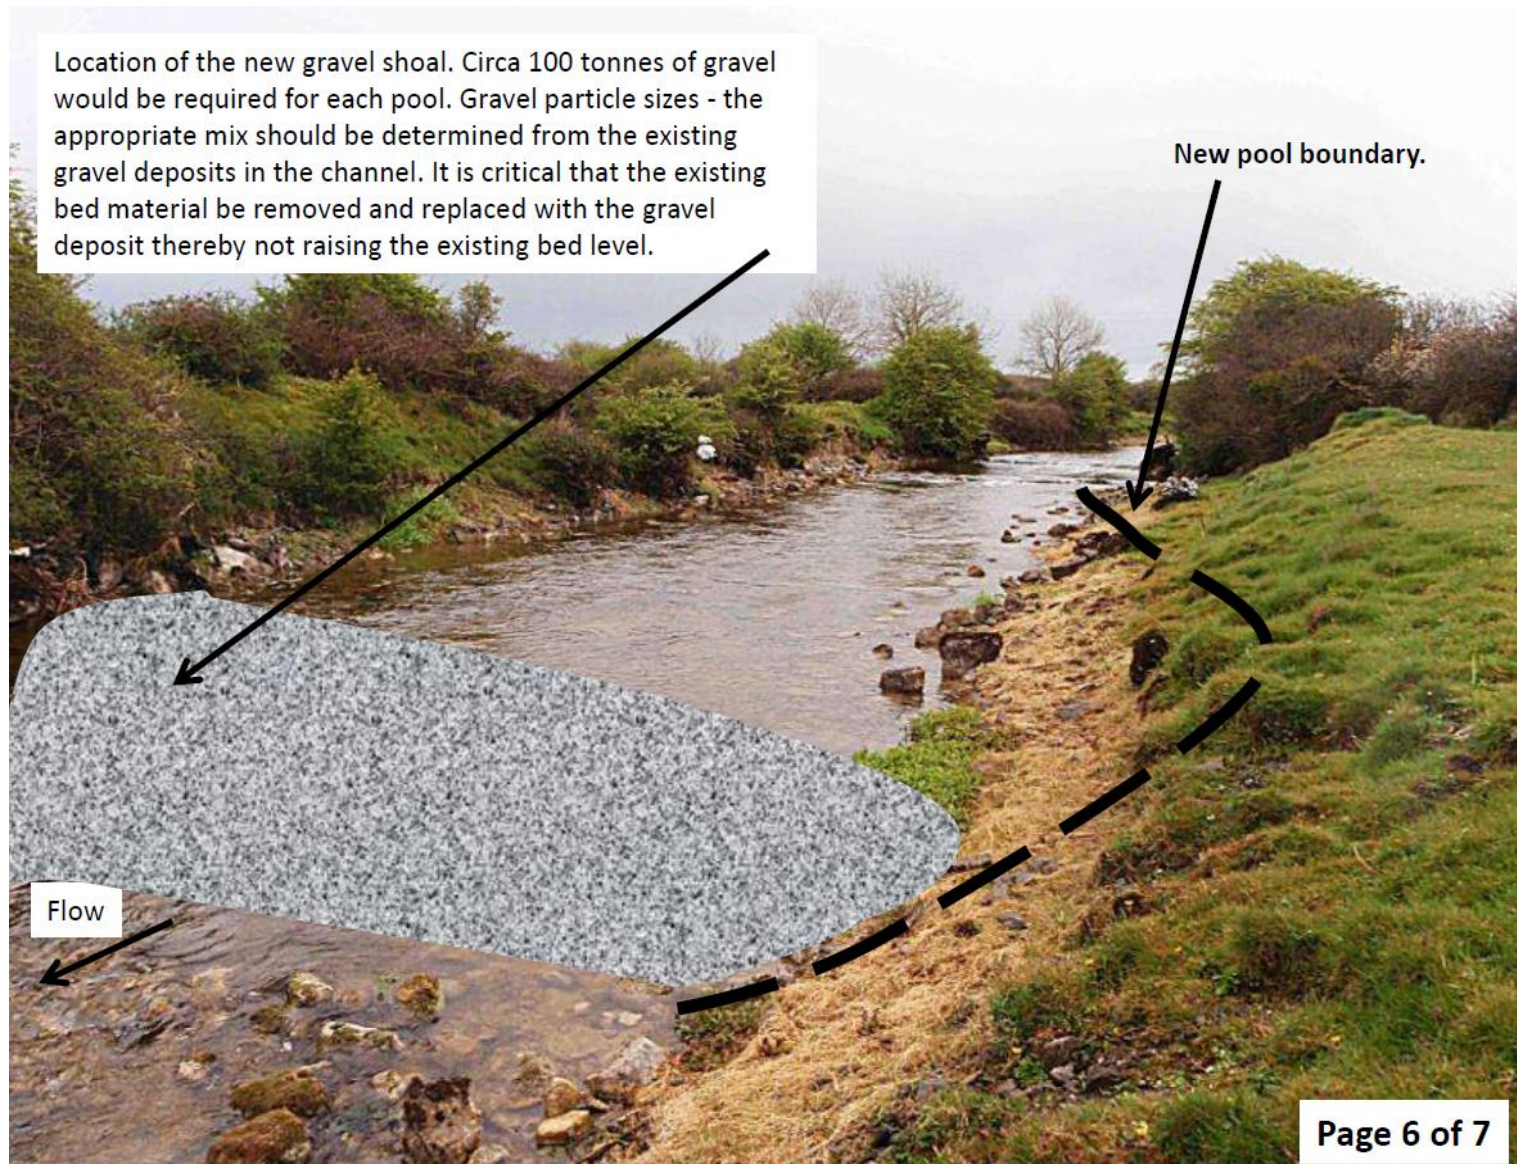
An Aerial View

A pair of low level stone deflectors of unequal proportions. The structure next the right bank is larger to ensure that the water, at low flow levels, is deflected down through the centre of the newly excavated pool.

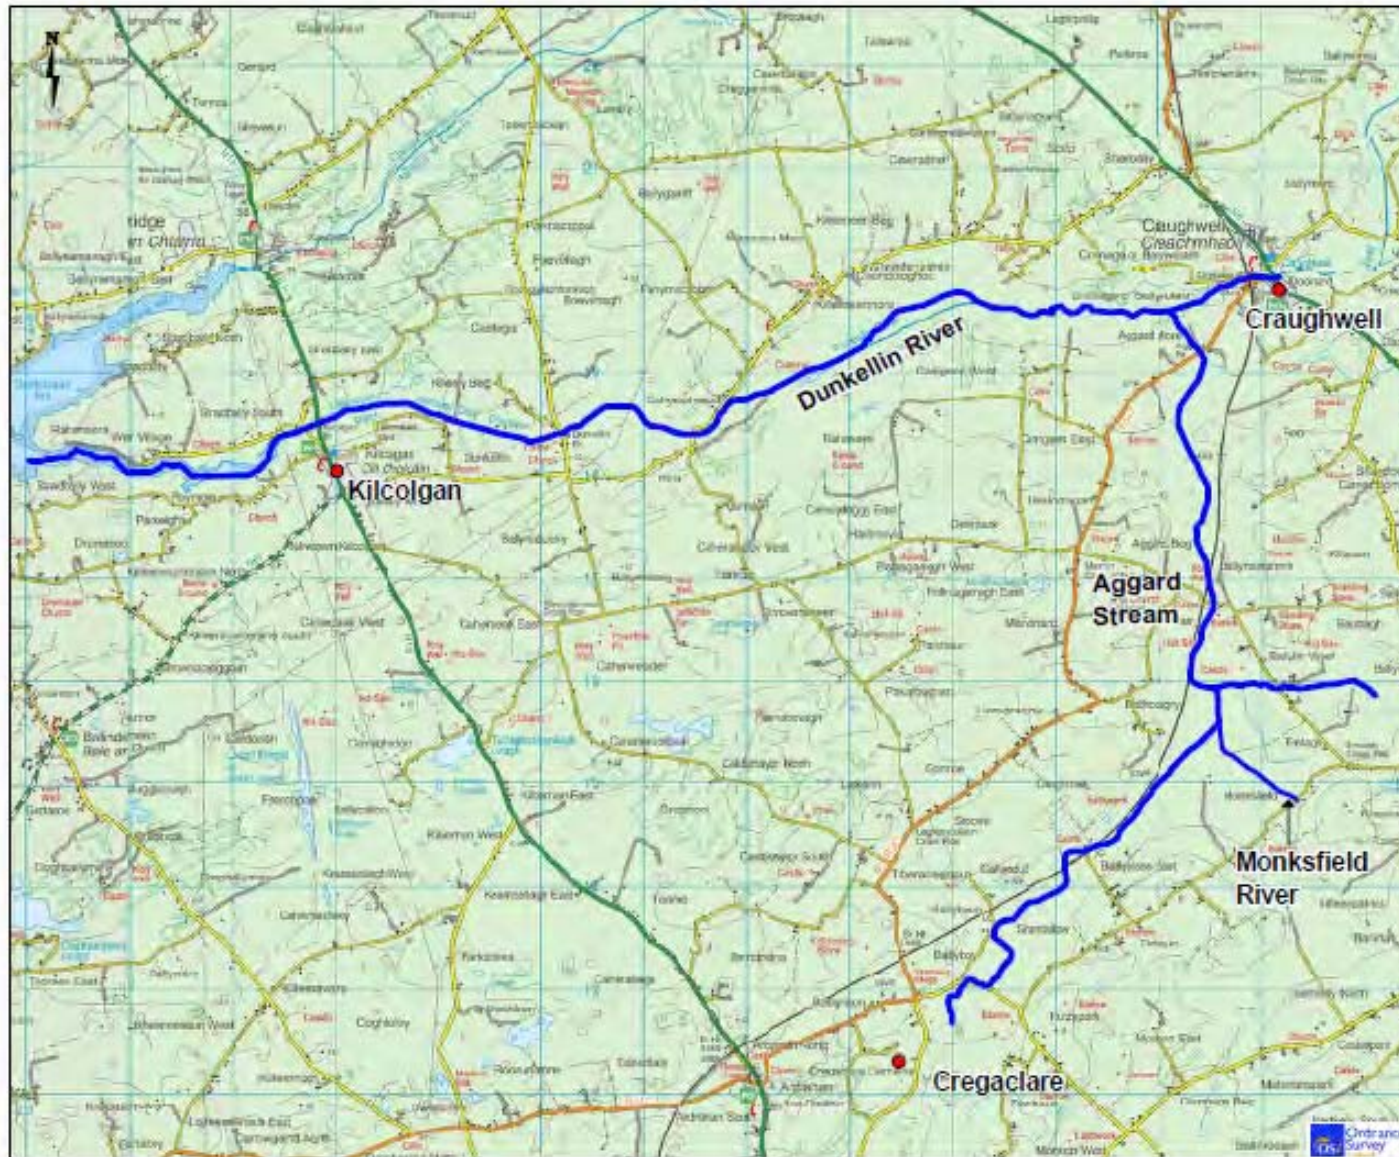
Figure 3.1 Extent of the Area Proposed for Flood Alleviation Measures

Location of Proposed Flood Alleviation Measures	<p>The principal study area for the proposed Flood Relief Scheme will be the channel, floodplain, and immediate surrounding areas of:</p> <ul style="list-style-type: none">- The Dunkellin/Craughwell River extending along the main channel from approximately 200m upstream of Craughwell Village, through the Rahasane Turlough cSAC, to the sea at Kilcolgan.- The Aggard Stream and Monks field River from the townland of Cregaclare (near Ardrahan) to its outfall at the confluence of the Dunkellin and Craughwell Rivers.- <p>Figure 3.1 shows the extent of the study area.</p>
--	--

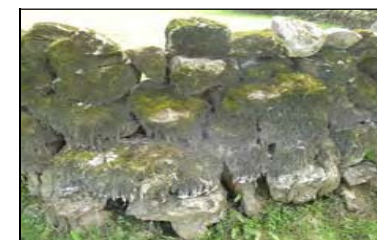
Stone wall on the south eastern side of the turlough. *Cinclidotus fontinaloides* moss and calcareous deposits indicate that this wall is inundated during the winter months

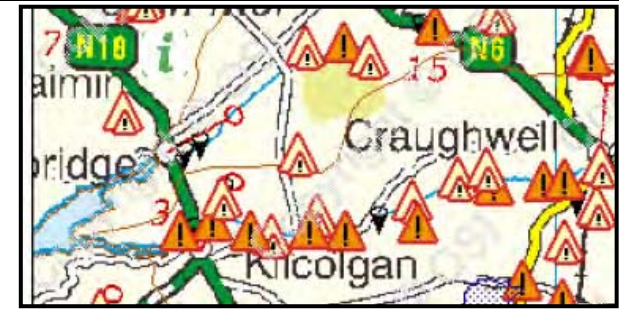
Figure 3.5 Flooding Events on the Dunkellin River (www.opw.ie)

There is a history of flooding in the Dunkellin River catchment including the most notable flood events of recent times in November 2009 and January 2005. **Figure 3.5** shows the numerous flooding events that have been recorded by the OPW in the study area.

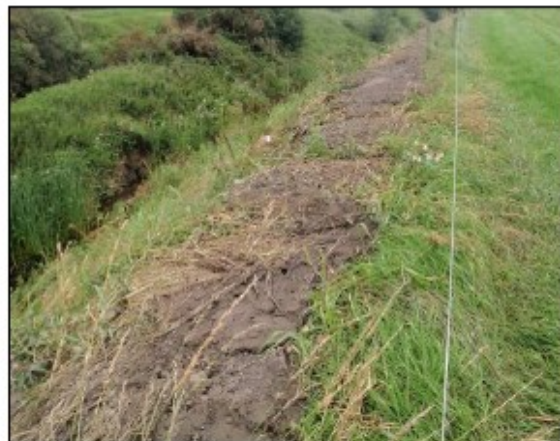
3. Spoil Management

- 3.1 Maximise spoil placement on bank full line or spoil heaps **and**
- 3.2 Minimise spoil placement on bank slopes
- 3.3 Spread spoil as thinly as possible
- 3.4 Allow water to drain out of bucket over the water – lets small fish, lamprey and crayfish escape

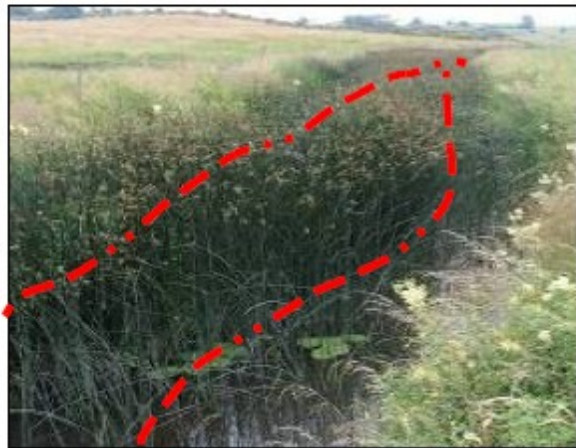
4. Selective Vegetation Removal

- 4.1 Retain a band of vegetation on both sides at water's edge
- 4.2 Selectively manage instream vegetation
- 4.3 Maximise use of weed-cutting bucket
- 4.4 Avoid maintenance in coarse fish channels from 1st April to 1st July

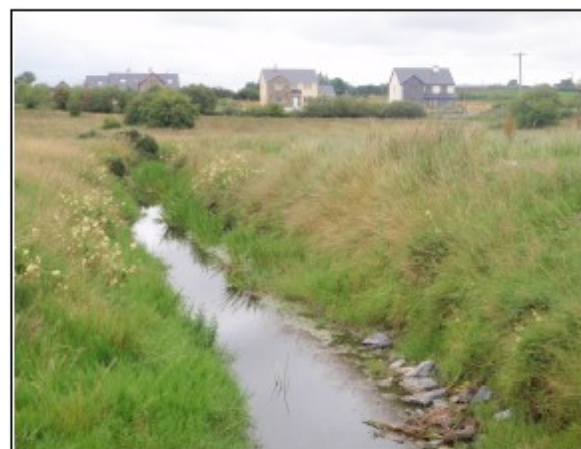
5. Leave sections untouched

- 5.1 If channel capacity is not affected, leave section alone

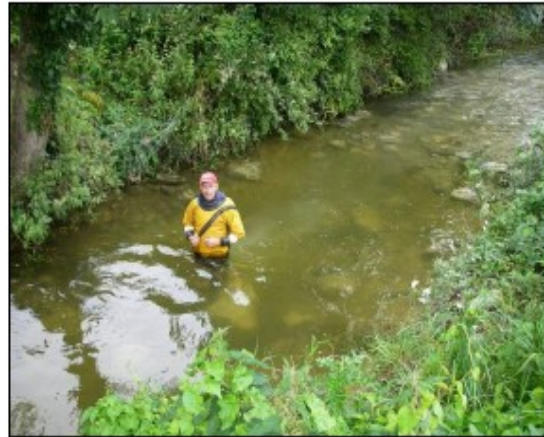
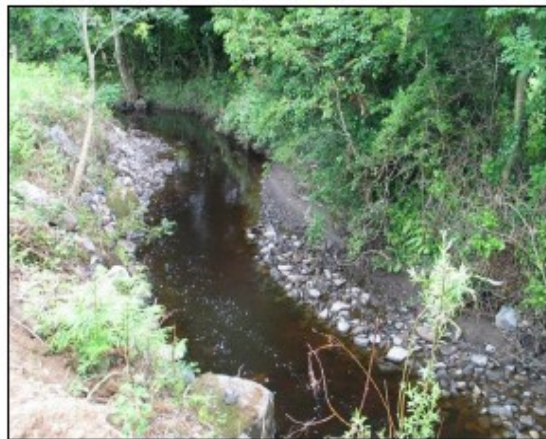
10.1 Excavate bed to form deeper pool areas and shallow riffles

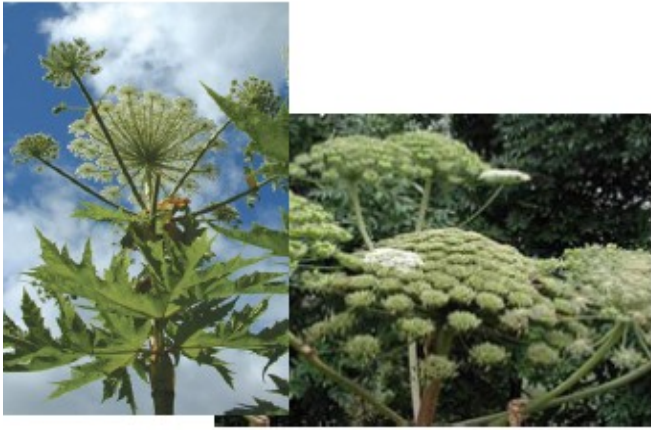
Giant Hogweed

Found on the banks of many rivers throughout Ireland.

Seeds are carried by water and spread very quickly.

!!!Avoid contact with the sap of this plant it can cause extensive lesions or blistering the skin.

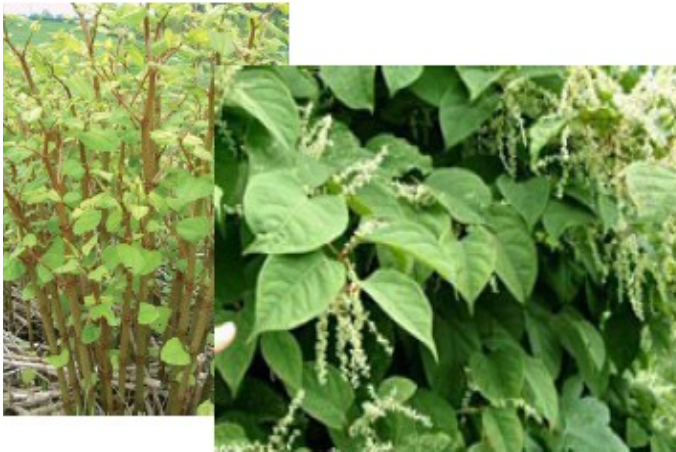
Japanese Knotweed

Grows up to 2-3m in height along roadsides and river corridors throughout the country.

Leaves are heart-shaped with a pale stripe down the centre.

In Summer cream flowers arise from the top of the red-flecked stems.

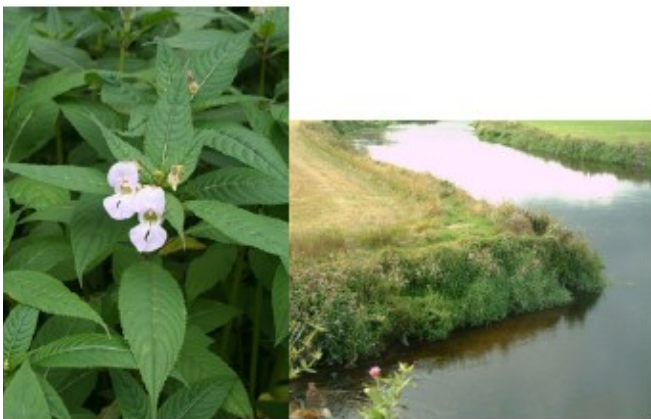
Himalayan Balsam

Grows in dense strands up to 3m high, and is found widespread across Ireland along banks of rivers.

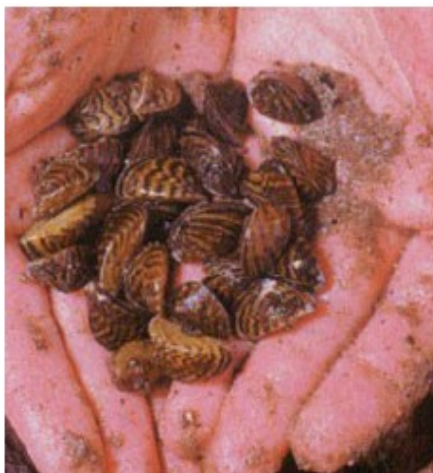
Zebra Mussels are thumbnail-sized black & orange striped shellfish. They grow into dense clusters and attach to any underwater hard surface. They are an invasive species that damage the natural ecology of the infested waters. They expand into catchments through been transported by man's activities e.g. transferring fishing boats. Once in a particular lake or river, if conditions are favourable, they will multiply and spread with the currents. It is envisaged that they will keep expanding their territory unless man makes a concerted effort to prevent transport of the Mussels into non-infested waters.

Although it is a relatively low risk, OPW could spread Zebra Mussels if aquatic vegetation or excavated material containing Mussels is inadvertently transported to another non-infested channel. Adult Mussels can survive for up to four weeks out of water hence its critical not to transport the same. Larvae are tiny and barely visible but will not survive on a machine bucket if there is no silt, stones or vegetation to shelter it.

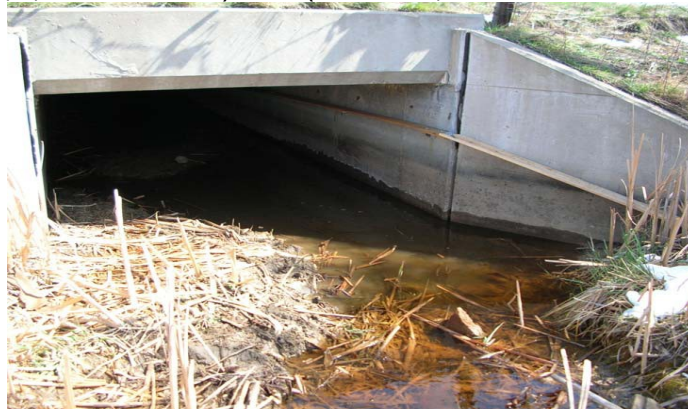
- At some sites, considerations of responsibility, cost, aesthetics or practicality might indicate the use of a solid ledge; this is most likely where an existing otter-ledge has proved to be sited too low to offer dry passage at spate conditions. A solid ledge can be created in 3 ways; concrete bagging, shuttering plus new concrete and concrete blocks.
