Dunkellin River and Aggard Stream Flood Relief Scheme,  
Description of the Proposed Works

# Galway County Council

### Description of the Proposed Works

**PROJECT:** **Dunkellin River and Aggard Stream Flood Relief Scheme**

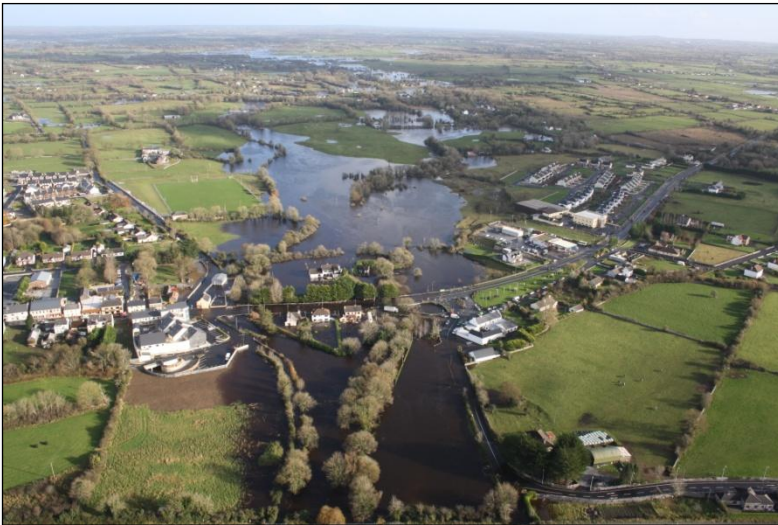
**Photograph A  
November 2009 Event.  
Looking Upstream from  
Craughwell**

Note the relatively small area (approximately 1.2ha) and therefore volume of flooding in Craughwell village when compared with the extent of lands flooded at the Rahasane Turlough (>350ha) in Photographs B and C.

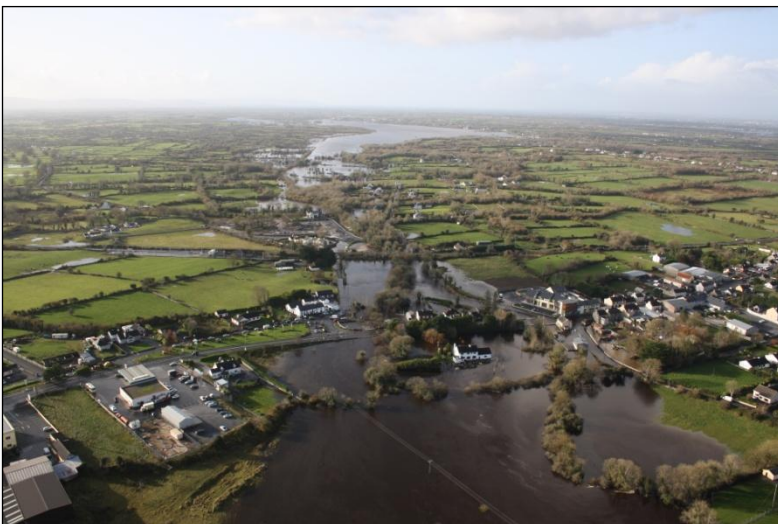
**Photograph B  
November 2009 Event.  
Looking downstream from  
Craughwell**

Note the relatively small area (approximately 1.2ha) of flooding in Craughwell in the foreground when compared with the extent of lands flooded at the Rahasane Turlough (>350ha) in background.

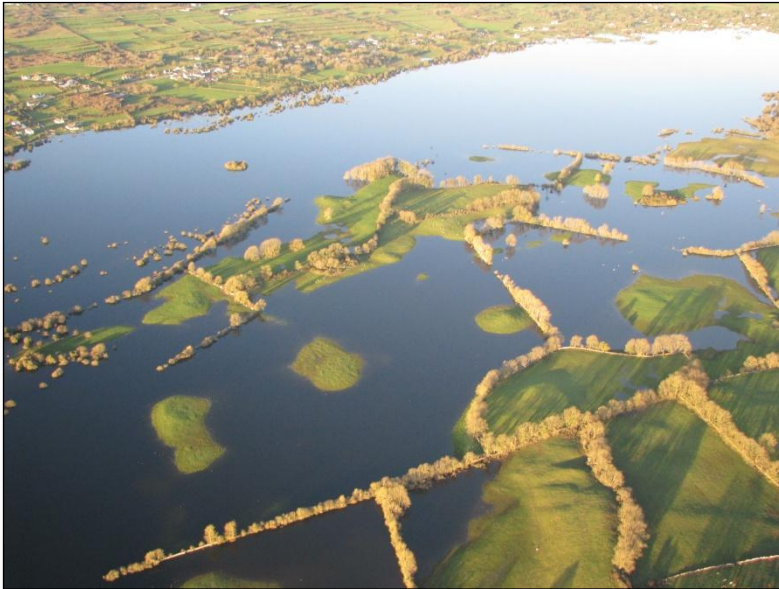
**Photograph C  
November 2009 Event.  
Looking northwards across  
the Rahasane Turlough**

The width of flooding shown is approximately 0.75 to 1.0km..

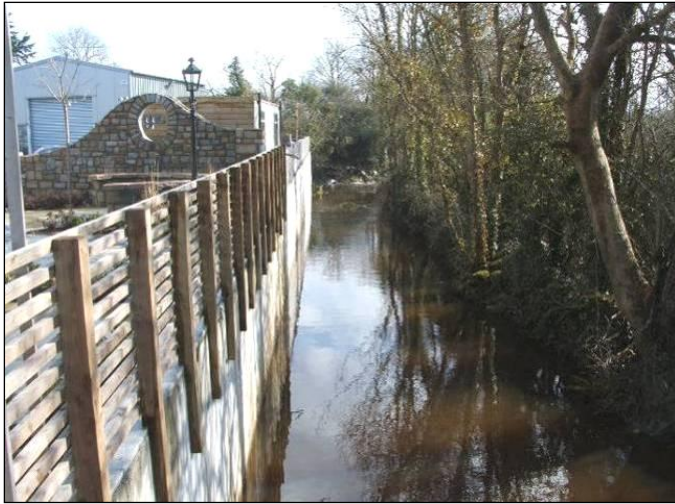
**Photograph No. 1**

**Overflow or Bypass Channel  
looking upstream from the  
R446 bridge crossing**

- a. The overflow or bypass channel within Craughwell Village (Photograph No. 1),
- b. The two road bridges (Photograph No's. 2 and 3),
- c. The old multi-arched stone bridge (Photograph No. 4) and
- d. The railway bridge (Photograph No. 5).

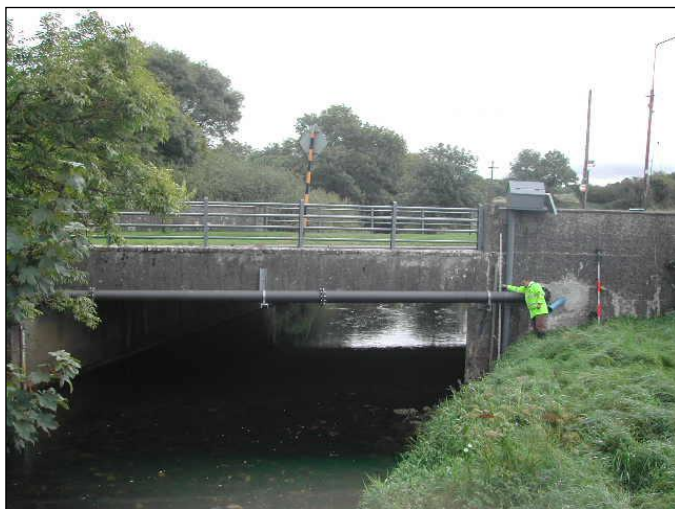
**Photograph No. 2**

**Main R446 Bridge Crossing  
along the main channel looking  
upstream from the multi-arched  
stone bridge crossing shown in  
Photograph No. 3**

Note : Full span of bridge available for flow and the water main located on the downstream face does not impede flows.

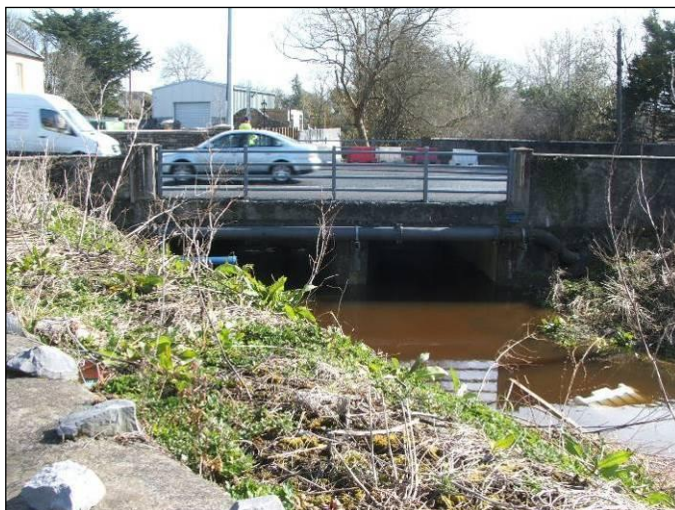
**Photograph No. 3**

**Bridge crossing of Bypass Channel  
looking upstream towards the channel  
shown in Photograph No. 1**

Note : Unlike the Main R446 Bridge crossing, this structure has a central pier/support which reduces the overall effectiveness of the bridge.

The water main is located on the downstream face of the bridge and does not impede flows.

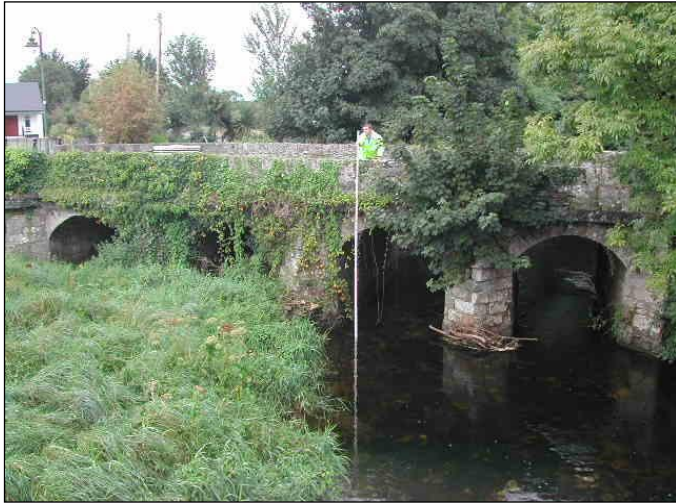
**Photograph No. 4**

**Multi-arched Stone Bridge looking downstream from the main R446 bridge Crossing shown in Photograph No. 2**

Note : Low Flows generally restricted to the main arches on the right of the photo. Only in times of high flows are the arches on the left utilised due to high bank levels.

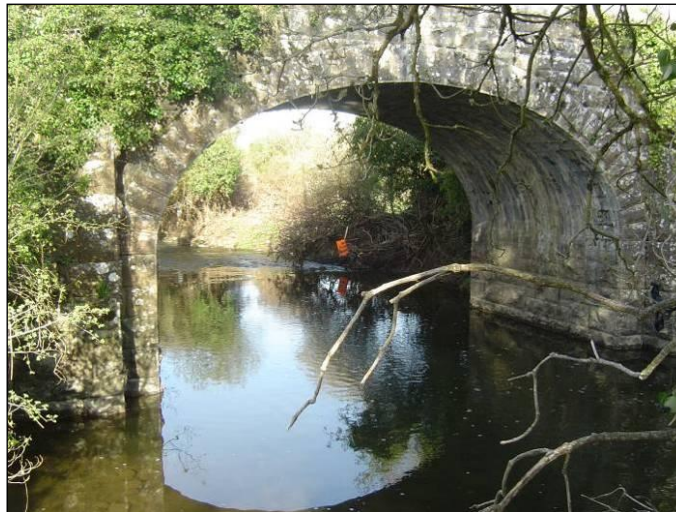
**Photo No. 5**

**Railway Bridge looking downstream through the stone arch.**

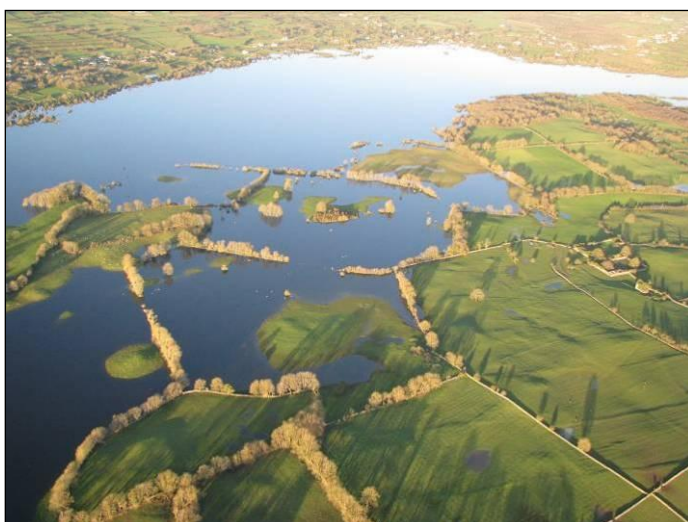
**Photograph No. 6  
Rahasane Turlough**

During flood conditions the width of the “Dunkellin River”, or the flood plain, increases quite significantly, as can be seen in Photograph No. 6.

In a number of locations along Rahasane Turlough cSAC, the flood plain can be greater than 1km wide and, at its highest levels, can extend to cover an area of over 300ha.

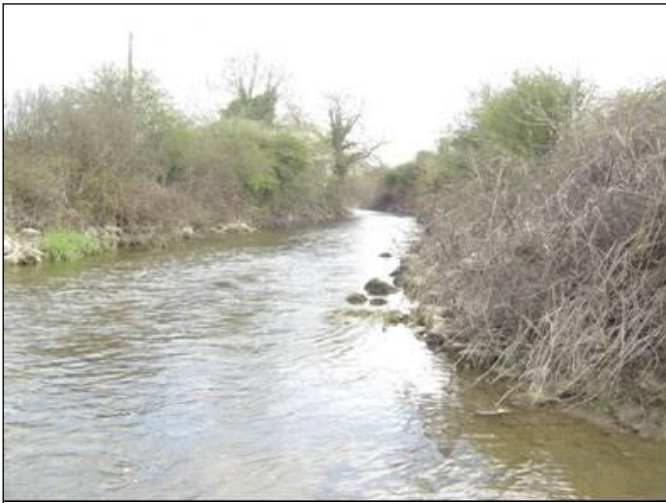
**Photograph No. 7**  
**Dunkellin River looking upstream**  
**from Rinn Bridge**

Downstream of the Rahasane Turlough cSAC, flow is westerly toward Rinn Bridge, through a well defined canalised channel, measuring up to 3.3m in depth, and 15 to 20m in width. The section of channel downstream of the turlough is shown in Photograph No. 7. This section of the channel is formed in a rock cut, for a significant portion of its length, and the gradient of the channel bed is typically 1 in 200.

The main channel exiting the Rahasane Turlough (Photograph No. 7) and the Rinn Bridge (Photograph No. 8), which is located approximately 800m downstream of the turlough, are the main downstream features impacting on the hydraulic control of the river.

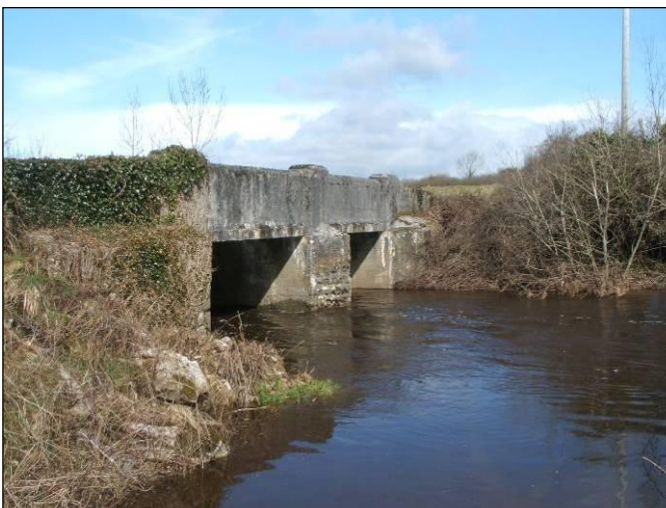
**Photograph No. 8**  
**Rinn Bridge taken from the upstream**  
**left bank**

Downstream of the Rinn Bridge, and during low flow conditions, surface water flows are restricted to the main Dunkellin River, which again, following the Arterial Drainage Scheme completed in the 1850's, can be described as being "canalised" for a significant portion of its length. During these low flows, this particular stretch of the river varies in width from 10m to 15m and, the gradient of the channel bed is approximately 1 in 300.

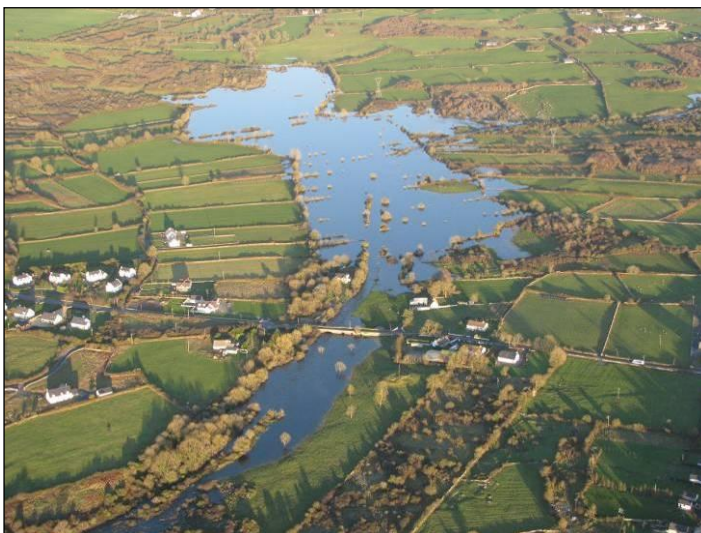
**Photograph No. 9  
Dunkellin Turlough**

Facing upstream with the Dunkellin Bridge in the centre of the image with a cluster of houses on each of the right and left banks

During high flows, the Dunkellin River also overtops its banks approximately 750m downstream of the Rinn Bridge and flood waters enter the Dunkellin Turlough as shown in Photograph No. 9.

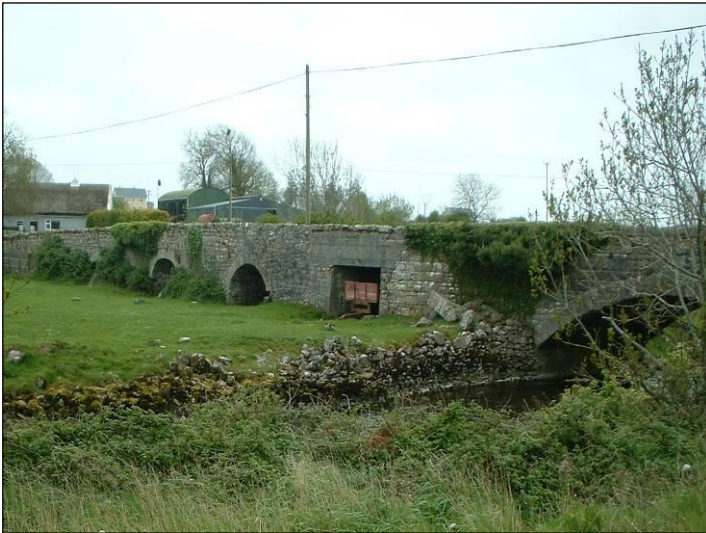
**Photograph No. 10**  
**Upstream face of the Dunkellin**  
**Bridge showing the main arch and**  
**flood eyes on the left bank**

Low Flows at this location are restricted to the main channel and stone arch visible on the right of the photograph.

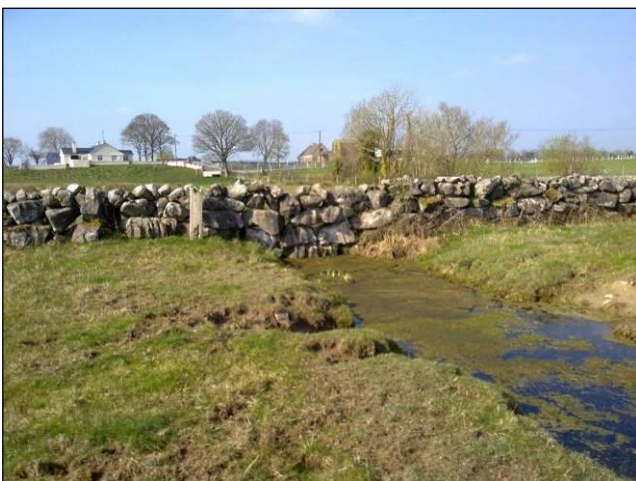
**Photograph No. 11**  
**Typical Boundary Crossing along the Aggard Stream in Cregaclare**

Note : boundary wall traverses the channel without any pipework crossing to improve conveyance

Along this stretch of the channel, field boundaries and local access crossings, as shown in Photographs 11 and 12, also impede the flow in the channel.

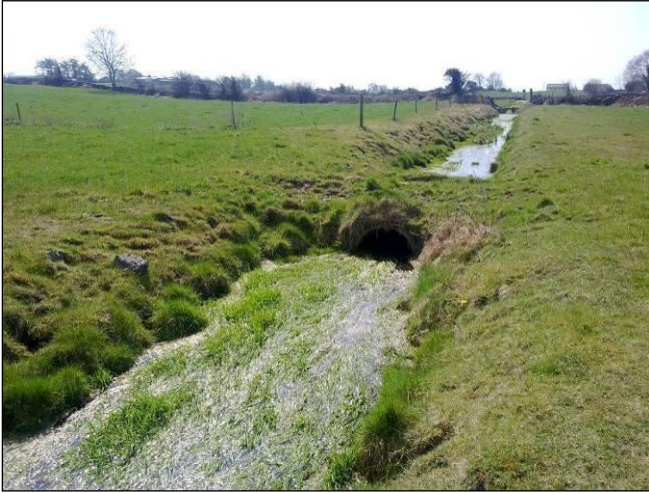
**Photograph No. 12**  
**Typical Field Crossing along the**  
**Aggard Stream in Cregaclare**

Dense weedy growth is also a significant feature of the upper reaches of this channel

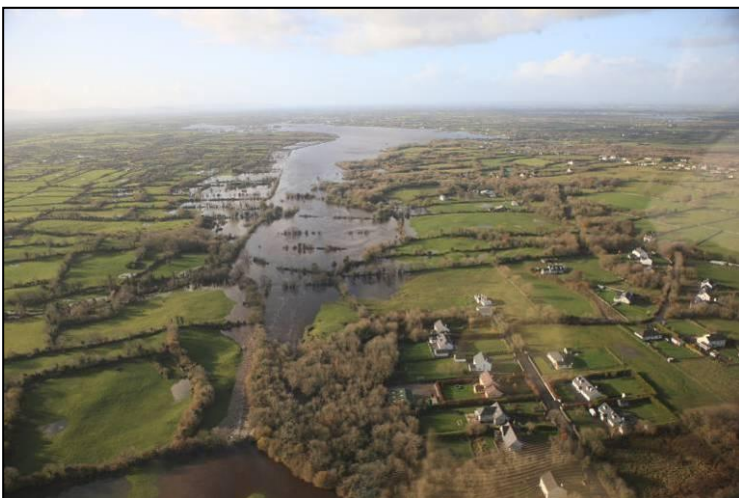
**Photograph No. 13**  
**January 2005 Event**  
looking downstream to the  
west of Craughwell towards  
the Rahasane Turlough on  
12<sup>th</sup> Jan 2005

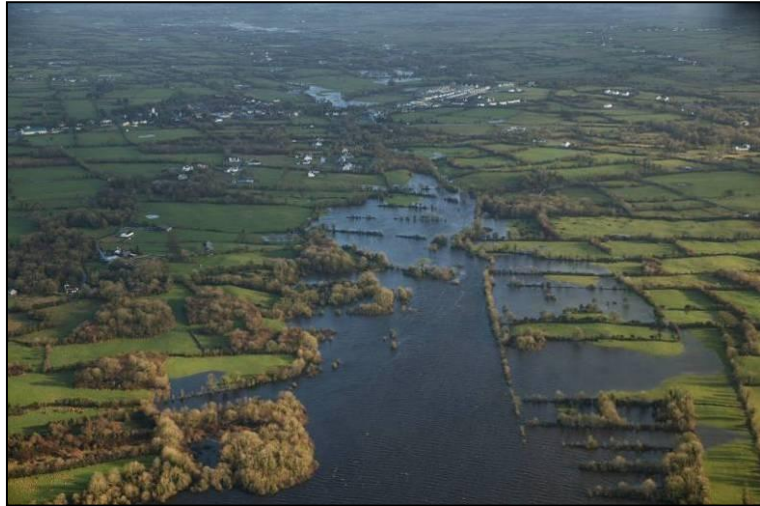
**Photograph No. 14  
January 2005 Event  
looking upstream towards  
Craughwell from the  
Rahasane Turlough on 12<sup>th</sup>  
Jan 2005**

The width of the flood at this location  
was approximately 375m

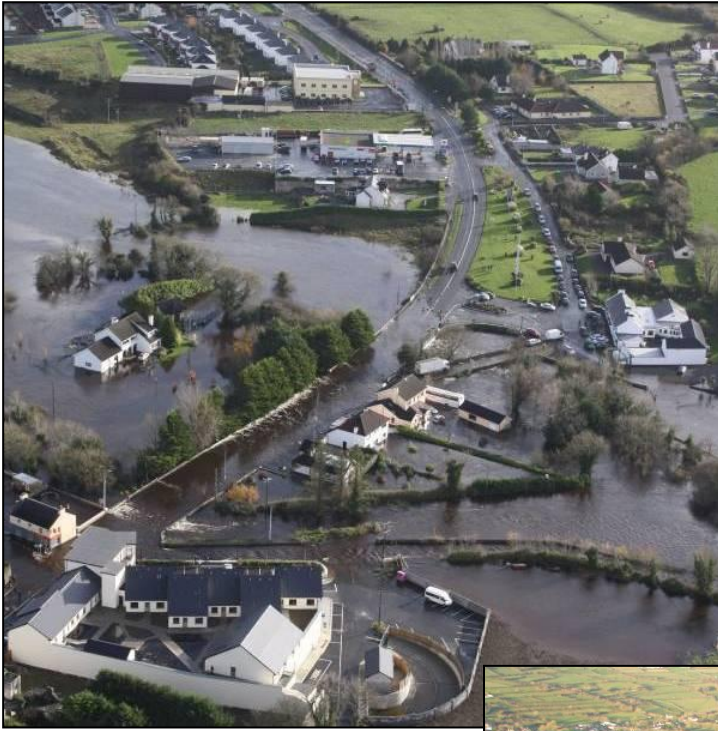
**Photograph No. 15 Flooding in Craughwell at the Main R446 crossing on 20<sup>th</sup> Nov 2009**

The extent of dwellings flooded, or at risk from flooding, in the village is evident .

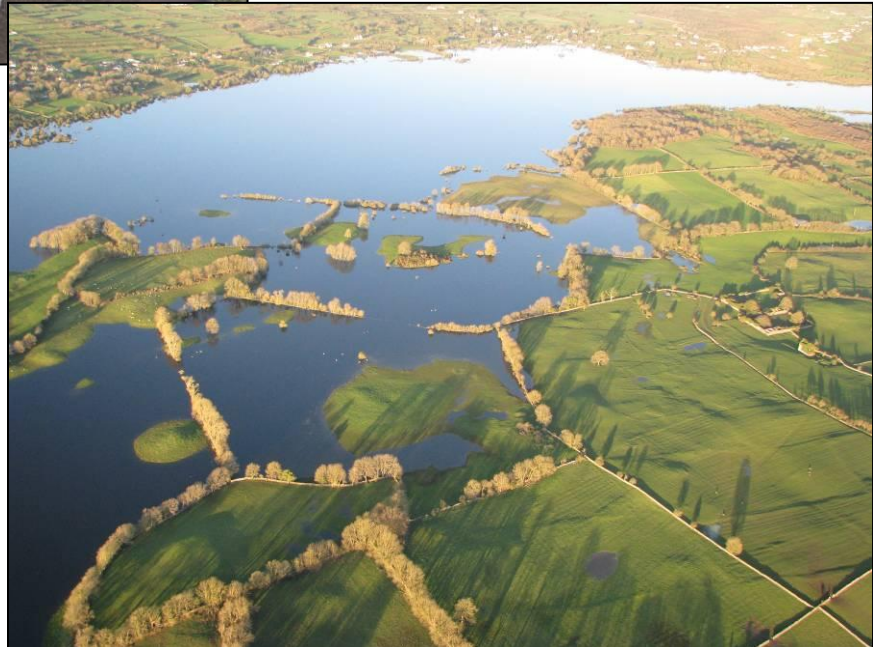
**Photograph No. 16 Rahasane Turlough downstream of Craughwell on 23<sup>rd</sup> Nov 2009**

The Kilcolgan Road with ribbon development is visible in the upper portions of the photograph. This road was closed for 10 days during this event and properties were flooded along this stretch of the Dunkellin River

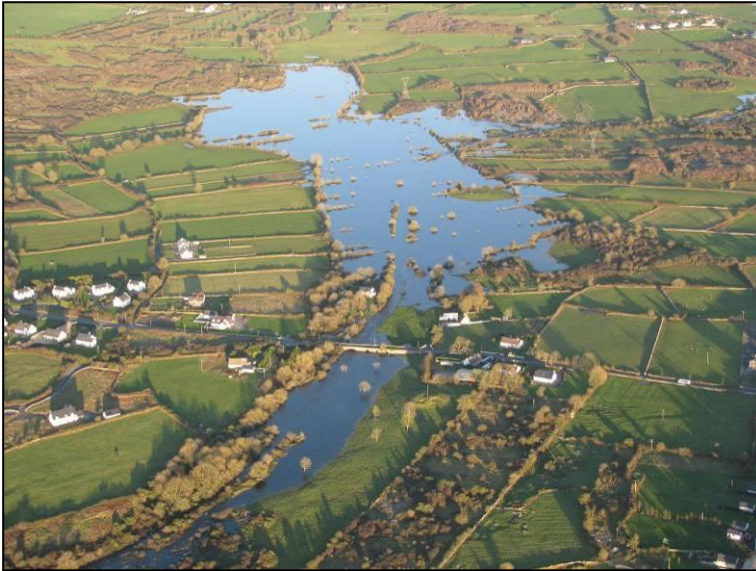
**Photograph No. 18**  
**Flooding at Dunkellin Bridge on 23<sup>rd</sup>**  
**Nov 2009**

View facing upstream with the Dunkellin Bridge in the centre of the image with a cluster of houses on each of the right and left banks

The Dunkellin Turlough is also visible in the background

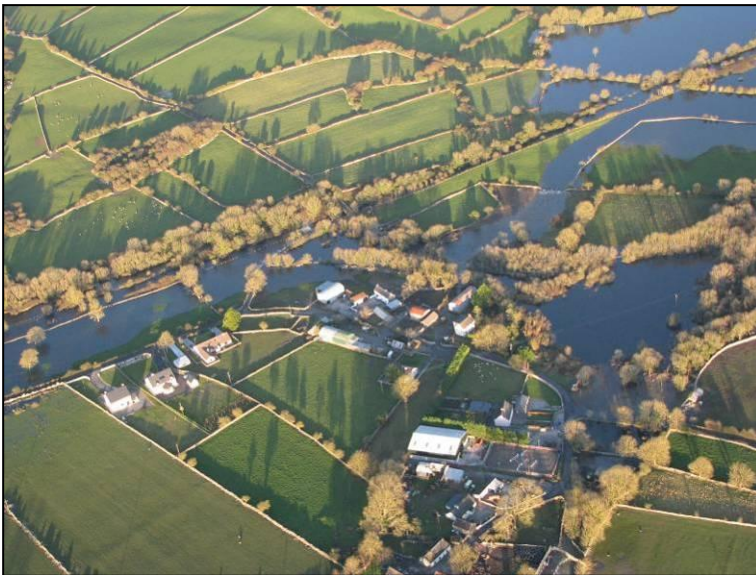
**Photograph No. 17**  
**Flooding in townland of Killeely Beg on**  
**23<sup>rd</sup> Nov 2009**

The “canalised” Dunkellin River is a straight section of channel in this location. The channel breaks its banks and follows the natural contours of the adjacent lands and ultimately bypasses the Killeely Beg Bridge in the centre of the photo (surrounded by trees).

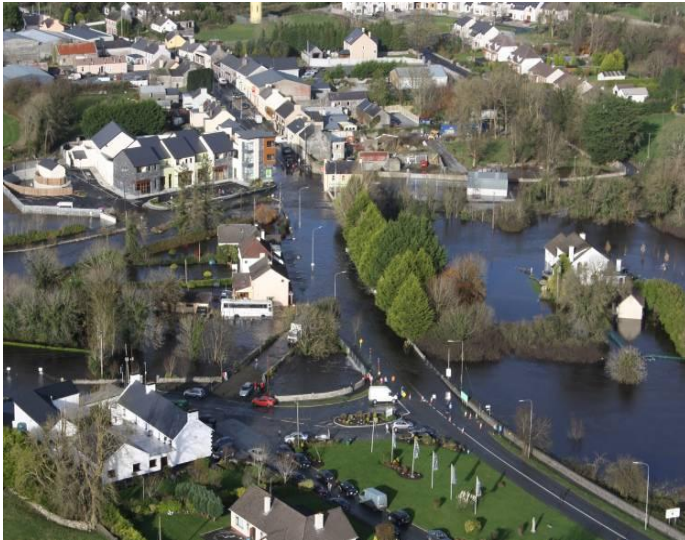
### **Photograph No. 19 Craughwell Village**

Three dwellings were flooded in Craughwell, located in the centre of the photo and to the left of the R446 roadway. The R446 was also closed for 4 days during this event.

Two commercial properties were also flooded including the underground car park of the new development in the top left hand portion of the image.

Whilst the dwelling on the right of the photo was not flooded the surrounding gardens were inundated with flood waters.

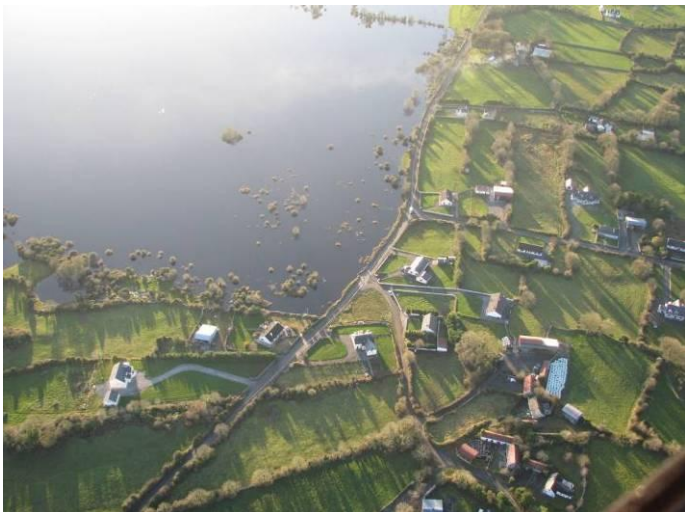
### **Photograph No. 20 Rahasane Turlough**

A number of properties were flooded at a number of locations along the northern shores of the Rahasane Turlough.

Whilst this image was taken after the flood had subsided, the threat to the Kilcolgan road is evident in this image.

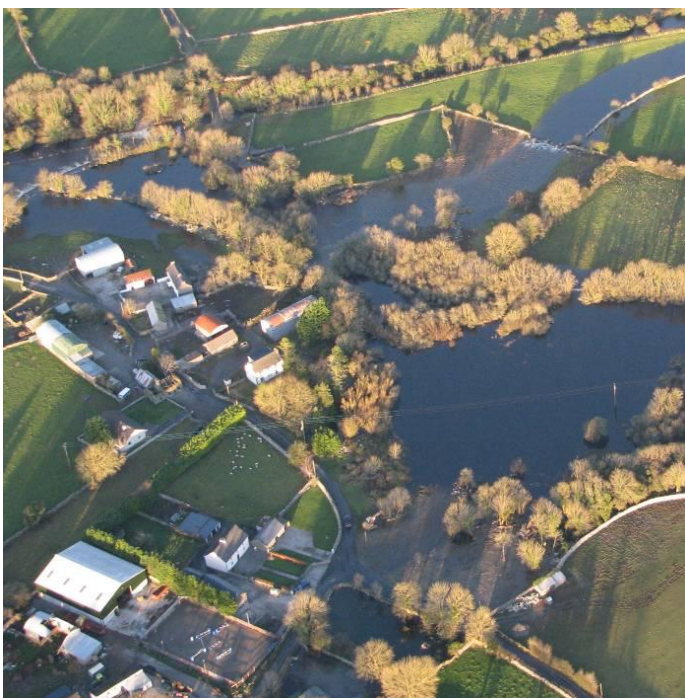
### **Photograph No. 21 Killeely Beg Townland**

A total of five dwellings were threatened by flood waters in the townland of Killeely Beg when the Dunkellin River broke its left bank and travelled along what appears to be the natural contour of an old channel.

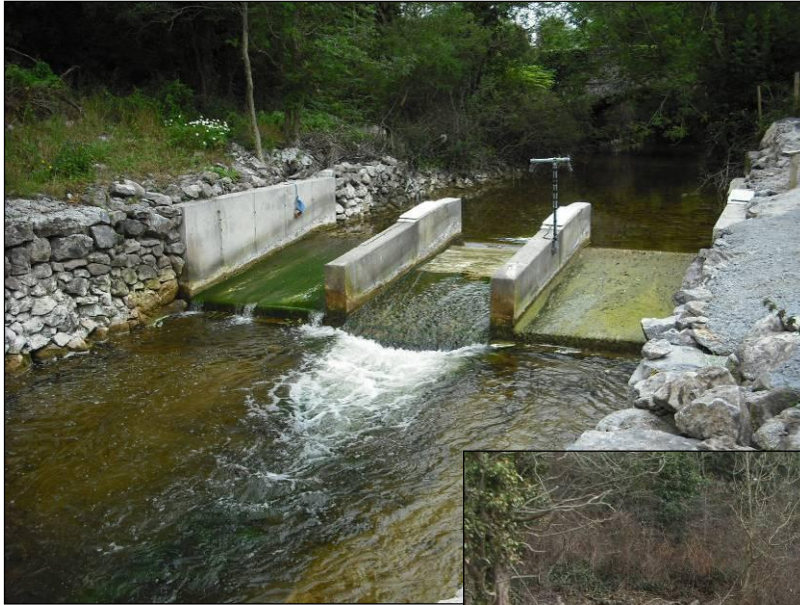
**Photographs No. 22 and 23  
Existing Salmon Counter**

*It is proposed to replicate the existing structure at a location upstream of the Killeely Beg Bridge.  
Note : change in depth of flow at this structure*

The existing salmon counter, shown in Photographs No. 22 and 23, is impacting on the high level water surface profile in the vicinity of Killeely Beg Bridge and is resulting in high water levels upstream of the bridge. Following consultation with the Inland Fisheries Ireland and

other local parties, it is proposed to relocate this structure to a location upstream of the Killeely Beg Bridge. The proposed structure will be similar in all aspects to the existing concrete structure.

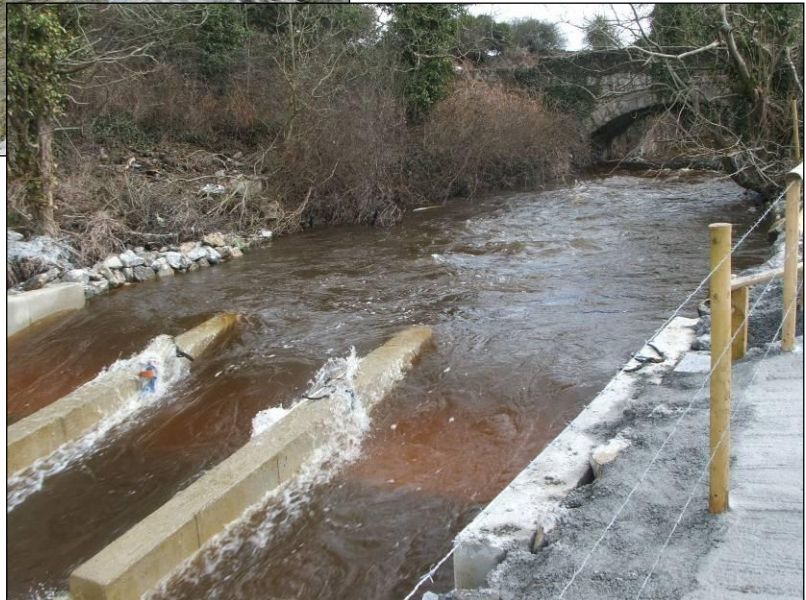
The proposed salmon counter will be constructed in cast-in-situ concrete and this will be undertaken in two halves, utilising cofferdam type construction whereby flow can be restricted to one half of the channel width allowing the civil engineering works to be undertaken in the dry conditions of the other half. This method of construction reduces the risk of wet concrete and other construction debris entering the river.

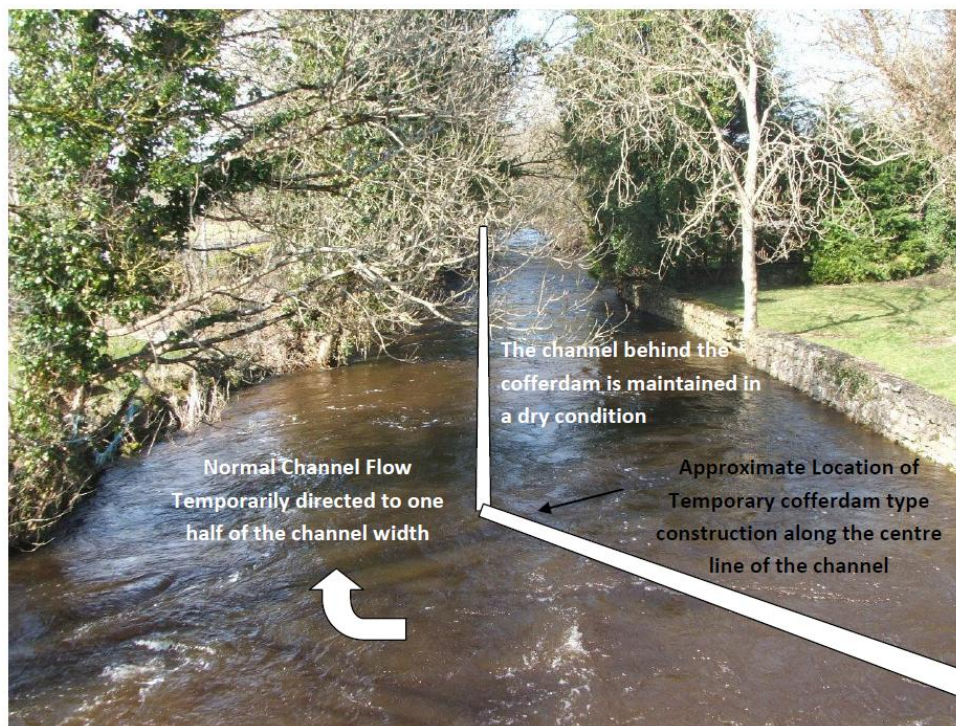
**Figure 3-8 – Proposed Works Channel Works in the vicinity of Craughwell Village and sketch of cofferdam location**

Figure 3-8 provides an illustration of a typical cross section of the works to be undertaken along this section of the river in the vicinity of Craughwell Village.

It is envisaged that excavation of the channel in this location will be dependent on the phasing of works along the bypass channel, low flow conditions in the river and the extent to which flow in the river can be diverted or restricted to one half of the existing channel. In addition it is also proposed to retain existing bankside trees (if healthy and suitable for retention) provided that their retention does not pose a concern with regard to the safe construction of the works, safe recreational use of the channel and safe maintenance of the channel. It is expected that a qualified arborist will be retained at the detailed design stage to examine and determine the most appropriate trees that can be retained or if necessary make recommendations with regard to the replacement of trees that require removal.

It is envisaged that temporary cofferdam type construction or temporary sheet pile walls (with a length of 50 to 100m depending on the depth of water and ground conditions) will be used in the location described in Figure 3-8. This process allows river water to be directed to one half of the channel width allowing the civil engineering works to be undertaken, in relatively dry conditions, on the other side of the channel. Once this half of the proposed channel works is excavated, within the confines of the cofferdam, it is expected that river water will be directed to the new section allowing the adjacent excavations to be completed. This sequence of construction is expected to commence at the lower downstream point of the works and continue upstream in this “*leap-frog*” type construction method. This method of construction reduces the risk of construction debris and silt entering the river.

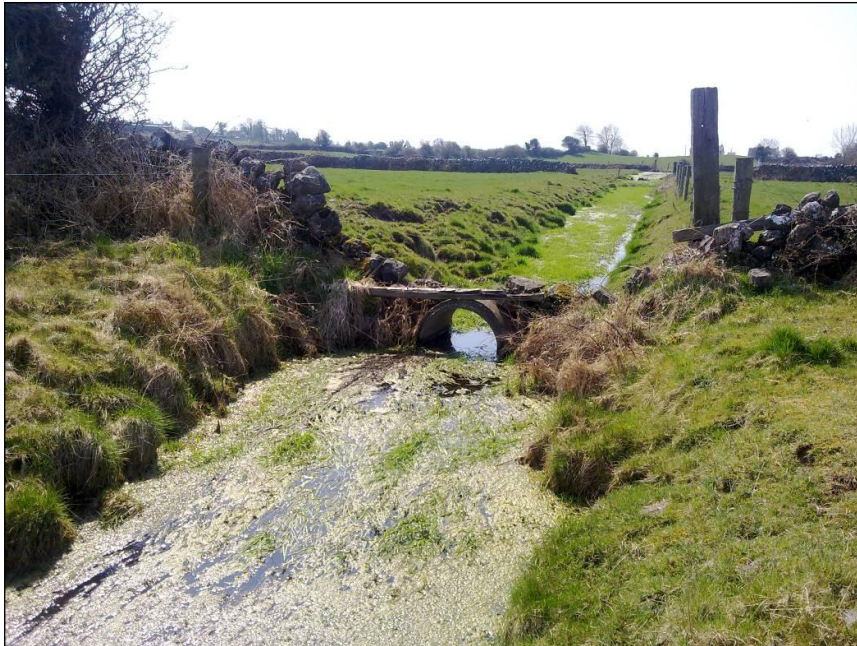
**Photograph 24 – Typical Culvert along the Aggard Stream which requires replacement**

The proposed works along the Aggard Stream will consist of culvert replacement works whereby existing blocked and undersized piped crossings will be replaced with larger diameter piped culverts. The proposed works will involve minor localised excavations within the existing stream. The overall proposal for works along the Aggard Stream is to replace blocked culverts (circa 14 No. culverts) with 1500mm diameter precast concrete open jointed pipes.

Photographs No. 24 & 25 provide an illustration of typical culverts which require replacement along the Aggard Stream.

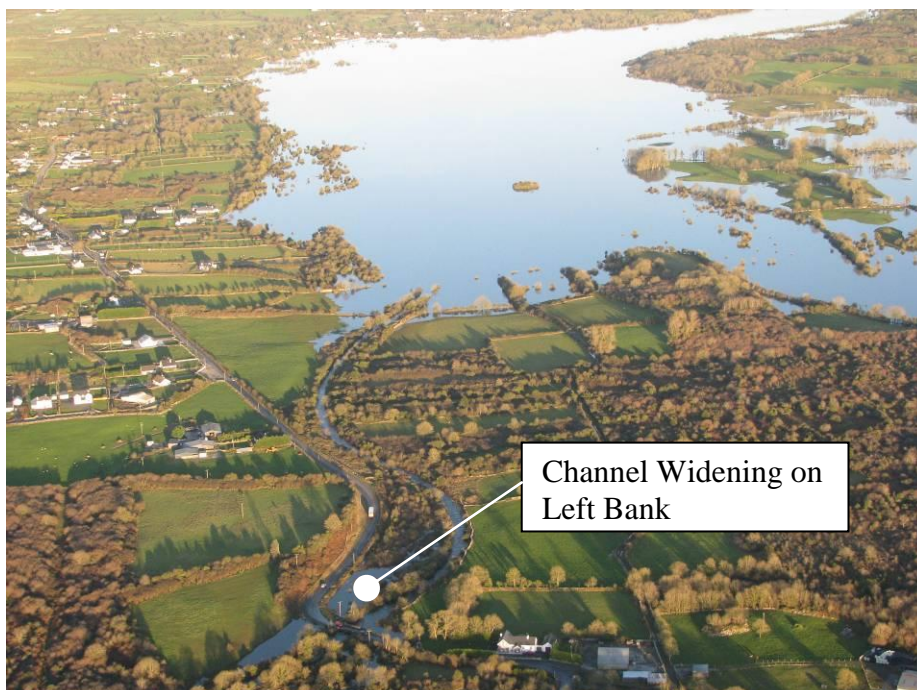
**Photograph No. 27 – Location of Channel Works upstream of Rinn Bridge**

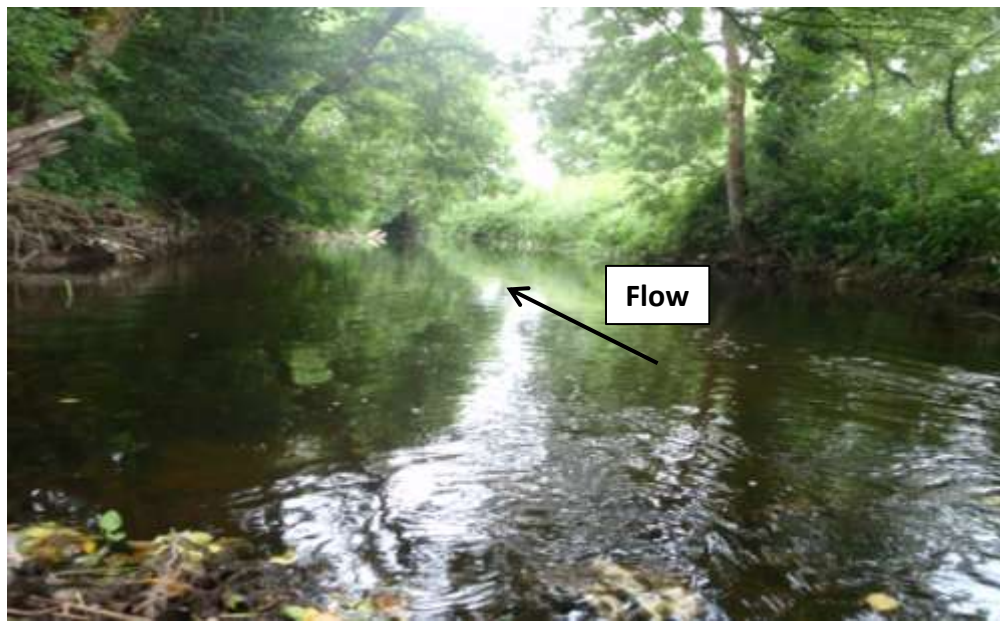
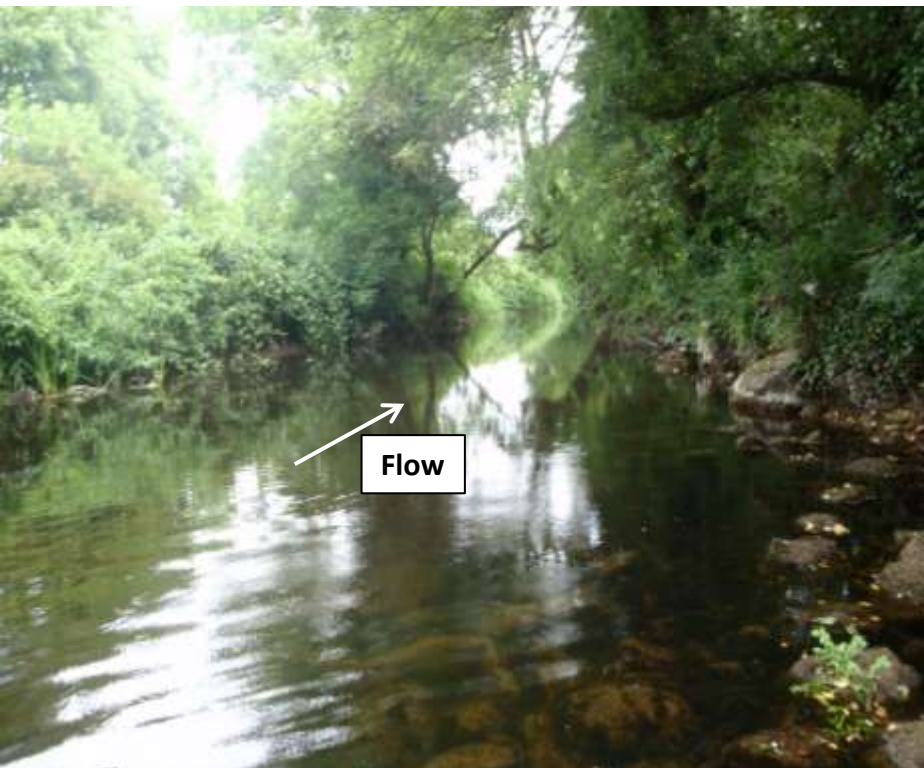
Sequential views looking d/s through Fishery Section 4 from it's upper reaches to the end of this zone at the Railway Bridge.

Following dredging cover the bed of this channel reach with the type of heavy cobble presently in situ and place large boulders (1.5 to 2.0 tonnes) in the channel at 10m. centres.

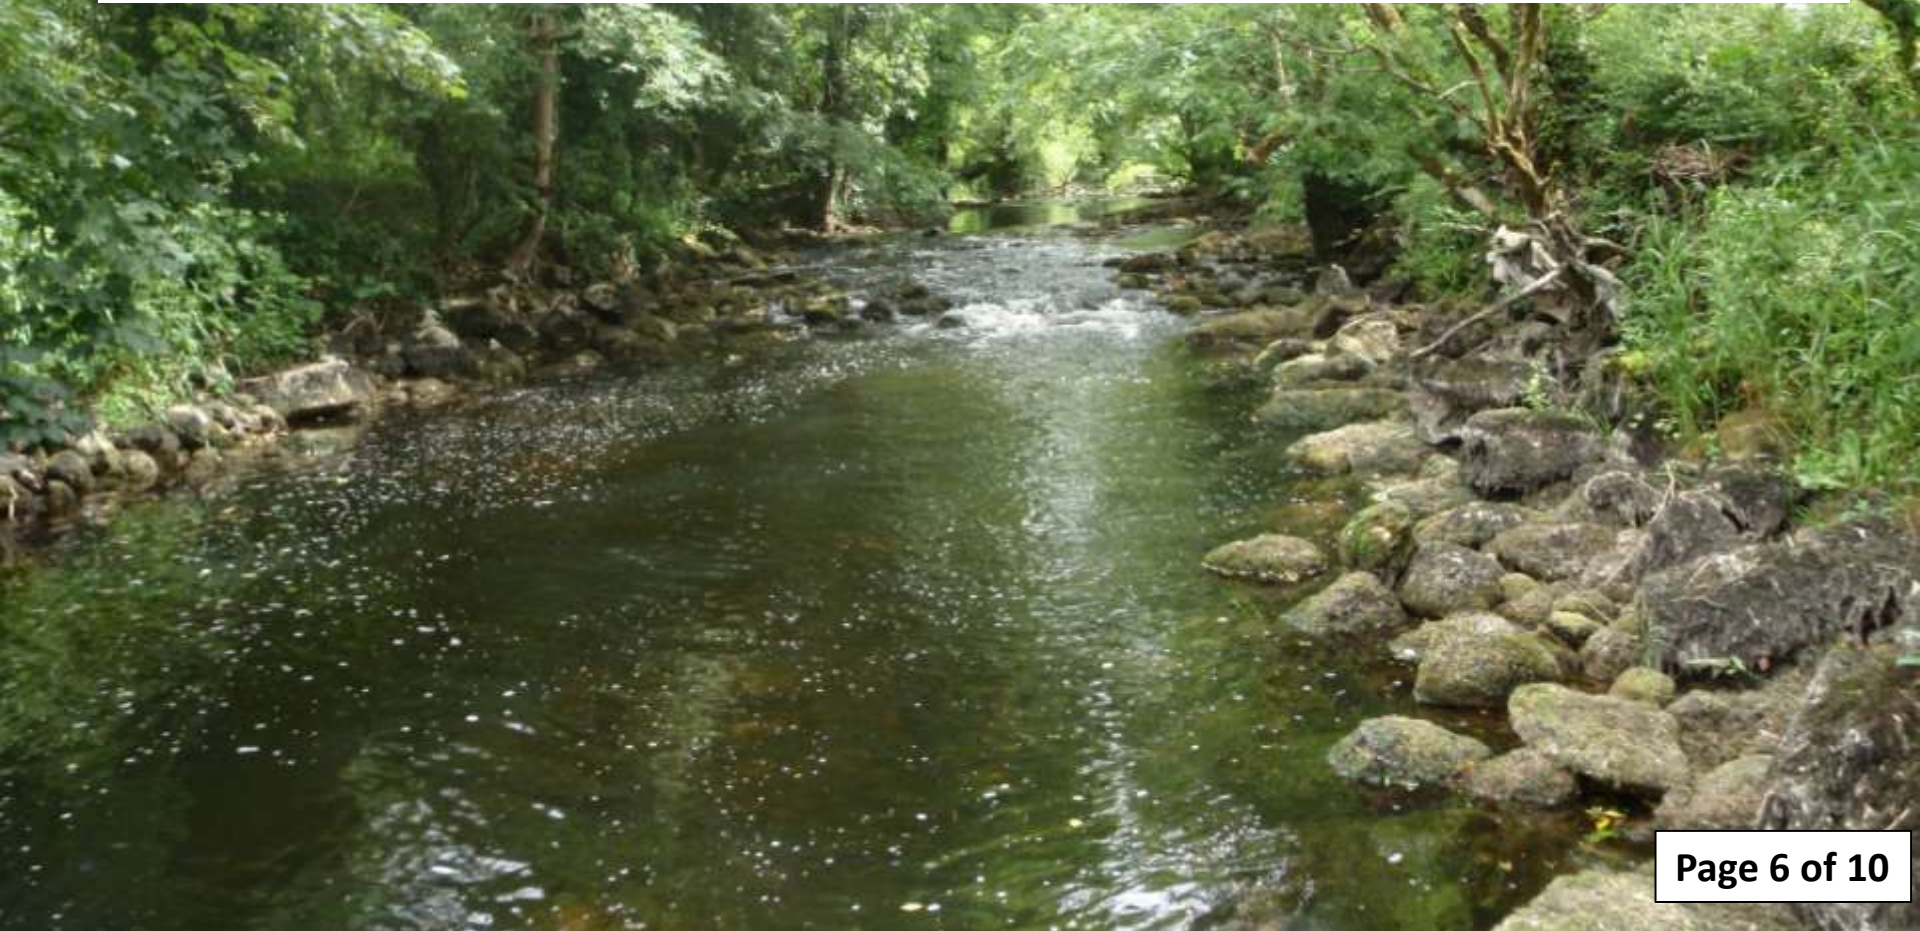
## Fishery Section 5

Currently the morphology of Fishery Section 5 is relatively uniform in nature with a cobbled bed throughout. There is only one high point on the bed in the middle of this reach (illustrated in this photo). Following the proposed flood relief dredging operation there will be a moderate gradient through a uniform glide over the entire length of Fishery Section 5 (circa 540m.). This will allow one to construct 12 paired stone deflectors with associated pools and gravel shoals, equidistant from one another, over this entire reach. The river bed sections, in between these structures, should be covered with a single layer of large cobbles like those evident along the margins in this photo.

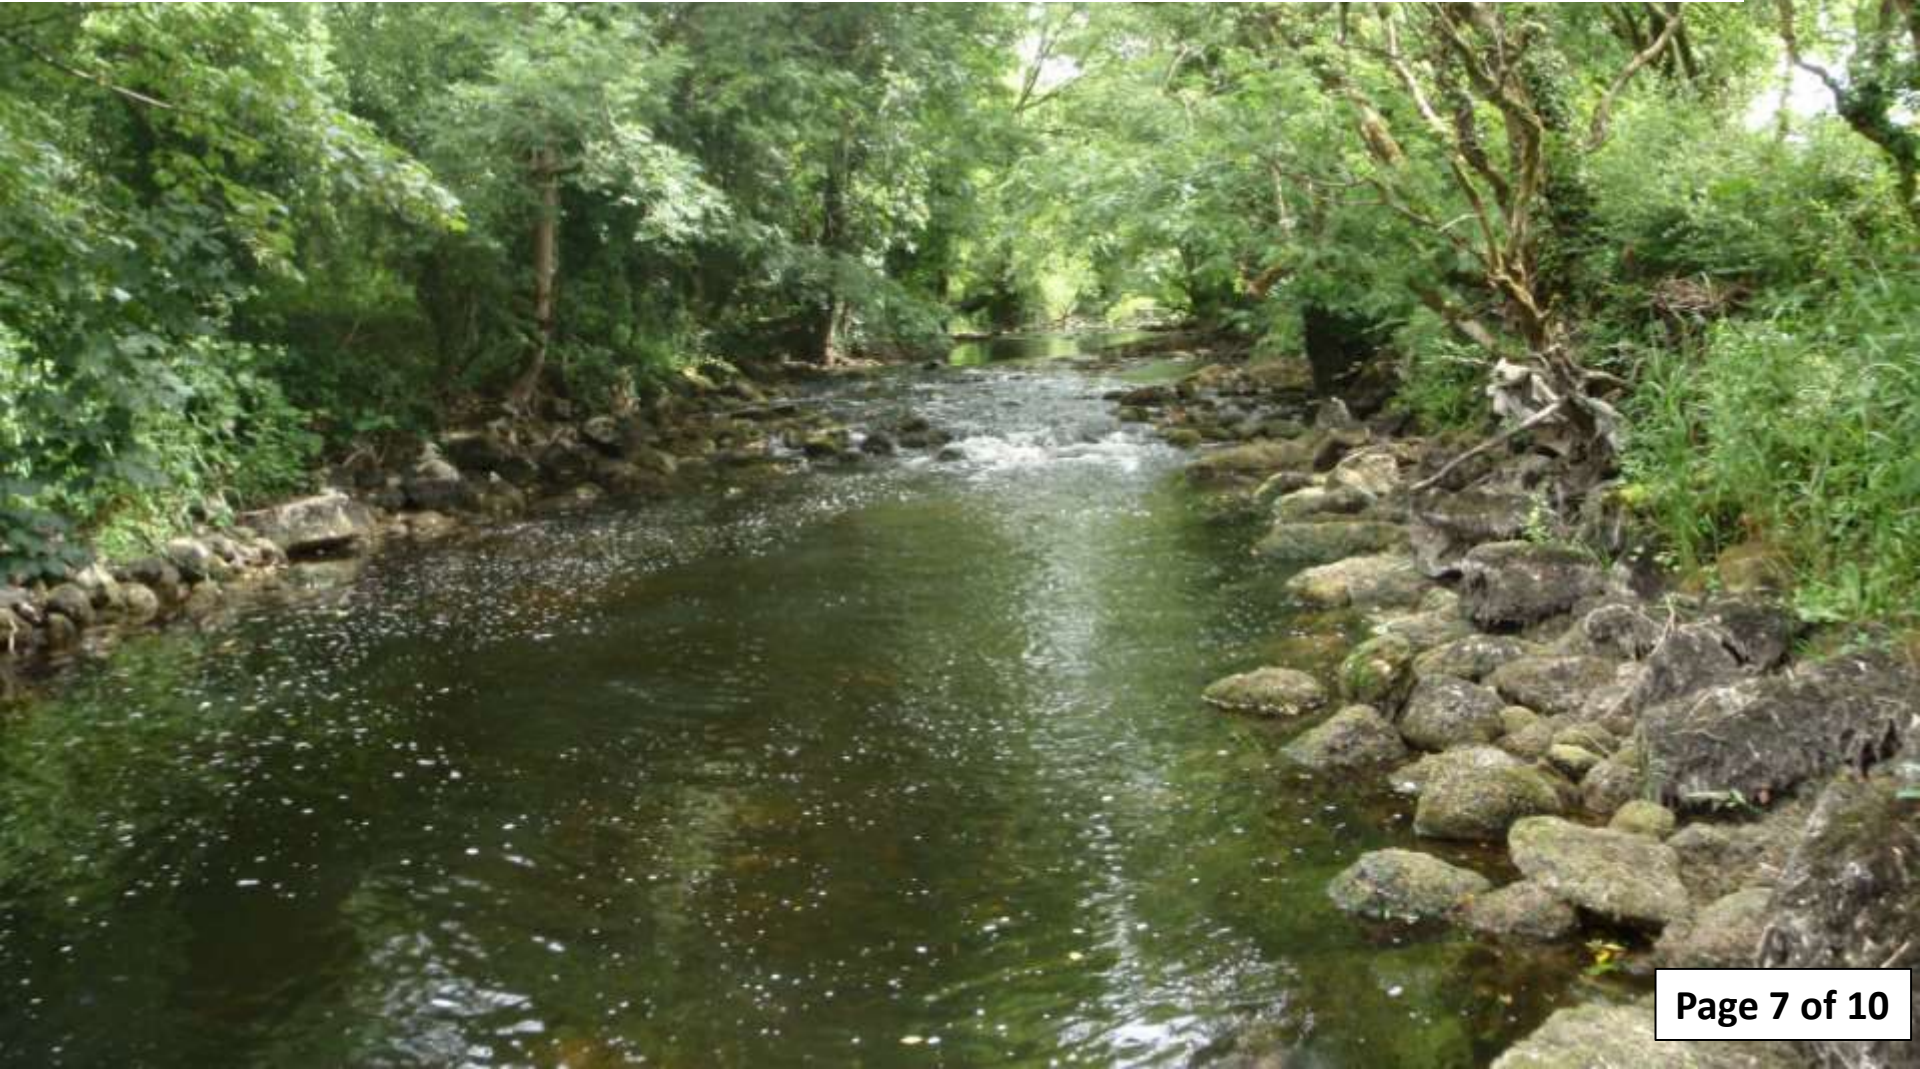
## Tunnelling Problems

Long sections of this channel reach are heavily tunnelled from the “old masonry bridge” downstream to the end of the proposed dredging reach – note the paucity of ---The overall ecological diversity of flora and fauna in the channel would benefit from a pruning programme carried out along the right bank. Selected areas for pruning should increase the incident light levels on the newly established riffle areas following the proposed physical enhancement of the channel.

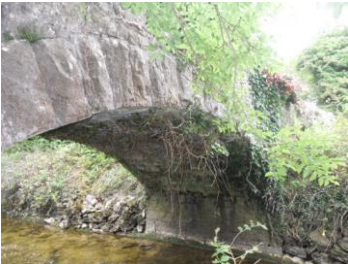
Bridge	Potential Bat Use	Value	Comments
<p><b>Kileely Bridge</b></p>	<p>Roosting, Foraging &amp; Commuting</p>	<p><b>High</b></p>	<p>Kileely Bridge has a very high potential for bat usage. The underneath of the bridge is covered in Ivy which provides ideal feeding areas for bats. A visual inspection of the bridge crevices was also undertaken and scored a 2* (2 = crevices ideal for bats but no evidence of usage) The watercourse has continuous riparian vegetation which provides both foraging and commuting areas suitable for many bat species.</p>

<p>Bridge Structure with Ivy underneath</p>

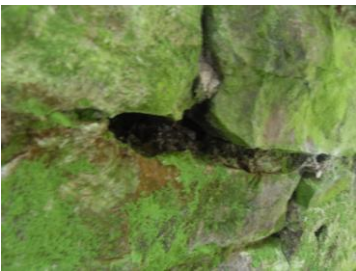
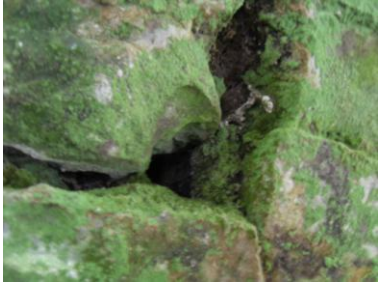
<p>Suitable crevices</p>

<p>Suitable crevices</p>
<p><b>Dunkellin Bridge</b></p>	<p>Foraging &amp; Commuting</p>	<p><b>Medium</b></p>	<p>Provision of a new flood eye on the right bank could interfere with potential foraging area but no roost potential. The existing flood eyes have potential with a significant number of suitable crevices under all 3. There is potential for bats to forage and commute along the river edge in particular along the right bank downstream where tree removal is proposed. Large mature trees present with potential use as resting areas together with a low lying hedgerow which may be utilised for gleaning insects. A visual inspection of the bridge crevices was also undertaken and scored a 2* (2 = crevices ideal for bats but no evidence of usage)</p>

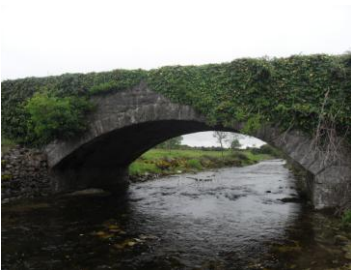
<p>Bridge Structure Main Arch</p>

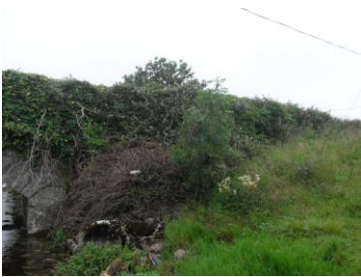
<p>Right Bank – wing wall potential foraging area which could be impacted if flood eye is placed here.</p>

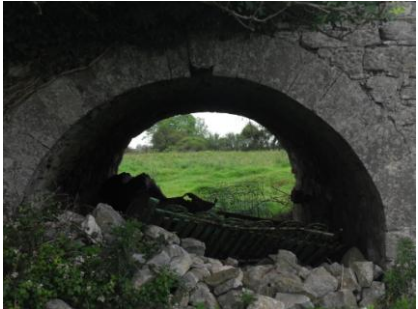
<p>Additional flood eyes containing suitable crevices</p>
<p><b>Rinn Bridge</b></p>	<p>Foraging &amp; Commuting</p>	<p><b>Medium</b></p>	<p>The current bridge structure has no potential underneath as a bat roost as it is a slab design. Foraging areas are present on both banks but with low value in the immediate vicinity of the bridge structure where works will take place. Farther up and down stream along both banks mature trees are present which provide potential foraging and commuting potential. These trees may have roosting potential and should be subjected to</p>

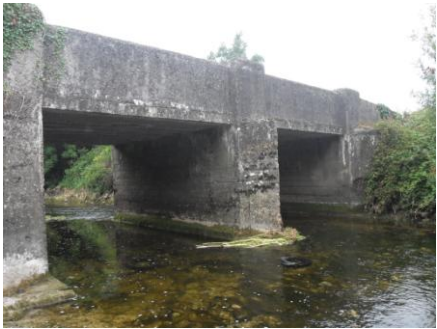
<p data-bbox="28 613 188 640">Bridge Structure</p>

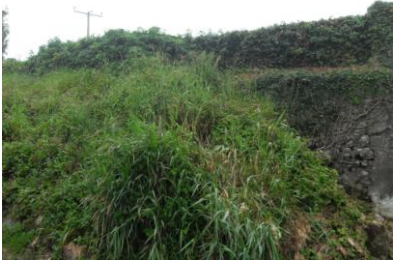
<p data-bbox="528 589 978 636">Bankside vegetation where additional flood eye will be placed</p>		<p data-bbox="1123 224 1490 248">a full survey if they are to be removed.</p>

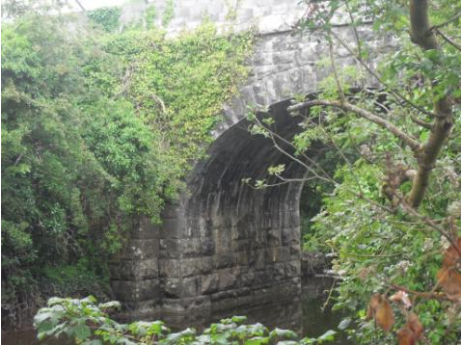
<p data-bbox="1123 602 1560 649">Foraging and commuting route along watercourse</p>
<p data-bbox="28 725 188 752"><b>Railway Bridge</b></p>	<p data-bbox="528 725 746 752">Foraging &amp; commuting</p>	<p data-bbox="1015 725 1096 752"><b>Medium</b></p>	<p data-bbox="1123 654 1560 826">While the proposed works will not cause a direct impact to the bridge structure the proposed works will impact on the riparian zone which has suitable foraging areas available to bats which would be lost if removed. Full night time survey required to assess usage.</p>

<p data-bbox="28 1227 272 1254">Railway Bridge Structure</p>
