Dunkellin River and Aggard Stream Flood Relief Scheme,  
Description of the Proposed Works

# Galway County Council

### Description of the Proposed Works

**PROJECT:** **Dunkellin River and Aggard Stream Flood Relief Scheme**

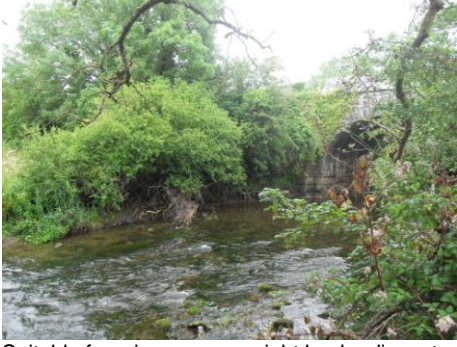
<p data-bbox="528 1205 970 1252">Suitable foraging areas on right bank adjacent to bridge</p>

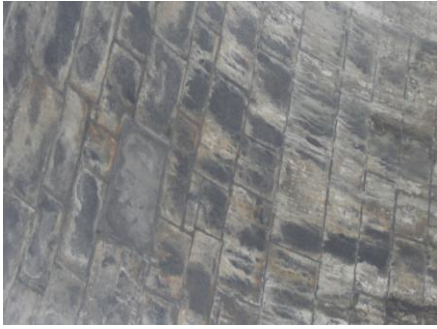
<p data-bbox="1123 1191 1481 1238">Underneath bridge structure no roost potential as all crevices are sealed.</p>

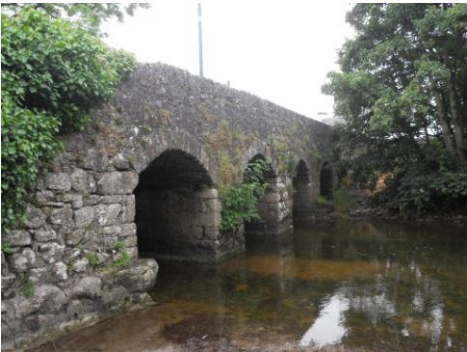
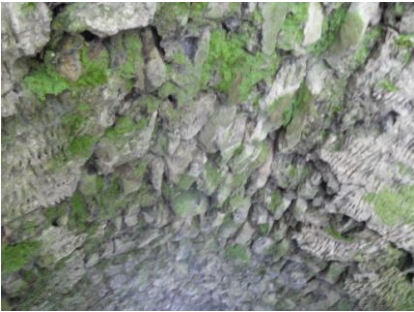
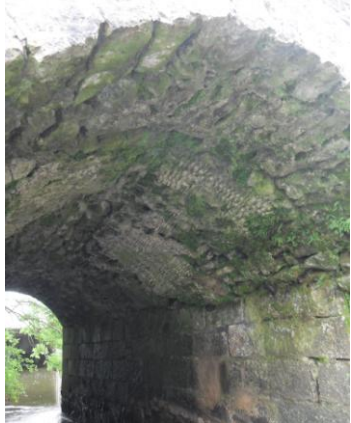
<p data-bbox="28 1391 392 1438"><b>Masonry Arch Pedestrian Bridge at Craughwell</b></p>	<p data-bbox="528 1402 868 1429">Foraging, Commuting and Roosting</p>	<p data-bbox="1015 1402 1064 1429"><b>High</b></p>	<p data-bbox="1123 1276 1560 1547">All 6 arches are currently suitable and contain suitable crevices for bat usage but no evidence was found (Grease stains, droppings or other evidence). A visual inspection of the bridge crevices was also undertaken and scored a 2* (2 = crevices ideal for bats but no evidence of usage) Potential foraging area downstream from bridge. Any structural work to this bridge could impact on bat species. Night time survey required to assess full usage.</p>

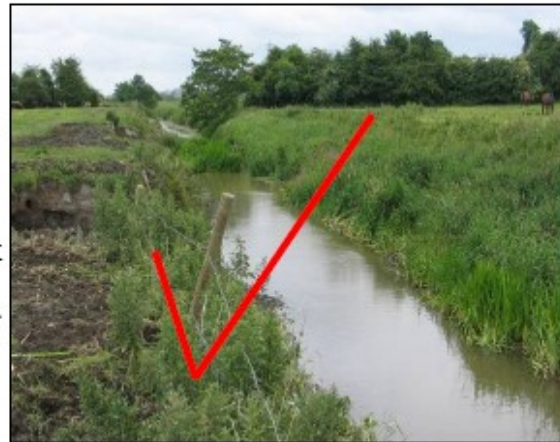
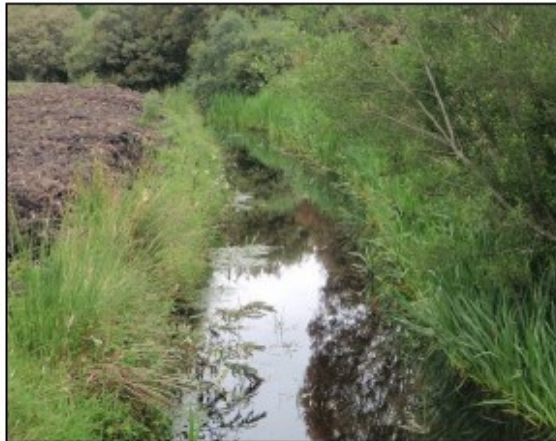
### 1. Protect bank slopes

- 1.1 Do not disturb the non-working bank slope
- 1.2 Minimise any effect on working bank
- 1.3 Leave margin of vegetation at foot of each bank slope

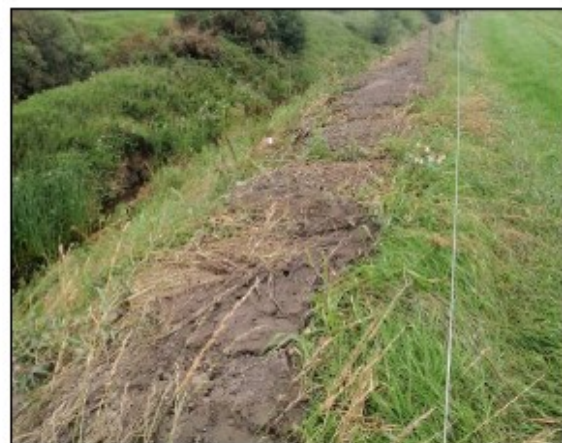
### 3. Spoil Management

- 3.1 Maximise spoil placement on bank full line or spoil heaps **and**
- 3.2 Minimise spoil placement on bank slopes
- 3.3 Spread spoil as thinly as possible
- 3.4 Allow water to drain out of bucket over the water – lets small fish, lamprey and crayfish escape

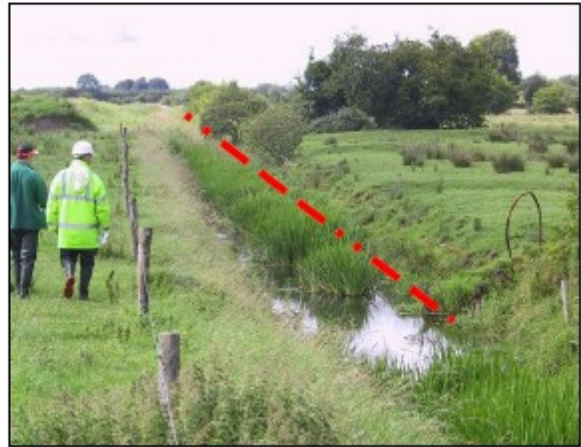
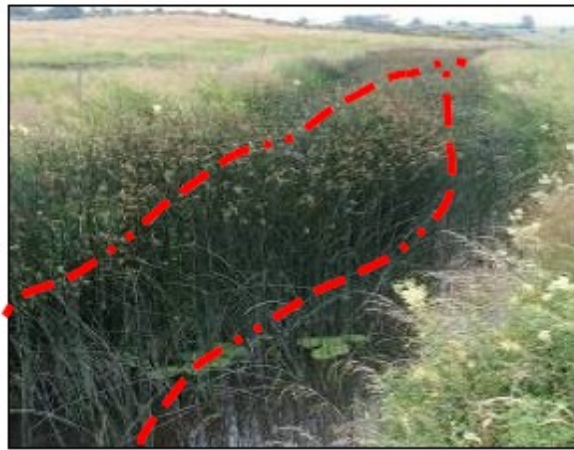
### 4. Selective Vegetation Removal

- 4.1 Retain a band of vegetation on both sides at water's edge
- 4.2 Selectively manage instream vegetation
- 4.3 Maximise use of weed-cutting bucket
- 4.4 Avoid maintenance in coarse fish channels from 1<sup>st</sup> April to 1<sup>st</sup> July

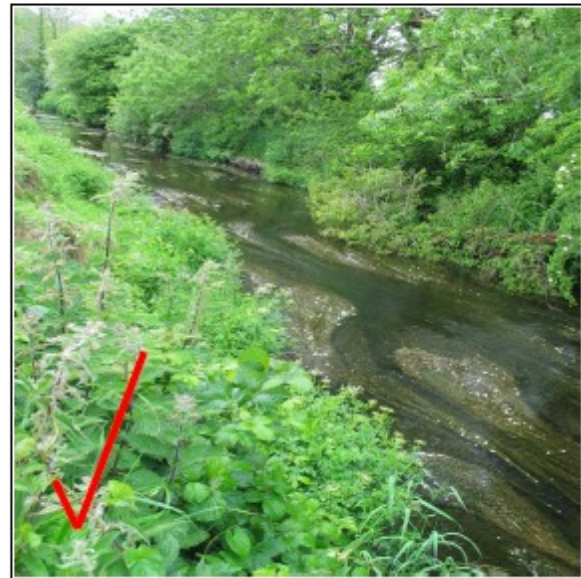
- 4.5 Retain 1/3 to 1/2 of instream floating type vegetation, such as *Ranunculus* (water crowfoot) – see photo to right

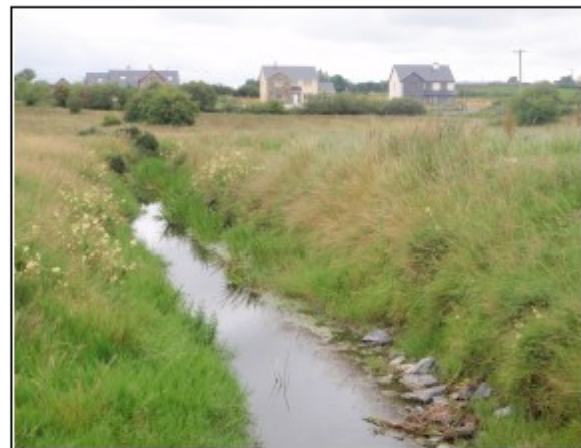
### 5. Leave sections untouched

- 5.1 If channel capacity is not affected, leave section alone

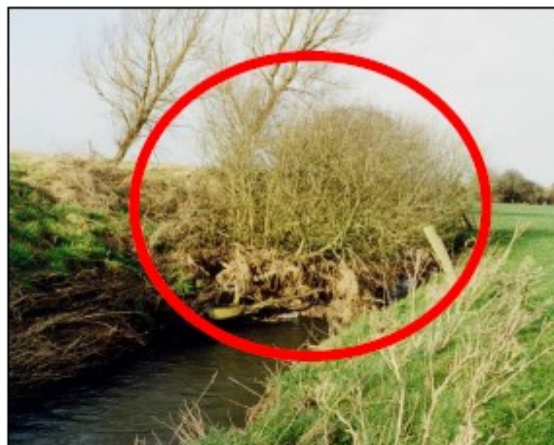
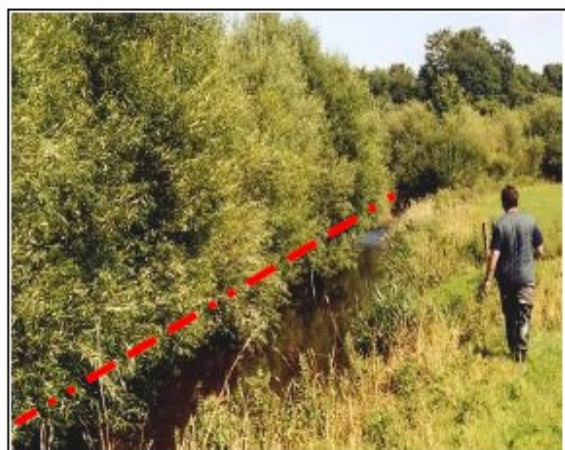
### 6. Management of Trees

- 6.1 Remove trees that are blocking the flow
- 6.2 Tree-cutting window 1<sup>st</sup> September to 28<sup>th</sup> February

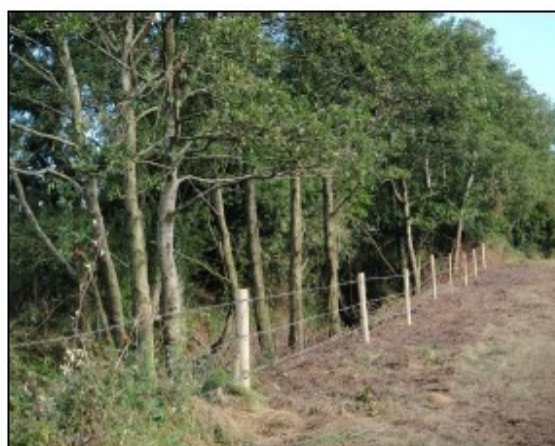
- 6.3 Remove overhanging branches to known flood level

- 6.4 Use saw secateurs for removal, not excavator bucket

- 6.5 Manage Trees to reduce very heavy shading
- 6.6 Manage briars and scrub.  
*See Otter SOP*

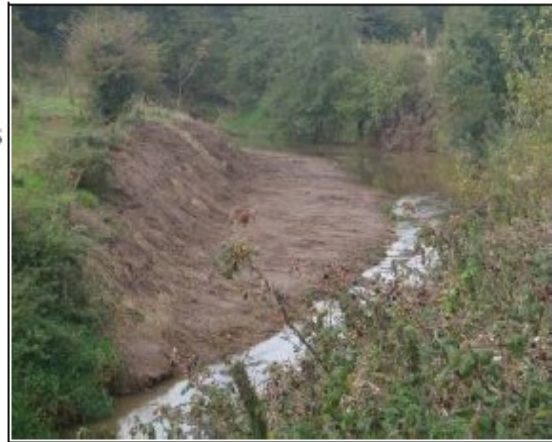
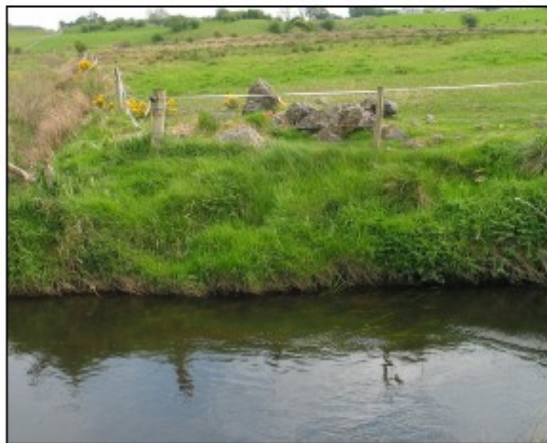
### 7. Manage berms to form two-stage channels

- 7.1 Retain berm where channel capacity is not affected
- 7.2 Remove top of berms to low flow levels
- 7.2 Remove vegetation and soil from gravel berms
- 7.3 Replace sod to the berm where feasible
- 7.4 Only narrow berms if 'excessively' wide for the channel (i.e. greater than a third of the channel width)

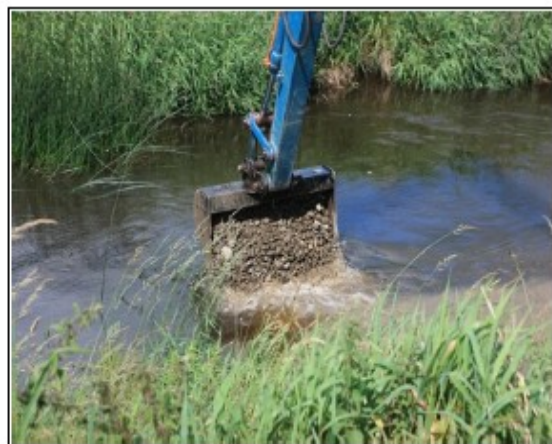
### 9. Work in gravel bed channels

- 9.1 Loosen or toss bed gravels to wash out fines
- 9.2 Only considered between 1st July and 30th September
- 9.3 No work in gravel bed / spawning channels in fisheries 'closed season'  
*Note:* This varies locally check with local IFI

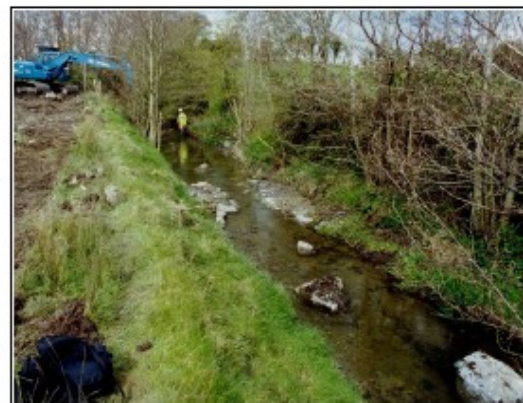
**10.2** Overdeepen the channel along one side and place spoil on opposite side –particularly on curves and bends

**10.3** Use existing boulders to form simple low-level structures

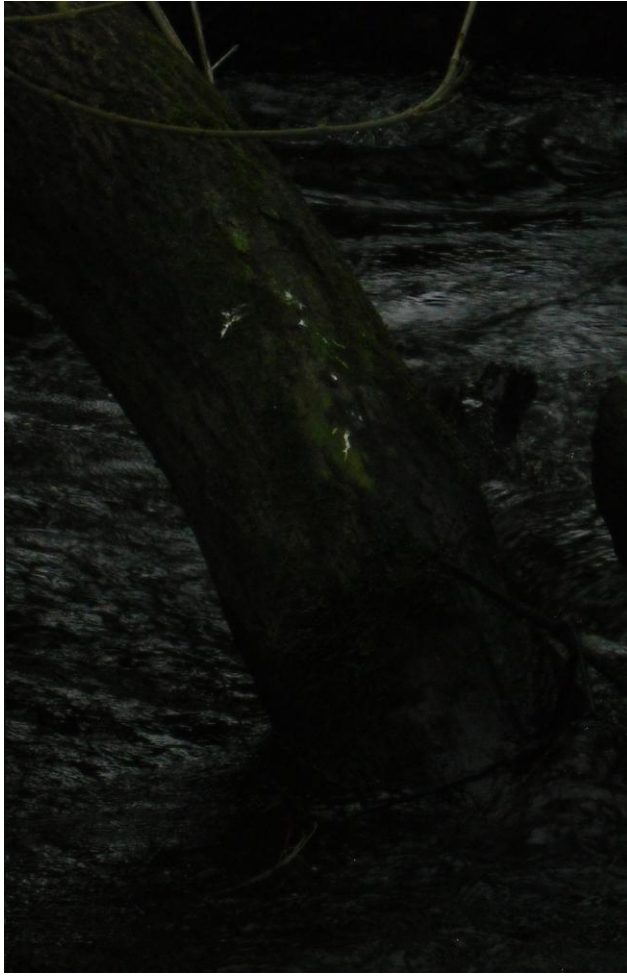
*Pic:1.0*

*In this section the banks are deemed unsuitable for nesting as they are too rocky. Some suitable perches were found, one with evidence of use (droppings on it) but no confirmation of what species of bird was using it. (See pic.1*

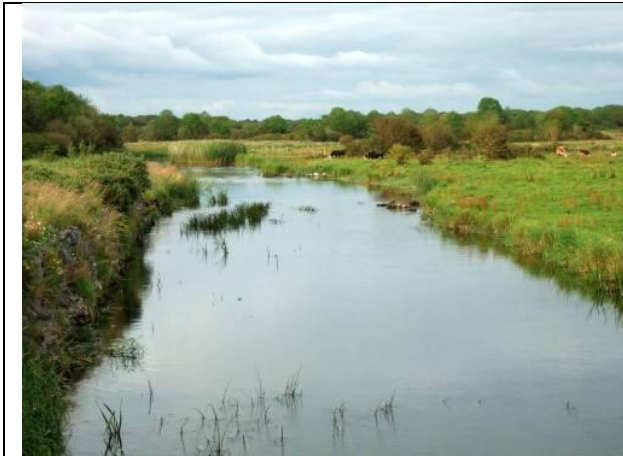
**Plate 1:** Broad glide upstream of Kilcolgan N18 Bridge on the Dunkellin River -view upstream (Point 1) (21-7-2011)

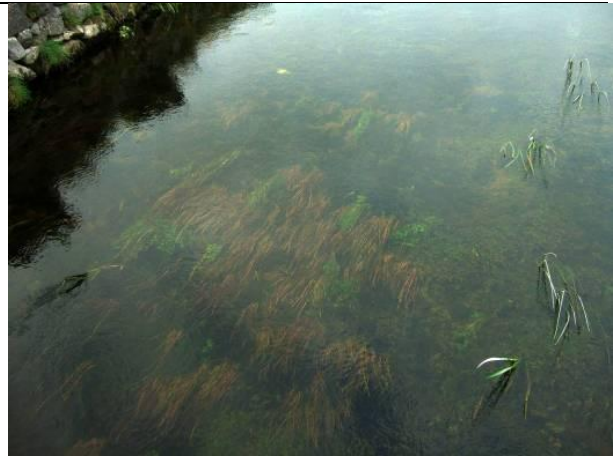
**Plate 2:** Just upstream of Kilcolgan Bridge showing submerged macrophytes in shallow glide / run. (21-07-2011)

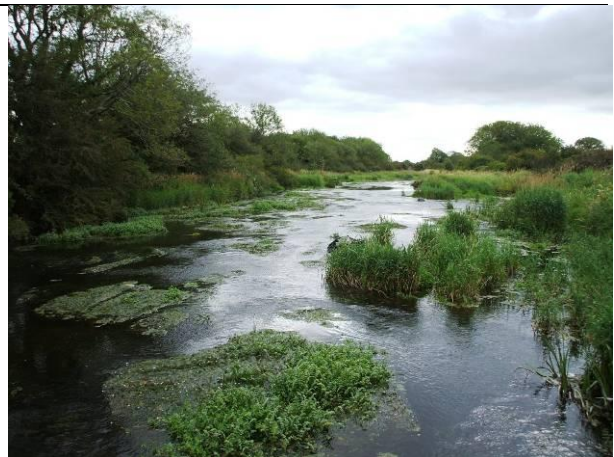
**Plate 3:** Cascade / turbulent run ~500m upstream of Kilcolgan bridge.

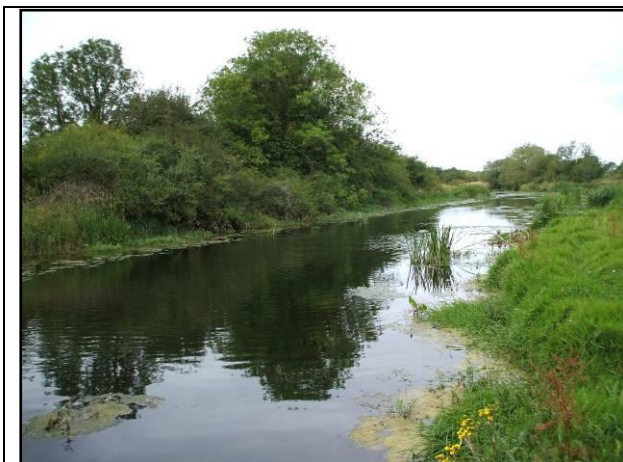
**Plate 4:** Shallow glide/run upstream of P3.

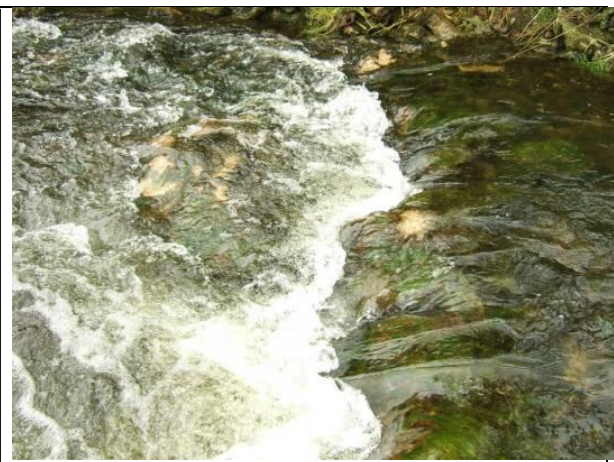
**Plate 5:** Glide-pool just downstream of the point where the channel narrows (9/8/2011)

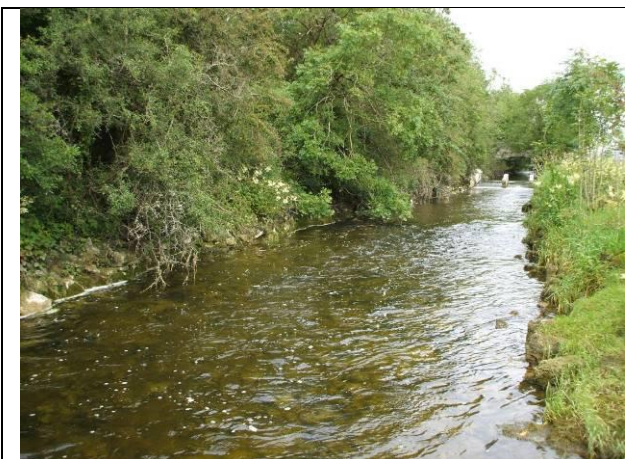
**Plate 8:** Salmon counter below Killeely Bridge - view downstream. (20-7-2011)

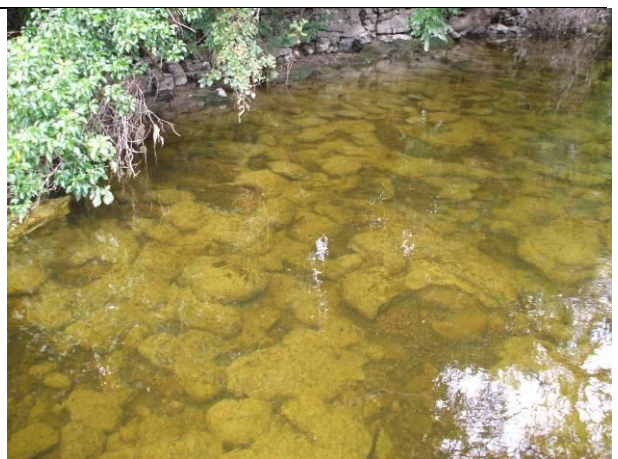
**Plate 9:** View upstream from approx. 100m D/S Killeely Beg Bridge showing true left bank with extensive rip-rap reinforcement and right bank of rock cut with crevices that would provide good refuges for crayfish (20-7-2011)

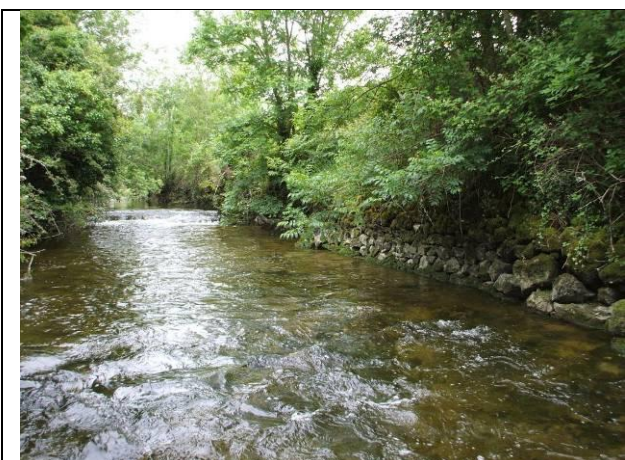
**Plate 10:** Typical substrates downstream of the Killeely Beg Bridge and salmon counter - with sculpted bedrock dominant with some scattered boulder with limited refuge availability for crayfish except in banks (20-7-2011)

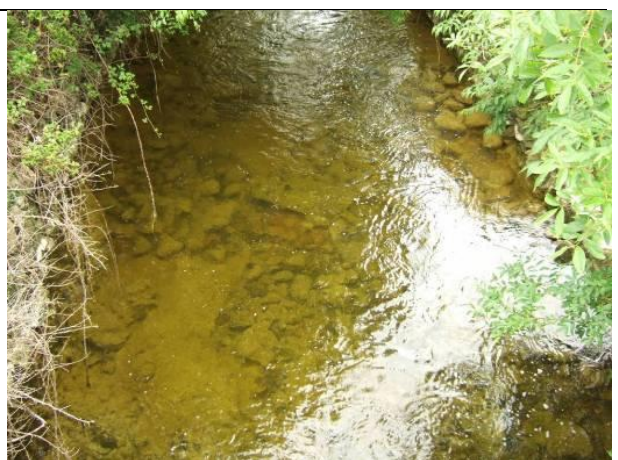
**Plate 11:** View US from approx. 50m US of Killeely Beg Bridge showing step-run-glide sequence and block armour on left bank (20-7-2011)

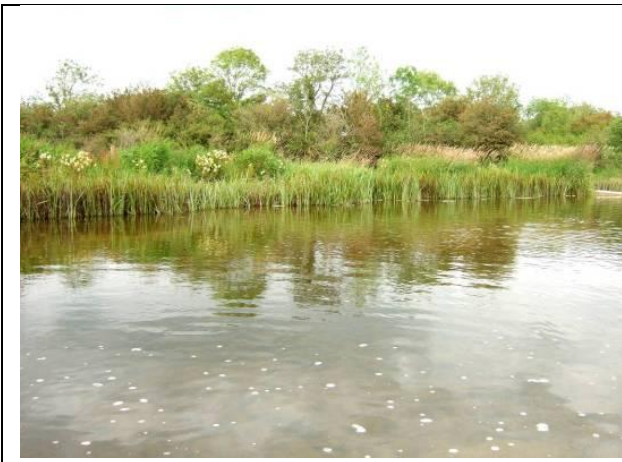
**Plate 12:** Typical substrates just upstream of Killeely Beg Bridge (20-7-2011).

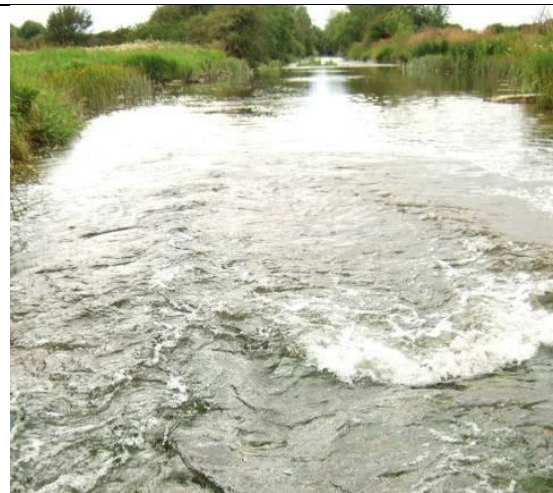
**Plate 13:** Broad shallow pool section at the head of a long glide upstream from Killeely Bridge showing emergent macrophytes on right bank. (21-7-2011).

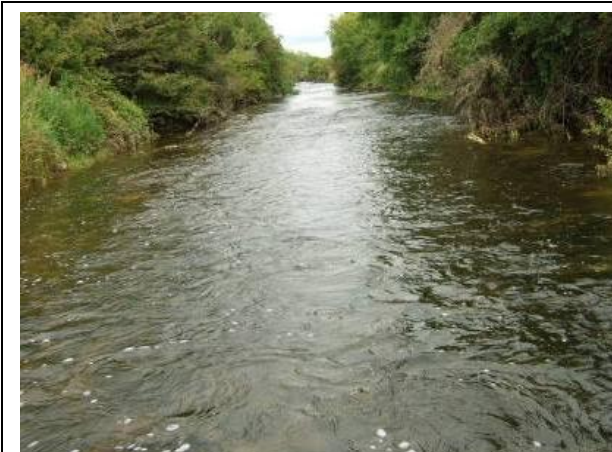
**Plate 14:** Turbulence at drop at the downstream end of a long shallow run in Point 15. View downstream over short deep pool and shallow pool at Point 13 downstream (21-7-2011).

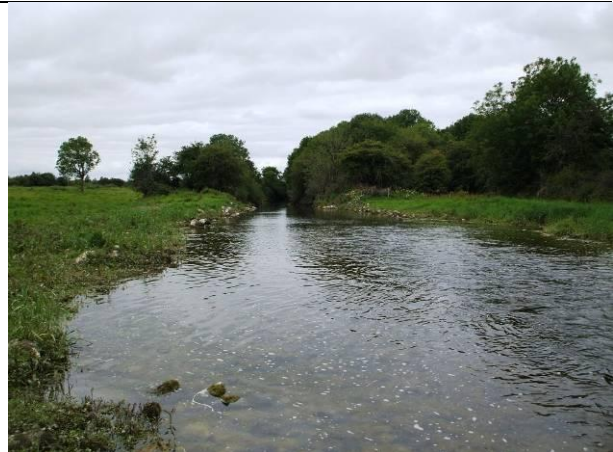
**Plate 15:** View upstream from Point 14 (above) along a long run heading up towards Dunkellin Bridge (21-7-2011)

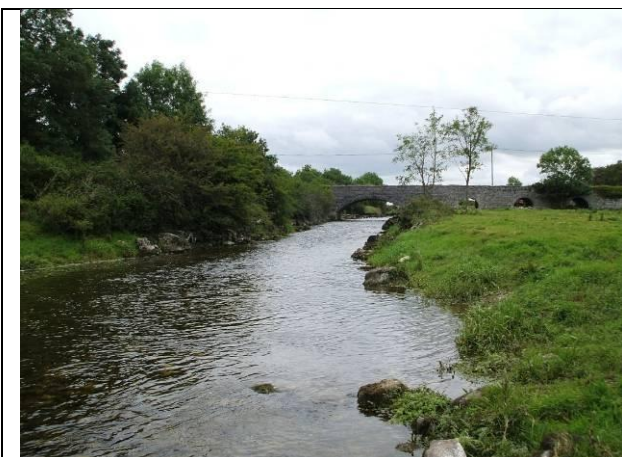
**Plate 16:** Looking downstream over shallow glide situated 80-90m below Dunkellin Bridge (21-7-2011)

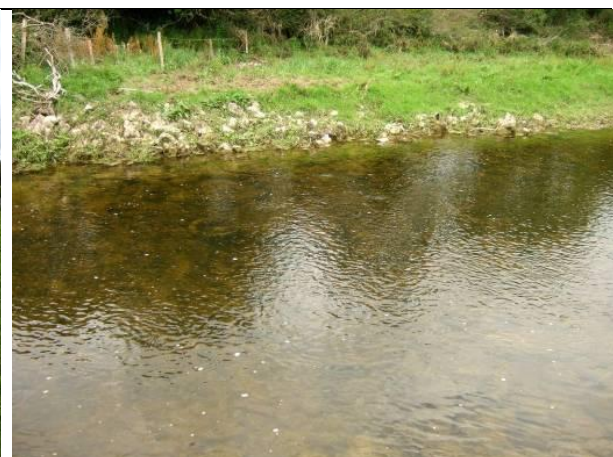
**Plate 17:** View upstream towards Dunkellin Bridge over shallow run / glide (20-7-2011).

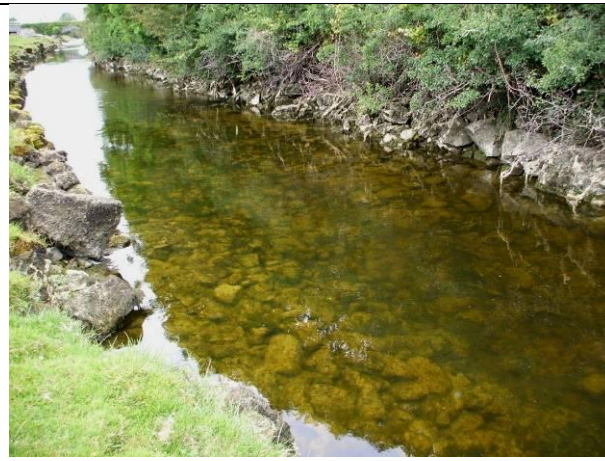
**Plate 19:** View downstream through Dunkellin Bridge showing riffle/ run (21-7-2011)

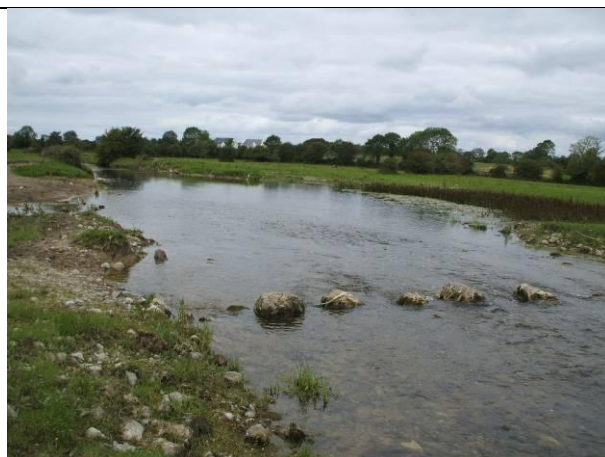
**Plate 21:** View upstream of slightly wider glide with marginal emergent macrophytes, upstream of canalised stretch shown in Point 20 (21-7-2011).

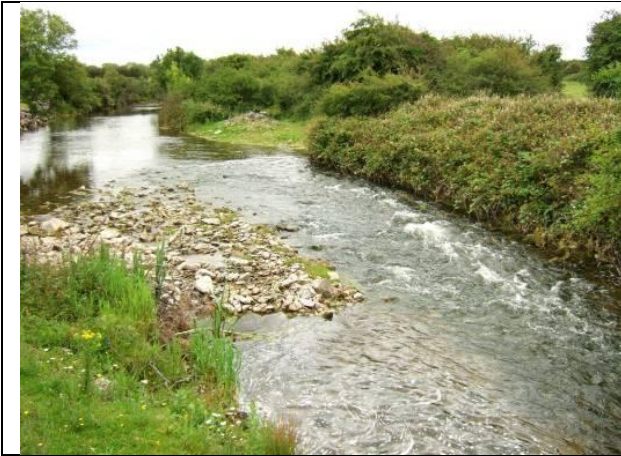
**Plate 24:** Close-up of coarse gravel used in salmon spawning situated at riffle shown in Plate 23 (21-7-2011).

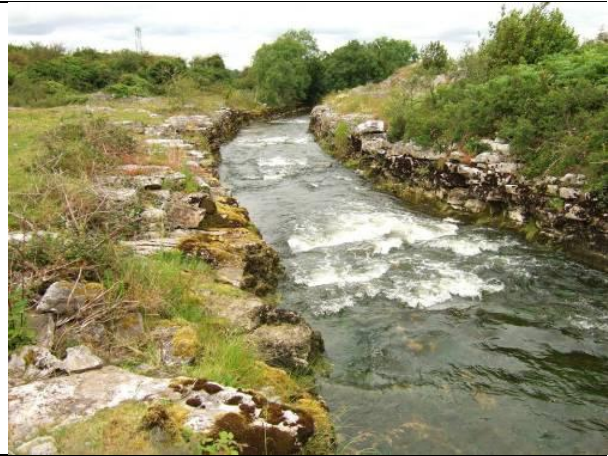
**Plate 25:** More typical, longer segments of glide, step run sequence (Point 23). (21-7-2011)

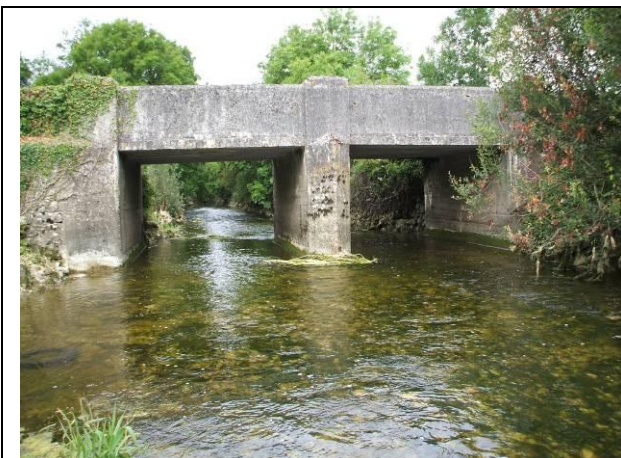
**Plate 28:** View upstream to Rinn Bridge at and of run which leads into long glide downstream. (21-7-2011)

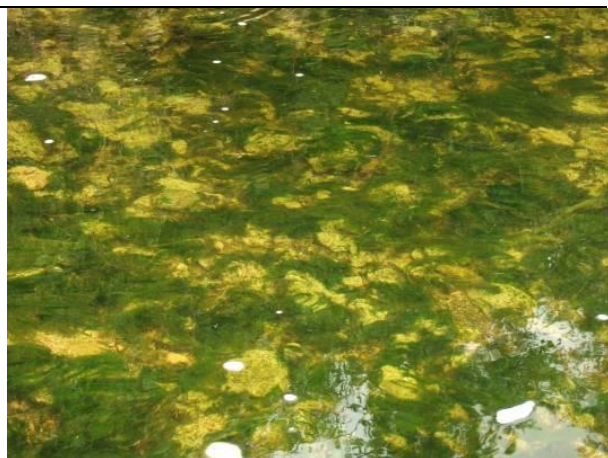
**Plate 29:** View downstream to Rinn Bridge showing shallow run/riffle at, and upstream of, the bridge (21/7/2011).

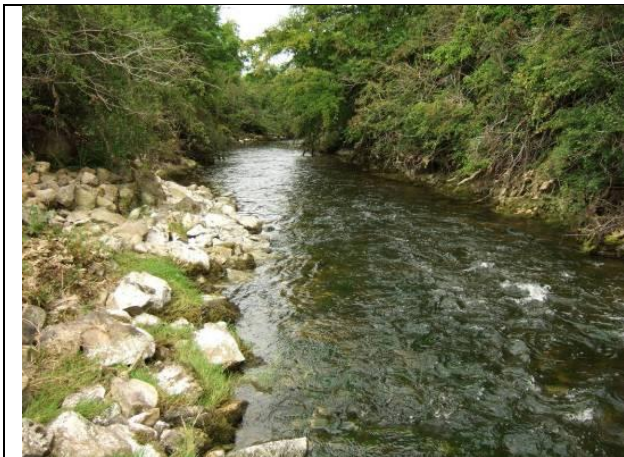
**Plate 30:** Moderately heavy algal cover on substrate in un-shaded shallow run upstream of Rinn Bridge (21-7-2011)

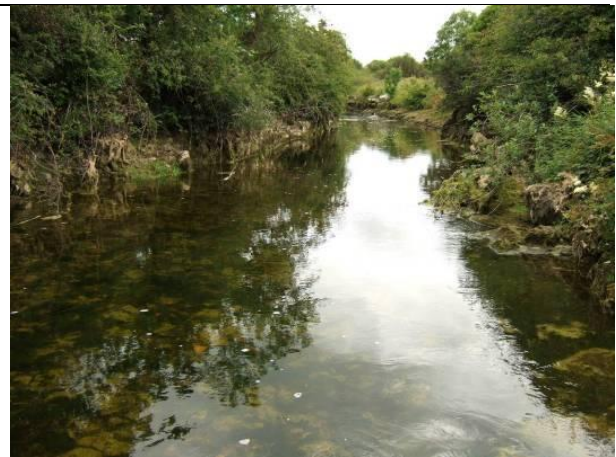
**Plate 31:** View of long run downstream from Point 32 toward Rinn Bridge. (21-7-2011).

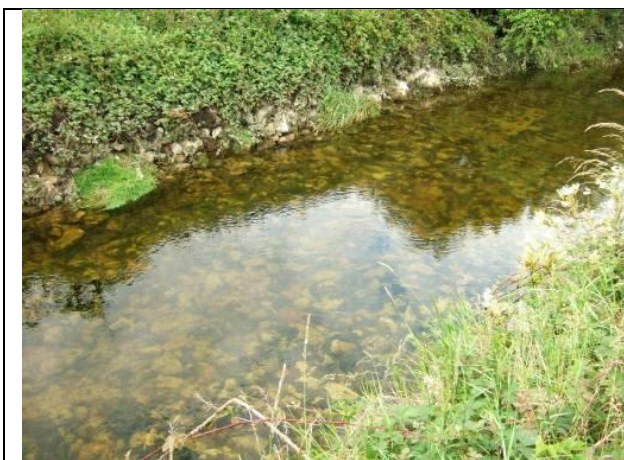
**Plate 32:** View upstream of long glide upstream from Point 32 (21-7-2011).

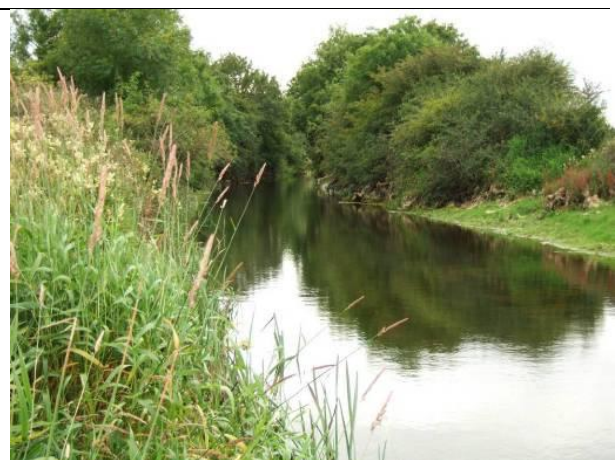
**Plate 33:** Shallow long glide downstream of Rahasane Turlough at Pt 33 - view upstream (21-7-2011).

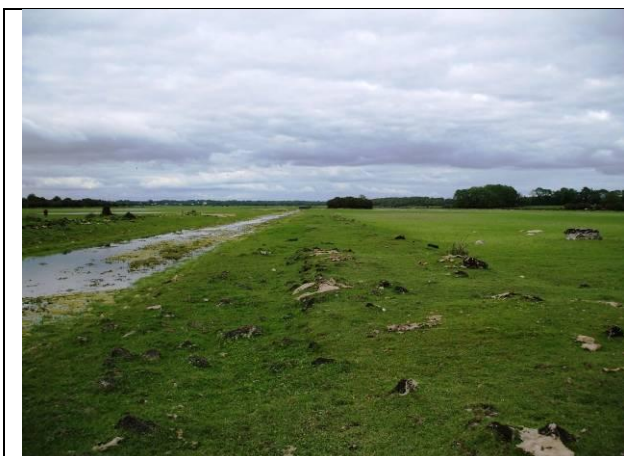
**Plate 34:** View of deeper glide at downstream exit from Rahasane Turlough to Dunkellin River - view downstream (21-7-2011).

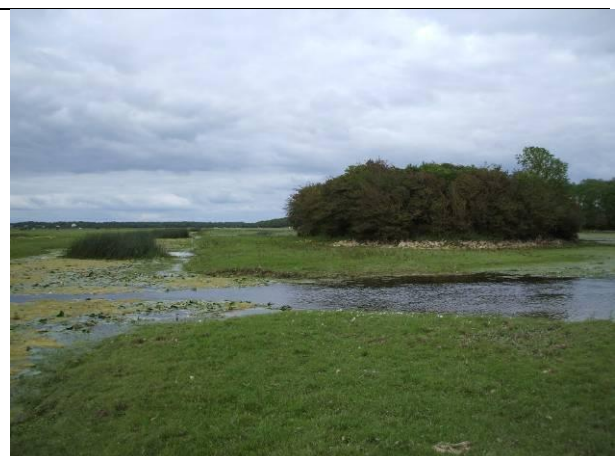
**Plate 35:** Rahasane Turlough drainage channel - view upstream from just above exit to Dunkellin River (21-7-2011). White-clawed crayfish hatchlings were caught in pond sweeps among submerged macrophytes.

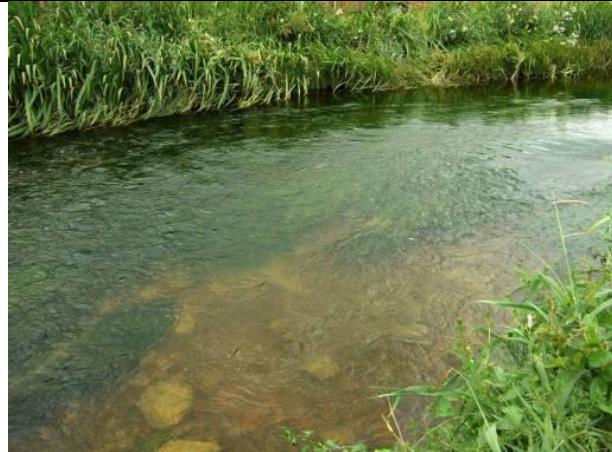
**Plate 39:** View US on Craughwell River just US of Aggard Stream confluence - note heavy crop of mid-channel *Ranunculus*. Crayfish were utilising marginal macrophytes, boulders/cobbles and rip-rap reinforcement on far bank (20-7-2011).

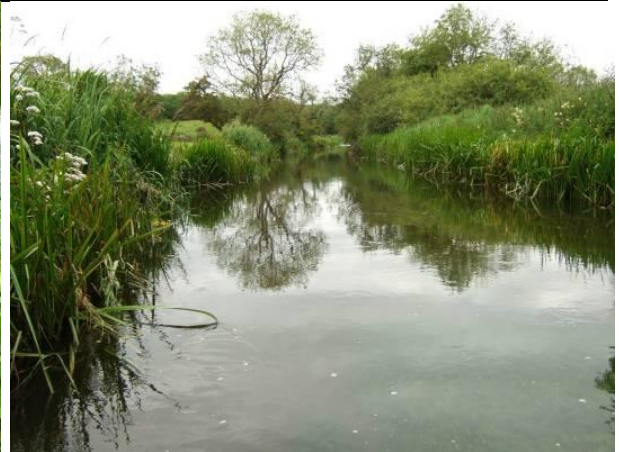
**Plate 40:** First glide upstream of Aggard Stream confluence - view upstream. Crayfish were present in marginal macrophytes (21-7-2011).

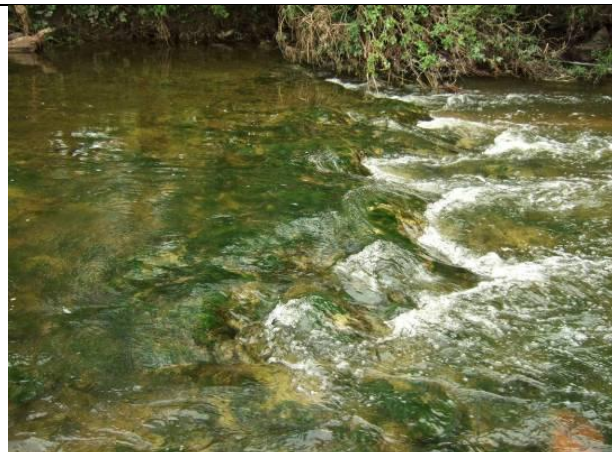
**Plate 41:** Short, step/weir - run sequence at Point 38 (21-7-2011)

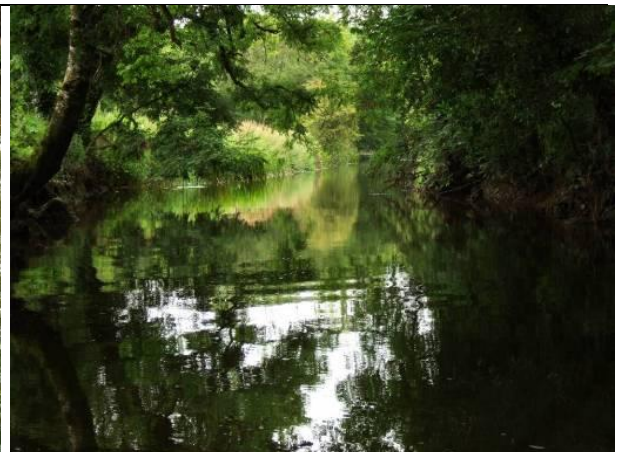
**Plate 42:** Middle lengthy glide between Aggard Stream confluence and Craughwell US from Point 42- view US (21-7-2011)

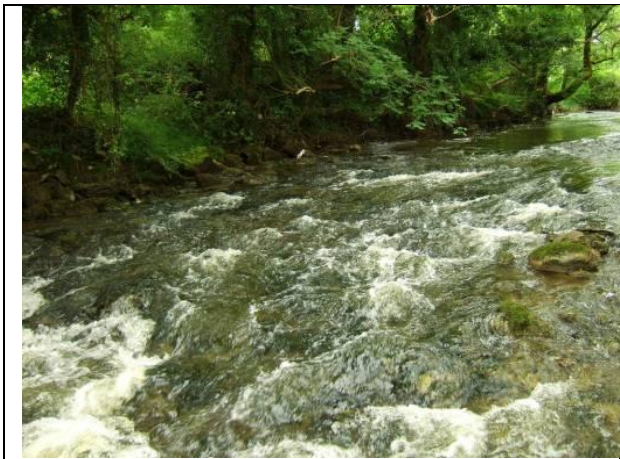
**Plate 43:** Short cascade leading into a run near Point 45. View US (20-7-2011). Crayfish found under boulders at margins in this habitat.

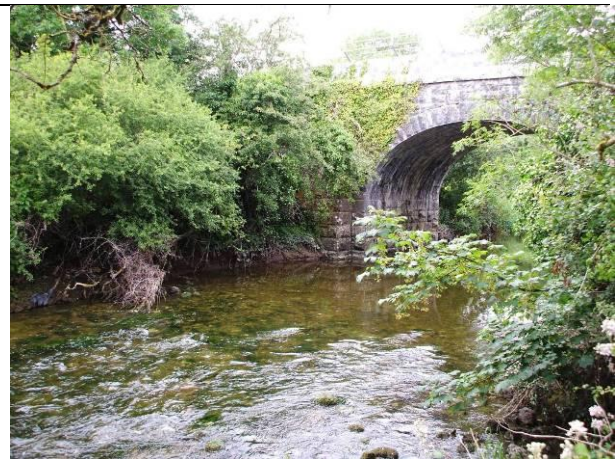
**Plate 44:** View US over shallow riffle /run downstream from the masonry railway bridge (Point 48) (20-7-2011).

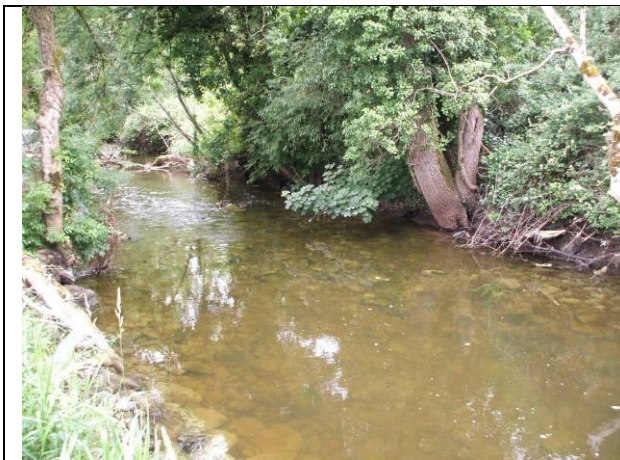
**Plate 45:** Riffle/run/glide downstream of railway bridge. Optimal crayfish habitat with submerged tree-roots and boulder/cobble substrates. Note the turbidity, evident in Craughwell R. but not below the turlough on the Dunkellin R. (20-7-2011).

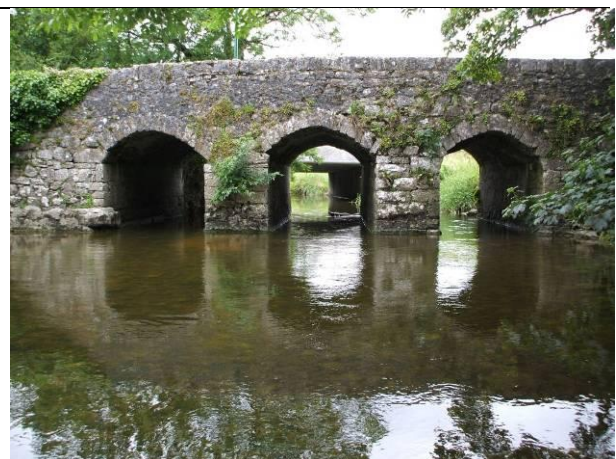
**Plate 48:** View upstream over shallow glide/run towards old bridge at Craughwell, with the N6 Bridge visible beyond. Crayfish were abundant under boulder/cobble in this stretch.

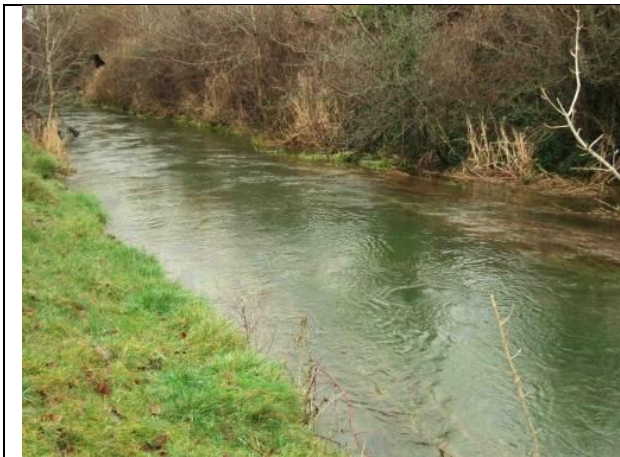
**Plate 61:** View d/s from AG5 - 'shoulders' of channel on both banks inundated - heavy *Ranunculus* in centre (8-1-2012)

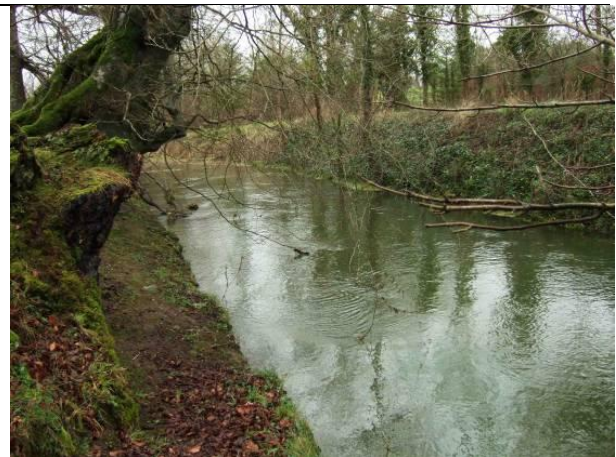
**Plate 62:** View d/s from AG6 - left foreground is toe of stepped drainage embankment (8-1-2012)

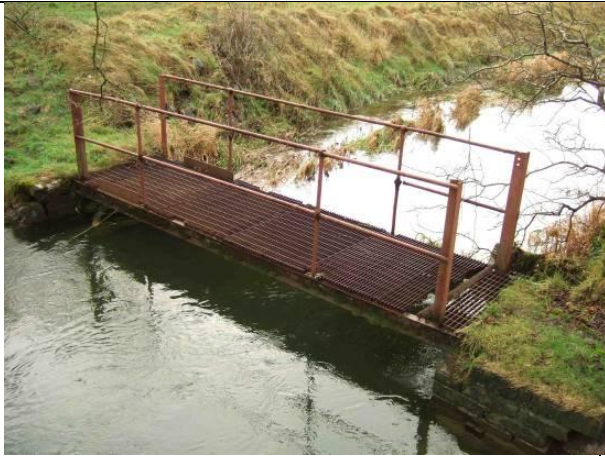
**Plate 67:** Metal footbridge at AG 10 - view u/s (8-1-2012)

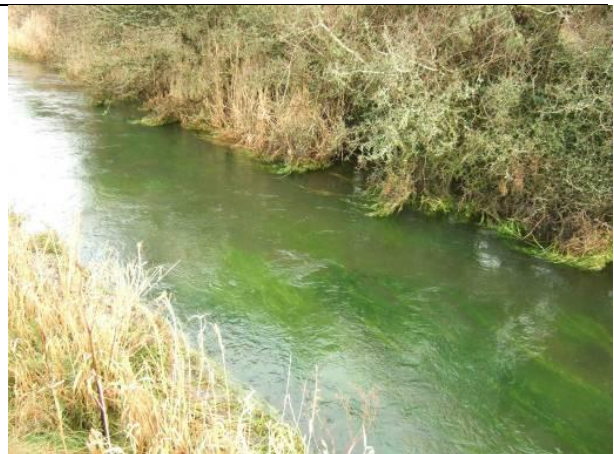
**Plate 71:** View u/s at AG13 -note swifter flows and heavy *Ranunculus* and open left bank (8-1-2012)

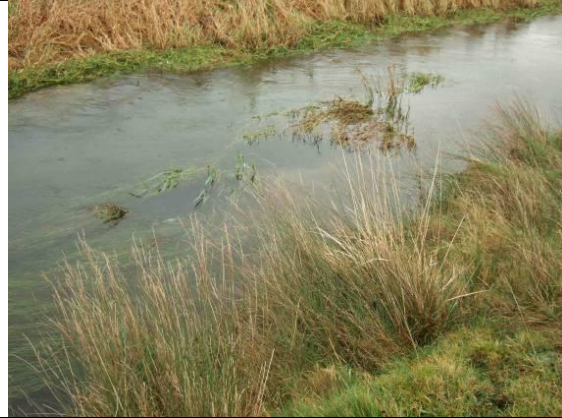
**Plate 74:** View u/s at AG16 – deeper, narrower channel (8-1-2012)

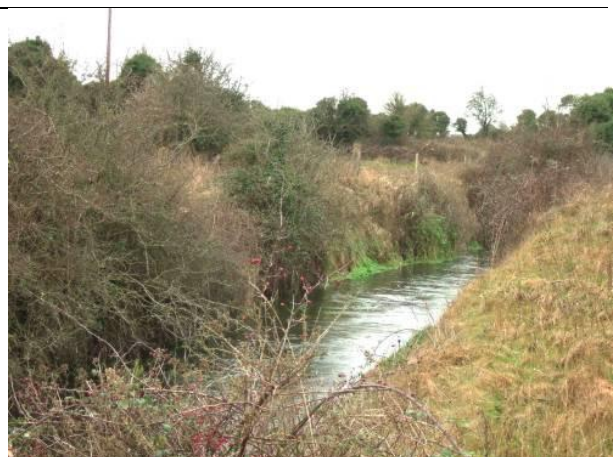
**Plate 82:** View upstream at AG24 - note narrowing of channel and steepness of banks (8-1-2012)

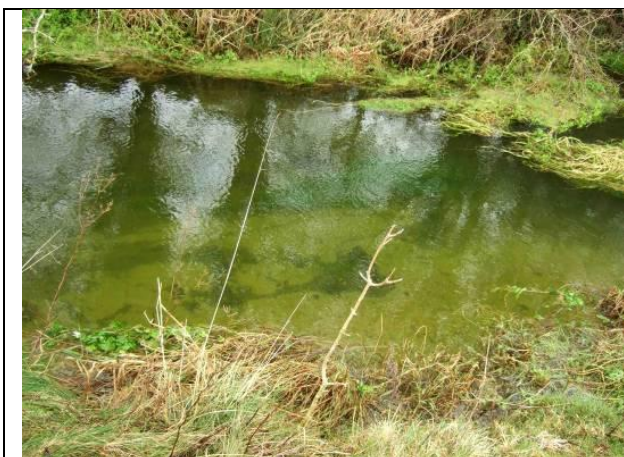
**Plate 83:** Clay-lined bottom / pool at AG26 (8-1-2012)

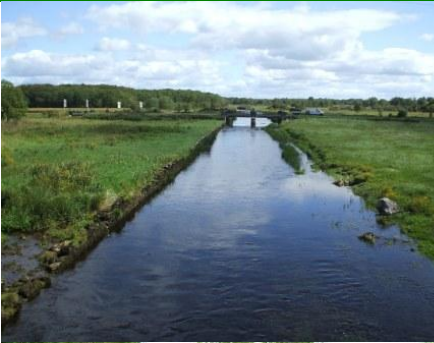
Location	Habitat description of survey 'patches' and methods employed.	Location	Site Photograph	Crayfish abundance (CPUE) and habitat assessment
<b>N18 Bridge</b>	Glide run with boulders and finer substrates with dense coverage of submerged and emergent aquatic macrophytes (e.g., <i>Apium</i> , <i>Berula</i> and <i>Sparganium</i> ).	M 41842 18502

<b>CPUE = 0</b> Absent or undetected. <b>Sub-optimal.</b>
<b>Between N18 Bridge and Kileely Bridge</b>	30m stretch of boulder/cobble overlaying silty gravels at river margin, with a lot of moss and liverwort. 15min manual search of refuges.	M 42469 18685

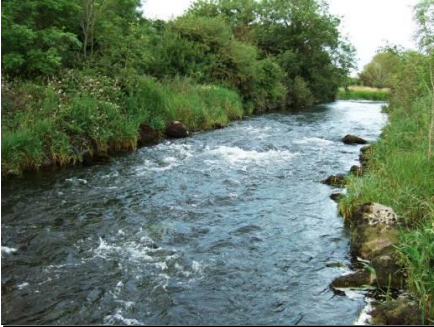
<b>CPUE = 0</b> Absent or undetected. <b>Sub-optimal at mid-channel mainly owing to channel velocity. Optimal habitat at river margin.</b>
<b>Kileely Beg Bridge</b>	5 habitat patches (50 refuges) searched in 100m stretch (50m either side of bridge). Banks of un-mortared block armour reinforcement. Channel substrates largely bedrock with a few overlaying boulders.	U/S: M 43260 18497

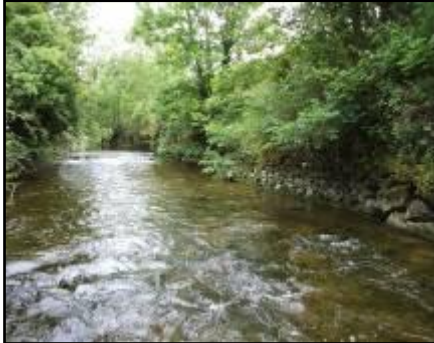
<b>CPUE = 0</b> Absent or undetected. <b>Sub-optimal or Poor habitat for juveniles and adults mid-channel. Optimal habitat at river banks.</b>

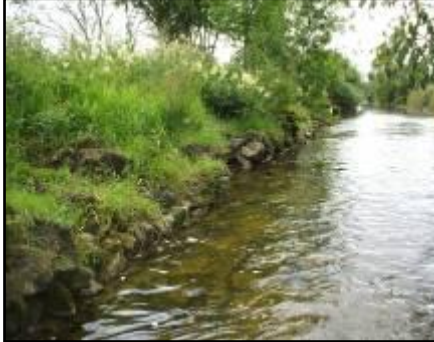
Location	Habitat description of survey 'patches' and methods employed.	Location	Site Photograph	Crayfish abundance (CPUE) and habitat assessment
		D/S: M 43098 18550

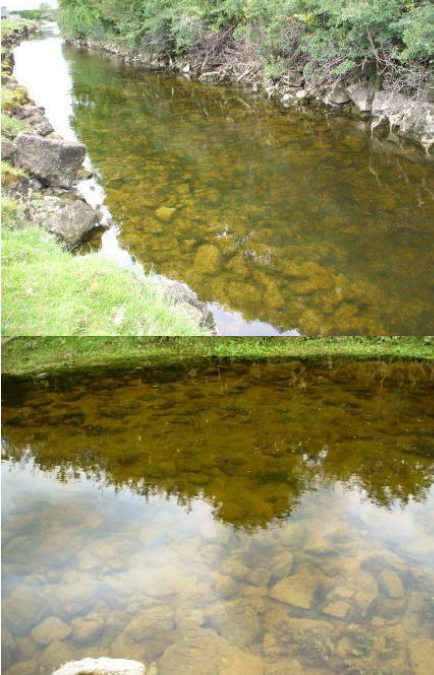
<b>Dunkellin Bridge</b>	<p>5 habitat patches (50 refuges) searched in 100m stretch (50m either side of the bridge).  U/S - Banks of cut-stone and un-mortared block armour reinforcement. Channel substrates of boulder and cobble with very little instream vegetation and glide/run flow.  D/S riffle/run into wider section of glide over boulder/cobble + finer substrates.</p>	U/S: M 44577 18590

<p><b>CPUE = 0</b>  Absent or undetected</p> <p><b>Optimal + some sub-optimal habitat for juveniles and adults mid-channel. Optimal habitat at river banks.</b></p>

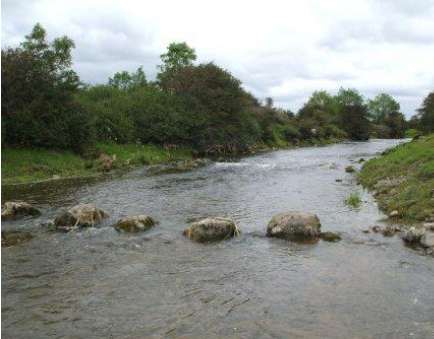
Location	Habitat description of survey 'patches' and methods employed.	Location	Site Photograph	Crayfish abundance (CPUE) and habitat assessment
<b>1<sup>st</sup> riffle U/S of Dunkellin Bridge</b>	Cobble/gravel riffle with small boulders. 10min manual presence/absence search.	M 44733 18676

CPUE = N/A  <b>Crayfish Present</b> (Total of 4 adults found under larger stones)  <b>Optimal habitat.</b>
<b>c.100m D/S Rinn Bridge</b>	15 min manual search under boulders at accessible margins. Long glide – primarily bedrock with small and large boulders and no in-stream plant cover. A lot of.	M 45394 18457

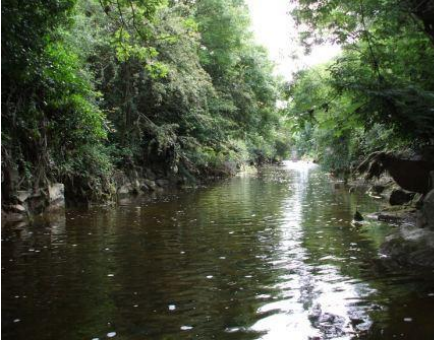
CPUE = approx. 1 per 10 refuges Moderate abundance  <b>Generally sub-optimal habitat. Many potential refuges were inaccessible so the CPUE may be an underestimate.</b>
<b>Rinn Bridge</b>	5 habitat patches (50 refuges) searched in approx. 80m stretch (40m either side of the bridge). Shallow riffle/run over cobble with moderate coverage of filamentous algae. Banks generally of cut stone.	M 45496 18387

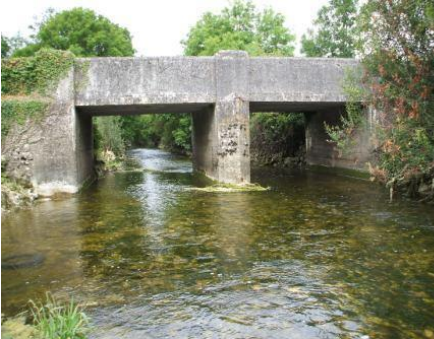
CPUE = 2 per 10 refuges Moderate abundance  <b>Optimal habitat. Both juvenile and adult crayfish present.</b>

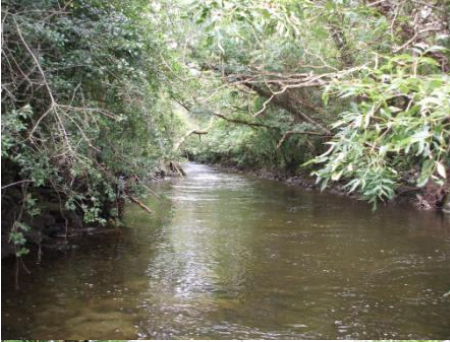
Location	Habitat description of survey 'patches' and methods employed.	Location	Site Photograph	Crayfish abundance (CPUE) and habitat assessment
<b>Craughwell River between Aggard confluence and Rail Bridge</b>	Spot sampling.

<p>CPUE = N/A</p> <p>Crayfish present.</p> <p>Sub-optimal habitat.</p>
<b>Craughwell River at Rail Bridge</b>	Spot sampling.

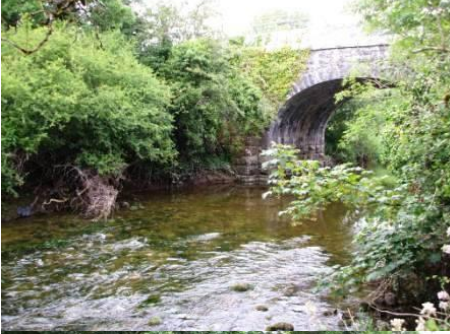
<p>CPUE = N/A</p> <p>Appears to be a moderate-high abundance.</p> <p>Optimal habitat.</p>
<b>Craughwell River N6 Bridge/ Stone arch masonry Pedestrian Bridge</b>	5 habitat patches (50 refuges) searched in 100m stretch (50m either side of the bridge).	M 51105 19930

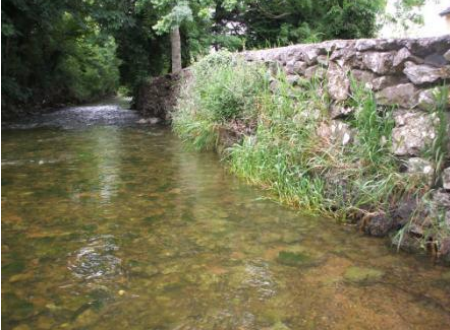
<p>CPUE = 3 per 10 refuges: High abundance.</p> <p>Optimal habitat.</p>

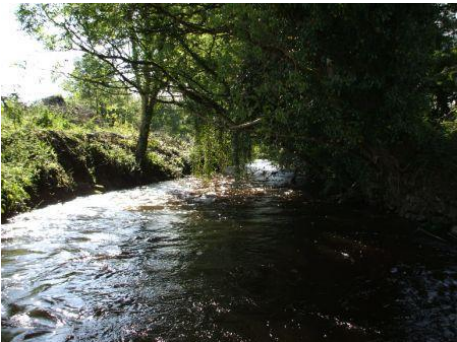
Location	Habitat description of survey 'patches' and methods employed.	Location	Site Photograph	Crayfish abundance (CPUE) and habitat assessment
<b>Craughwell River, c.1.5km U/S Craughwell.</b>	15min manual search of refuges along margins. Boulder over gravel/sand. Water levels very high and coloured which limited efficacy.	M 52658 20044

CPUE = N/A <b>4 crayfish</b> <b>Crayfish present.</b>  Optimal habitat.
