Dunkellin River and Aggard Stream Flood Relief Scheme,  
Description of the Proposed Works

# Galway County Council

### Description of the Proposed Works

**PROJECT:** **Dunkellin River and Aggard Stream Flood Relief Scheme**

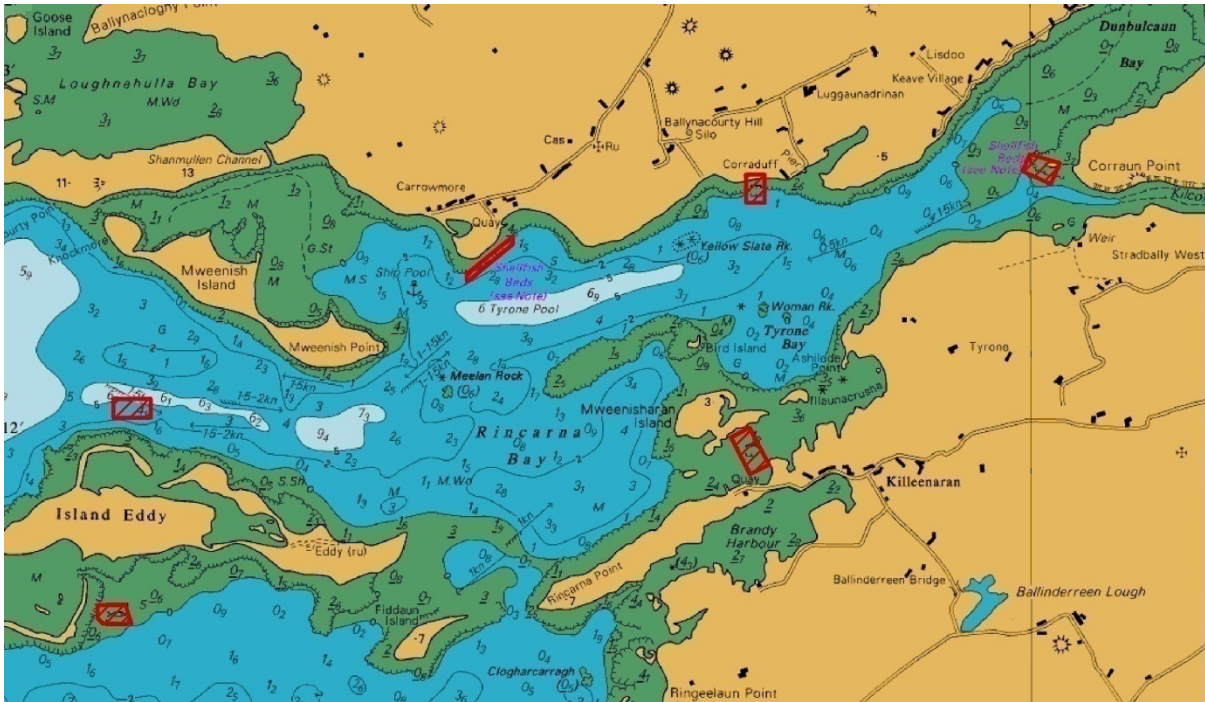
Figure 3.5: Licensed aquaculture sites - red hatched areas

In order to provide a balanced comparison, rather than a ‘worse case snapshot’ the effect of the scheme on the shellfish beds was investigated over the period of the event. All licensed sites in the vicinity were analysed as illustrated by the red hatched areas in Figure 3.5. The site at Lynch’s Quay was found to be representative of the most affected areas and is presented in more detail. Figure 3.6 and Figure 3.7 show the salinity comparisons at this location for the model period and in detail over peak discharge period respectively. It may be seen that the change in the hydrograph due to the flood alleviation scheme has a virtually undetectable impact on the salinity variations at the shellfish beds. The greatest difference is approximately 0.15 PSU which occurs immediately following the peak flow; the hydrographs shown on the detailed plot demonstrate this.
