Route Options Report on the N17 Milltown to Gortnagunned Road Improvements Scheme

Archaeology and Architectural Heritage

Jerry O'Sullivan, TII Archaeologist
August 2018; Revised February 2019

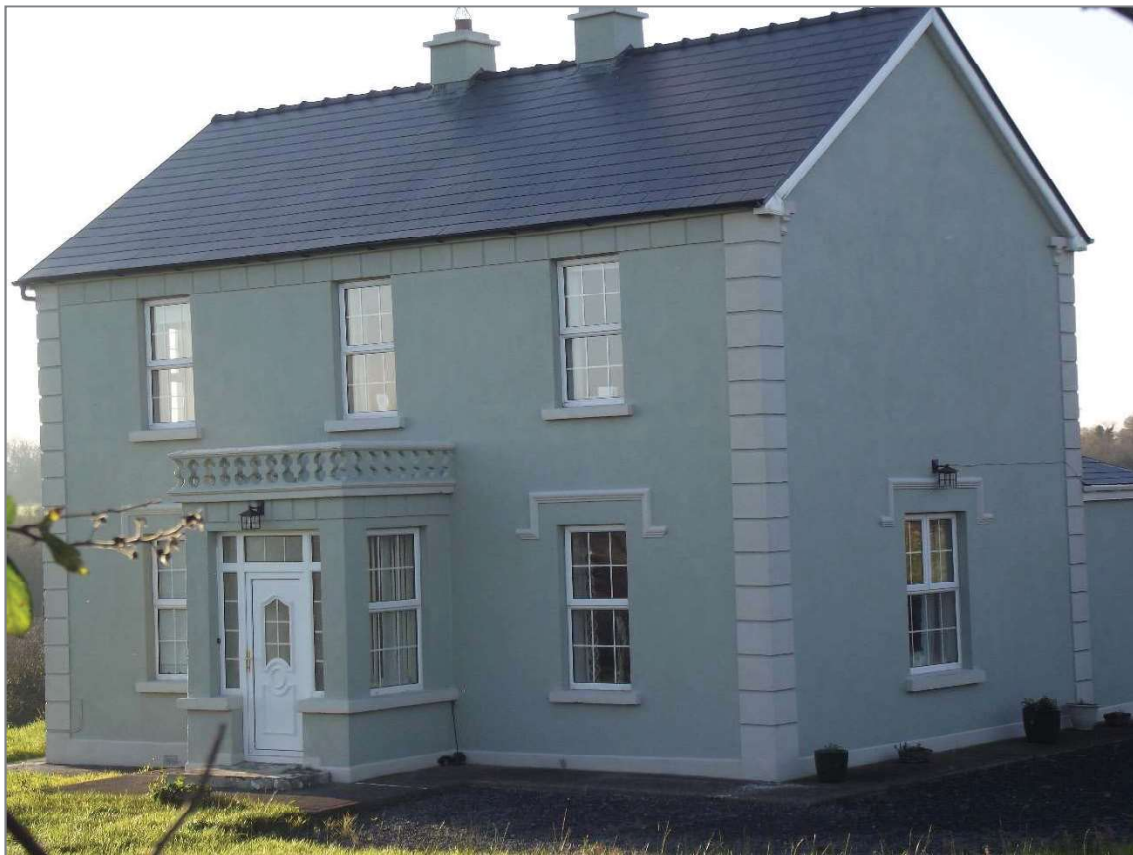
Illus. 5.1 and 5.2—Two attractive, well-maintained houses with traditional features are directly threatened by Route Option 2 (Inventory No. 15, above) and Route Option 3 (No. 18, below) and would be demolished, amounting to severe impacts of these options.

- **Route Option 2** would have five slight impacts, two moderate impacts and one severe impact. Again, the slight impacts would be to boundary features (walls, gateways), the railway level crossing (No. 7), and townland name plaques along the margins of the existing road (No. 24). The moderate impacts would be the loss of a boundary wall with mature broadleaf trees (No. 25); and demolition of a ruined early modern farmhouse (No. 26). The severe impact would be demolition of a well maintained farmhouse in a highly visible roadside setting (No. 15).

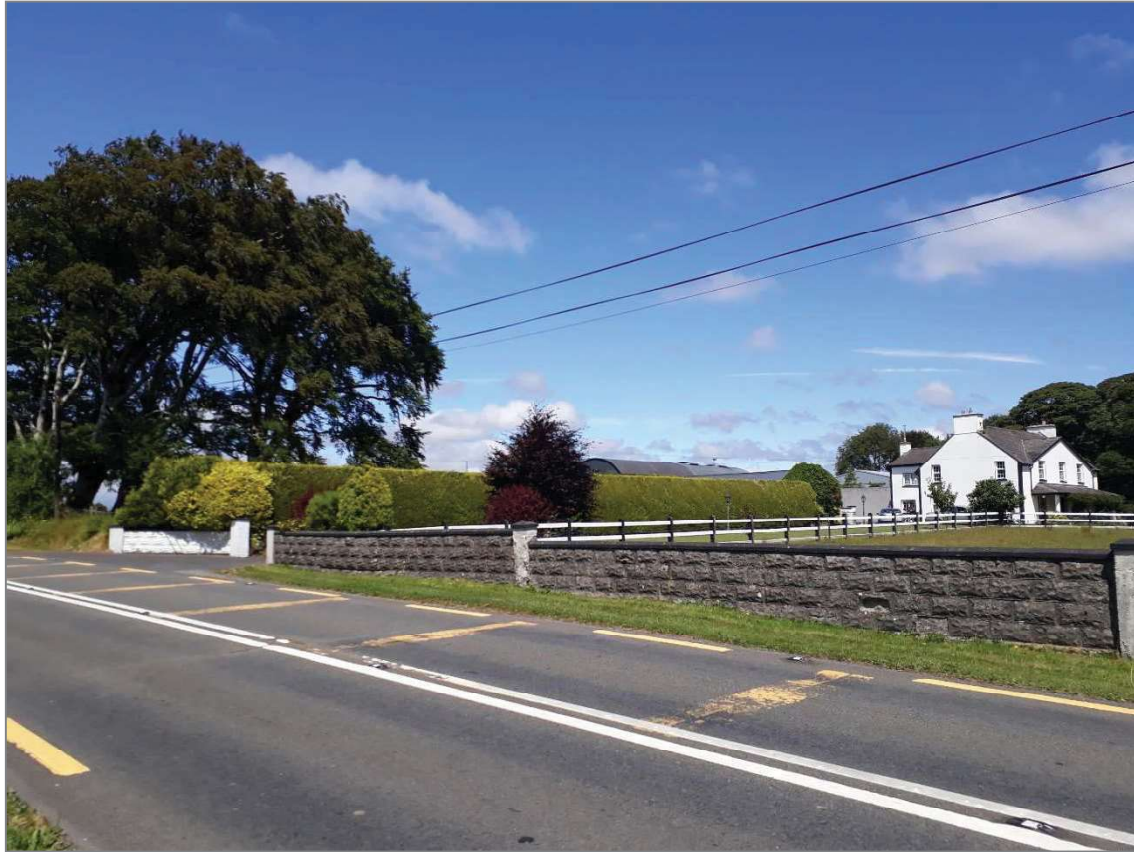
Illus. 5.3 and 5.4—Roadside boundaries with mature trees are threatened by all four options: Inventory No. 17, above (Option 1) and No. 25, below (Options 1, 2, 2A and 3). These are rated moderate impacts of these options.

- **Route Option 1** would have four slight impacts, three moderate impacts and no severe impacts. The slight impacts would be to boundary features (walls, gateways), the railway level crossing (Inventory No. 7) and townland name plaques along the margins of the existing road (No. 24). The moderate impacts would be the loss of boundaries with mature broadleaf trees at two early modern houses (Inventory Nos 17 and 25) and demolition of a ruined early modern farmhouse (No. 26).

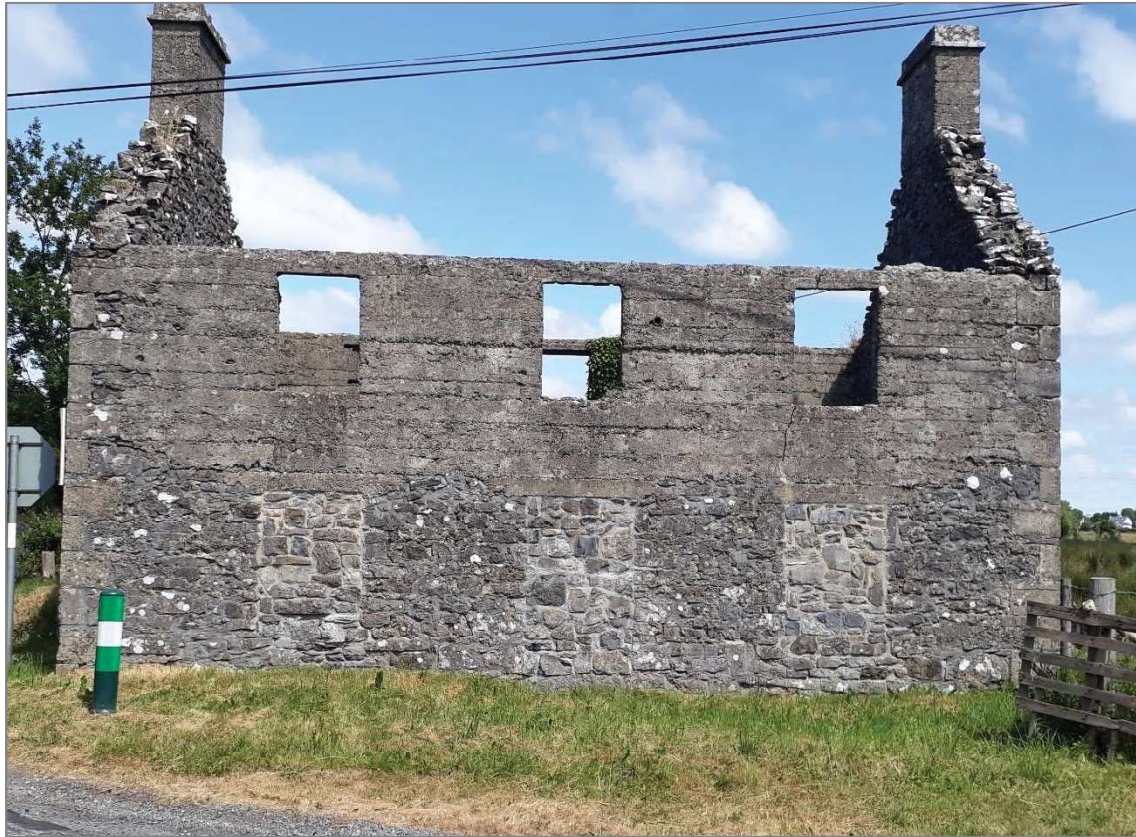
Illus. 5.5 and 5.6—A ruined early modern farmhouse would be demolished on Route Options 1 and 2 (Inventory No. 26, above), which is rated a moderate impact. Inscribed townland names along the existing N17 (No. 24) would be removed by all four options, and should be reinstated on the new road.

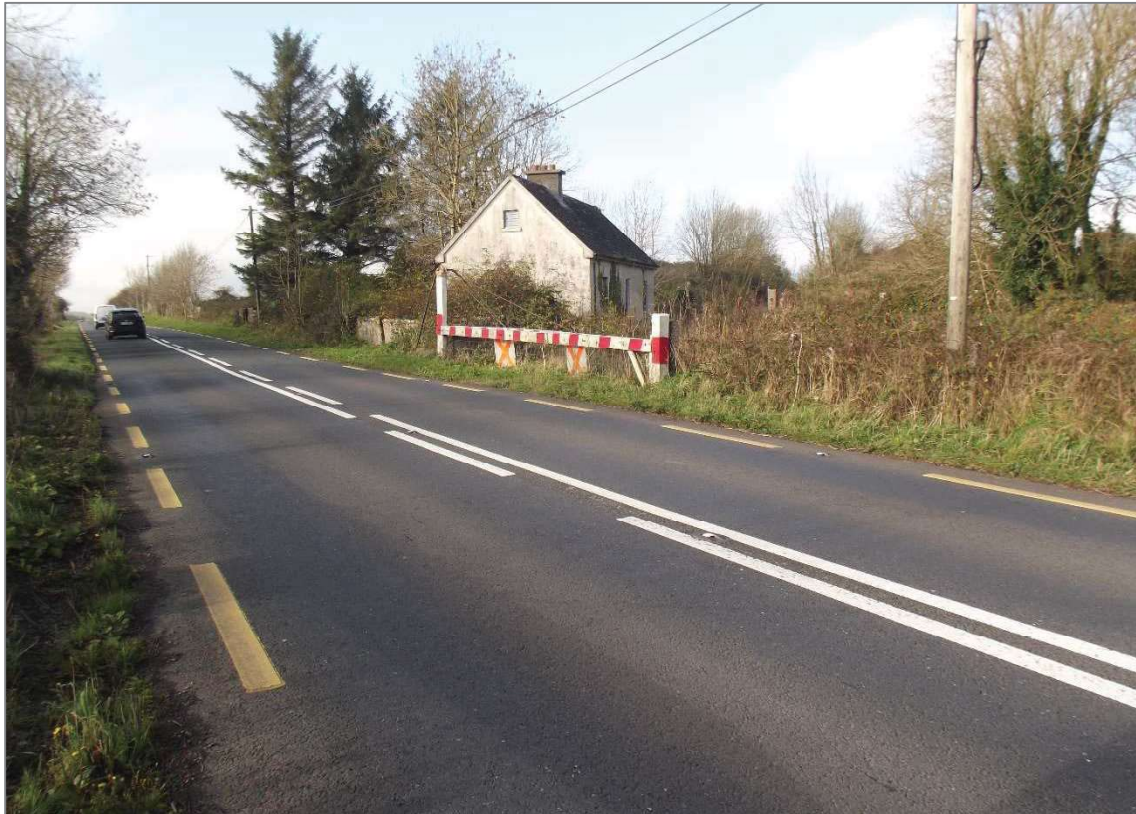
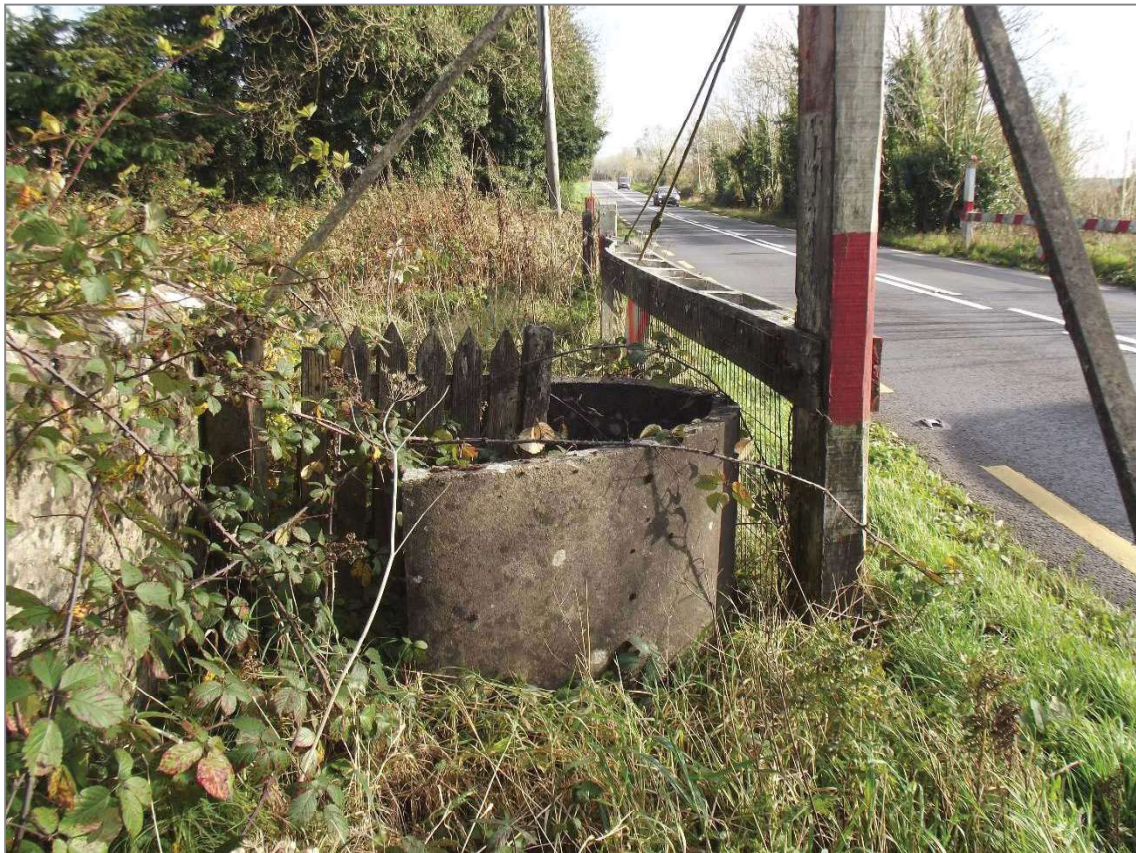
Illus. 5.7 and 5.8—Railway crossing on the N17 (Inventory No. 7). Options 1 and 2 would affect the boundary wall and pedestrian stile (below); Option 2A would result in the demolition of the keeper's cottage also, which is rated a severe impact of the road project.

- **Route Option 2A** would have two slight impacts, one moderate impact and one severe impact. Again, the slight impacts would be to boundary features (walls, gateway) and roadside name plaques (No. 24). The moderate impact would be the loss of a boundary wall with mature broadleaf trees (No. 25). The severe impact would be to a group of railway features including crossing barriers, a boundary wall and pedestrian stile and the crossing-keeper's cottage (No. 7).

Arising from the above the preferred route option in terms of potential impacts on the archaeological and architectural heritage is Option 1, followed by Option 3 then Options 2 and 2A. Although three options have severe impacts, the loss of a railway crossing-keeper's cottage on Route 2A is deemed to be a worse outcome than the loss of dwelling houses, albeit well maintained and of traditional form, because the crossing-keeper's cottage is part of a larger group and is a less common building type.
